CK-2050

CHILLIWACK LAKE 8km

2018 Inspection

| Crossing Name | Paleface Creek |

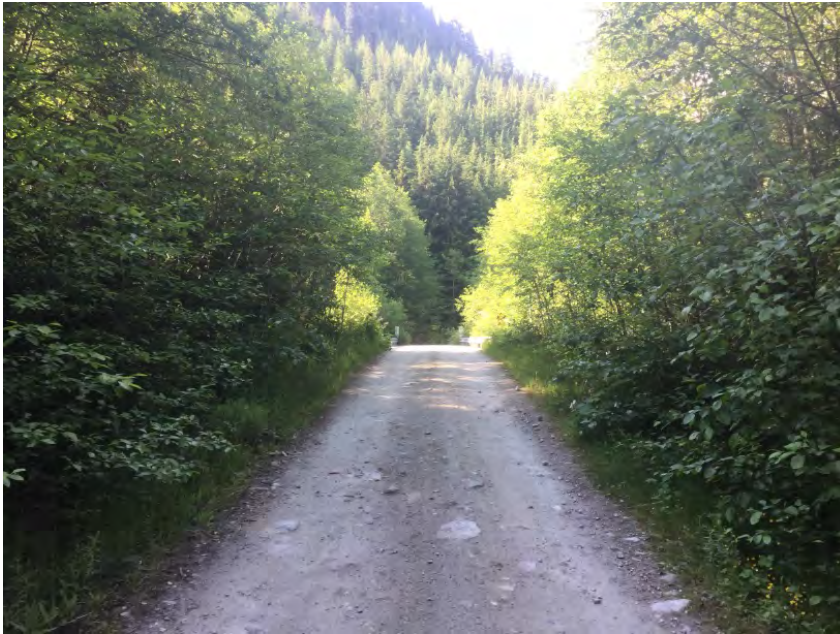
Approach from Right Bank when facing downstream

Potholes at either approach

| 1 | Medium | Brush and grade approaches |

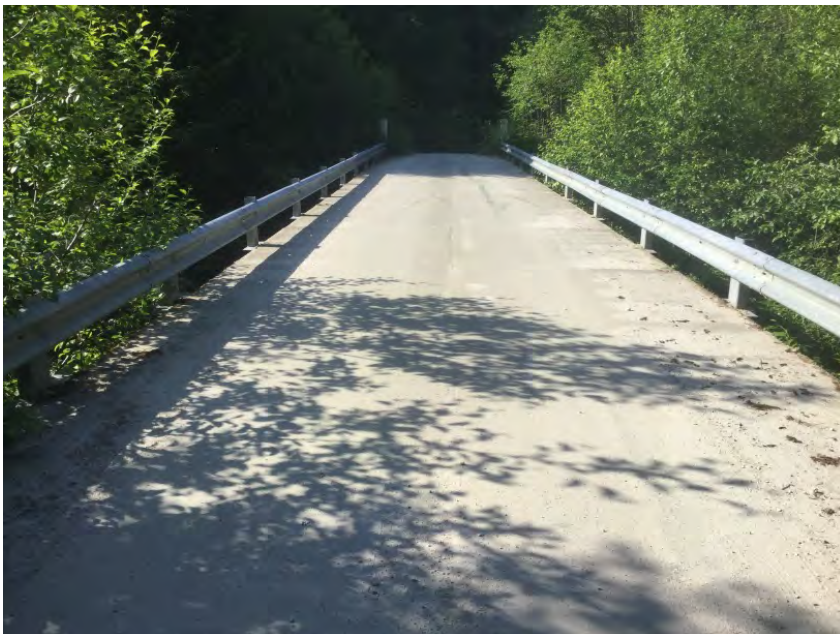
Overall Deck Condition      Good

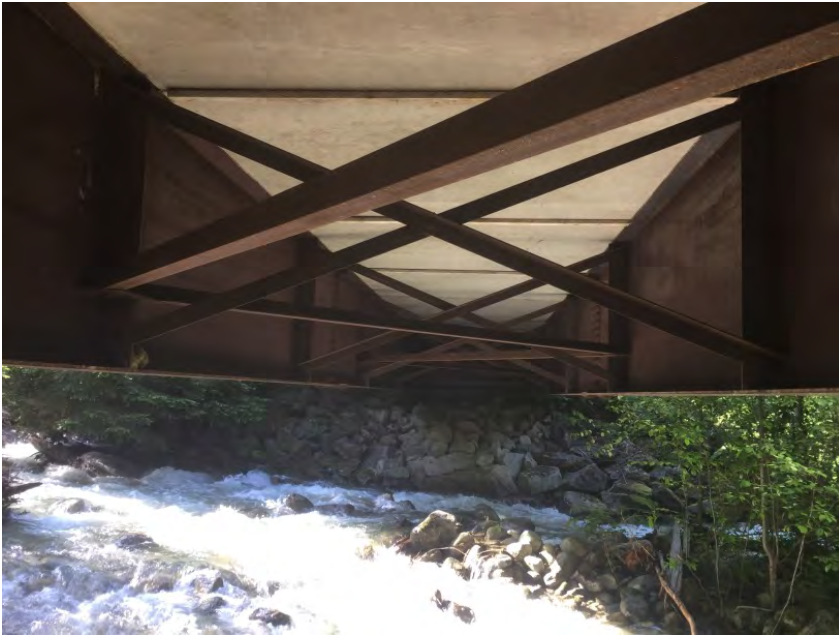
Superstructure

Girders Good
