CK-2051

CHILLIWACK LAKE 8.1km

2018 Inspection

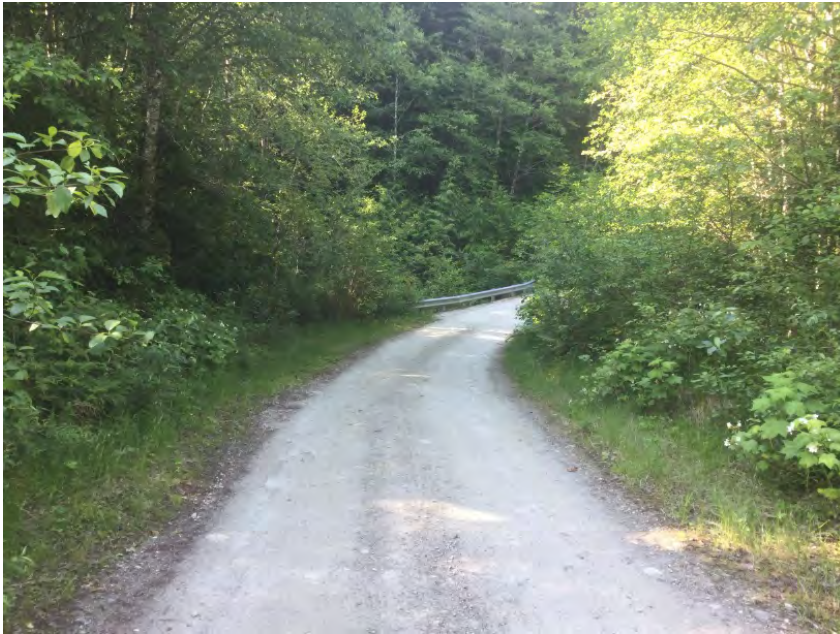
HC and VC right approach, HC left approach

Approach from Right Bank when facing downstream

| Repair | | Repair Description |
|---|---|---|
| 1 | Medium | Brush and grade approaches |

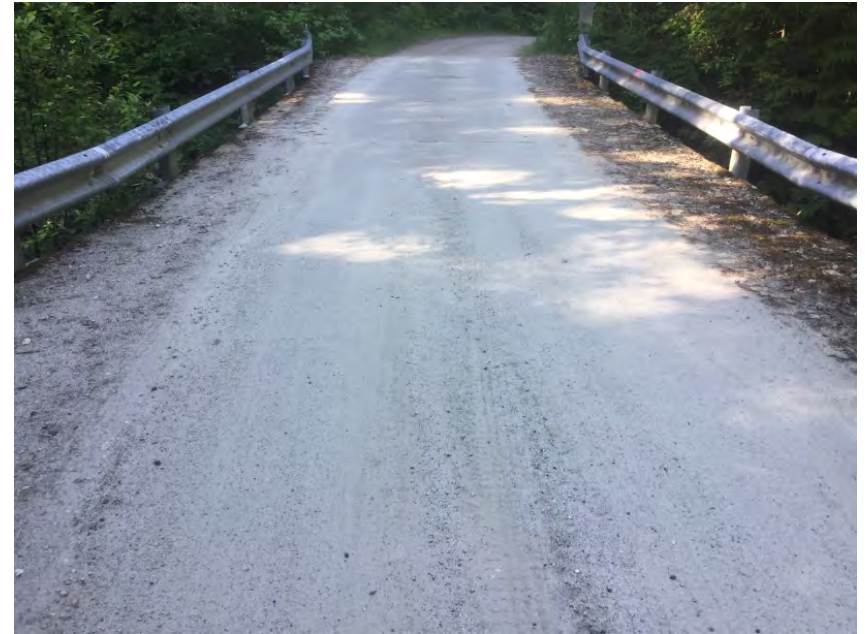
Deck

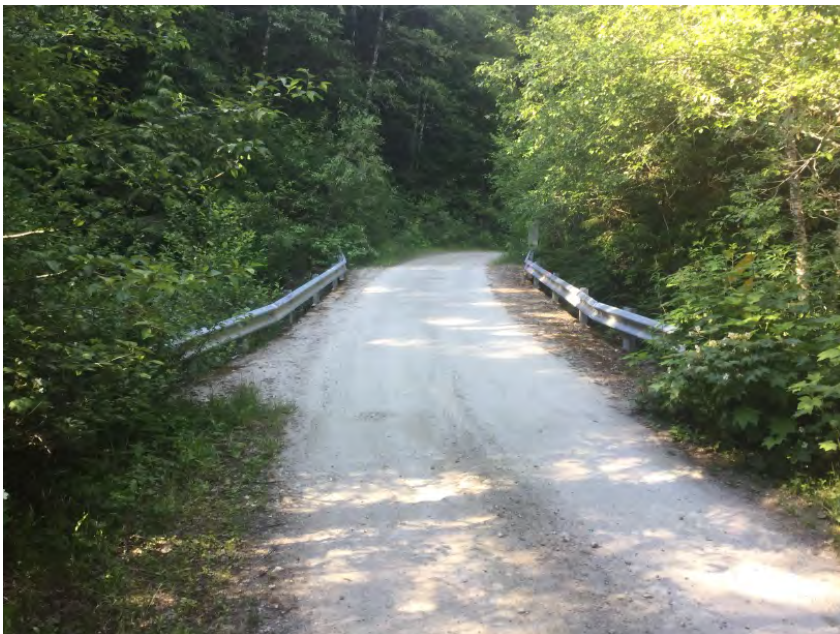
Approach from Right Bank when facing downstream

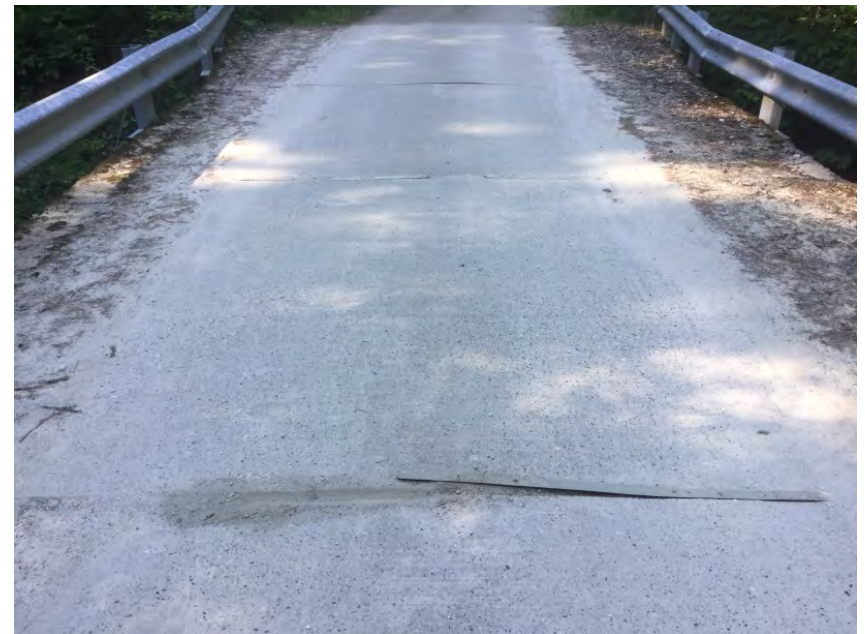
Deck Joints      **Fair**      Paraseal coming off

Paraseal wearing in locations

| Repair | | Repair Description |
|---|---|---|
| 3 | Medium | Replace paraseal deck joint sealant |

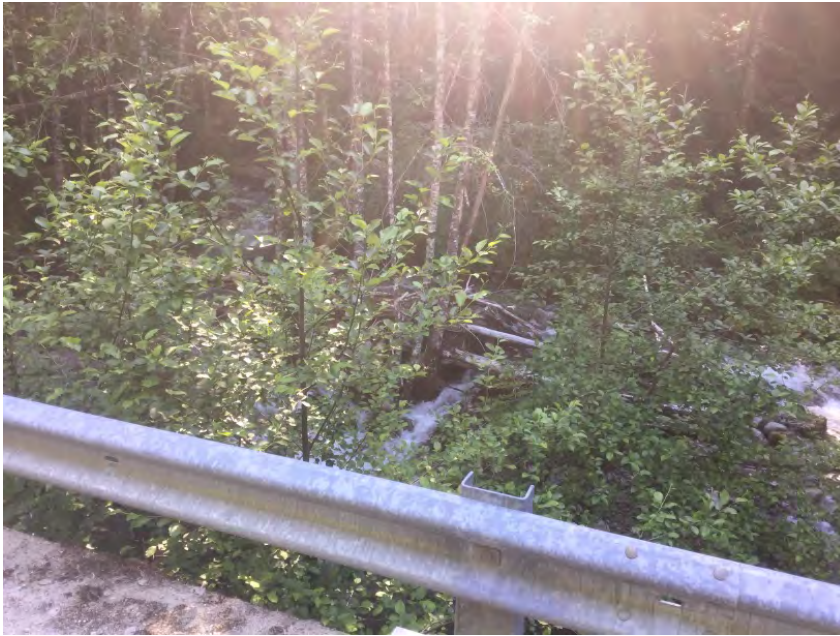
Upstream from Crossing

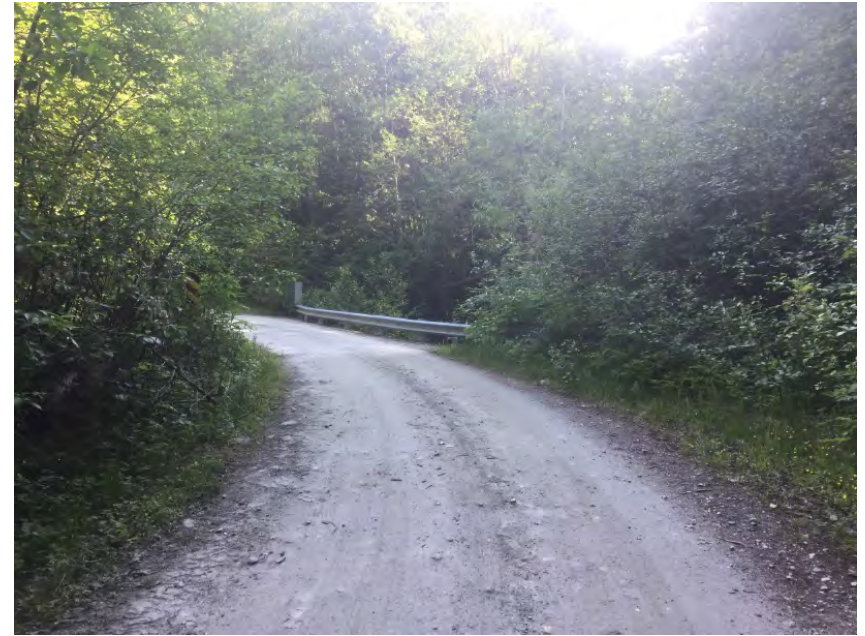
Approach from Left Bank when facing downstream

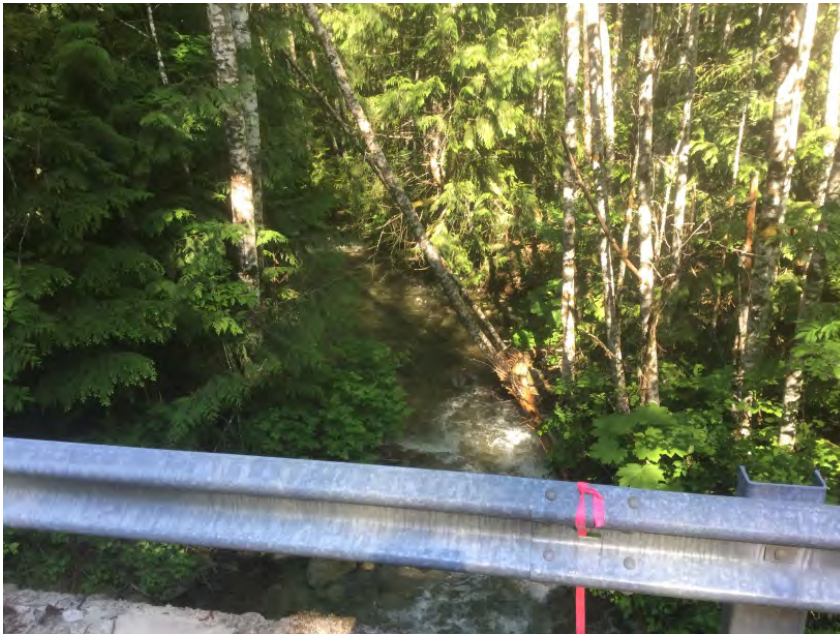
Downstream from Crossing

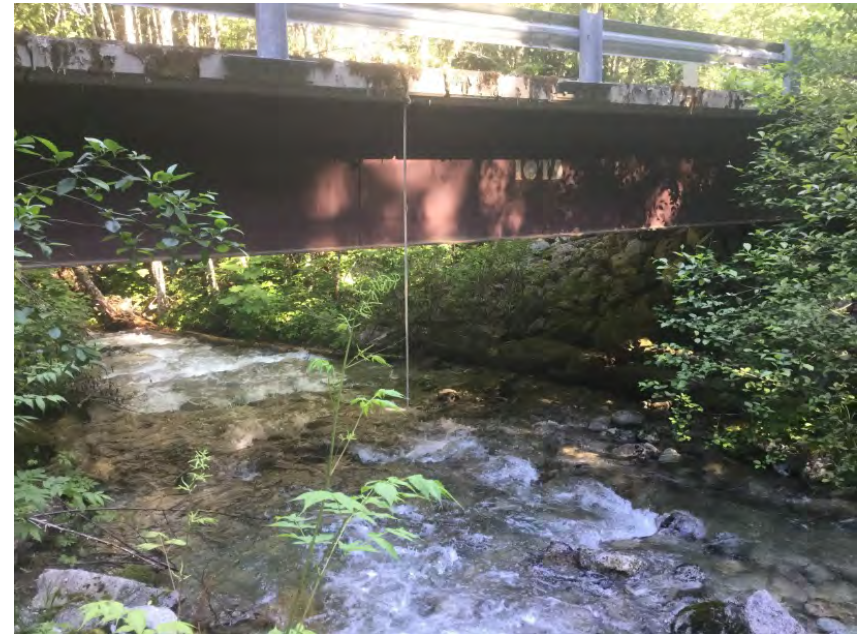
Upstream Profile

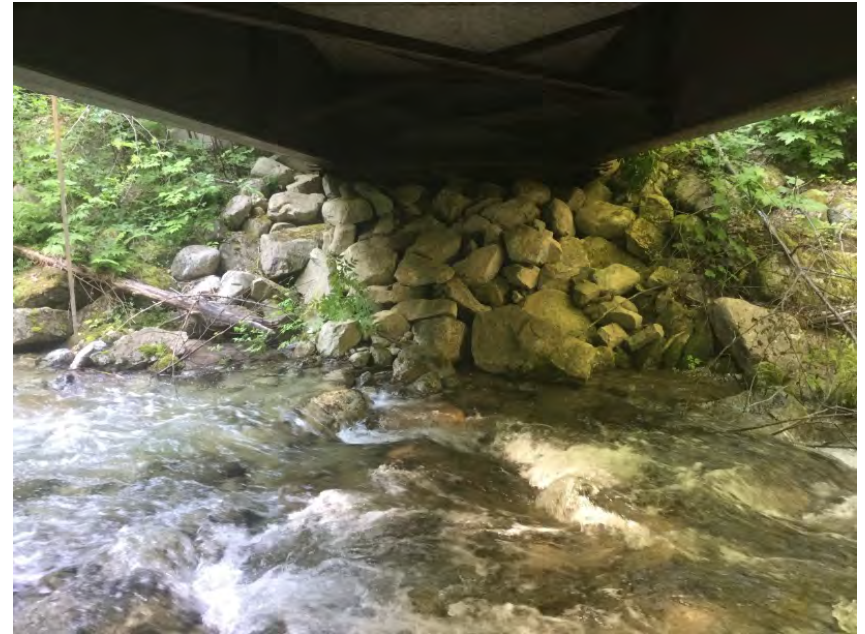
Left Bank Abutment when facing downstream

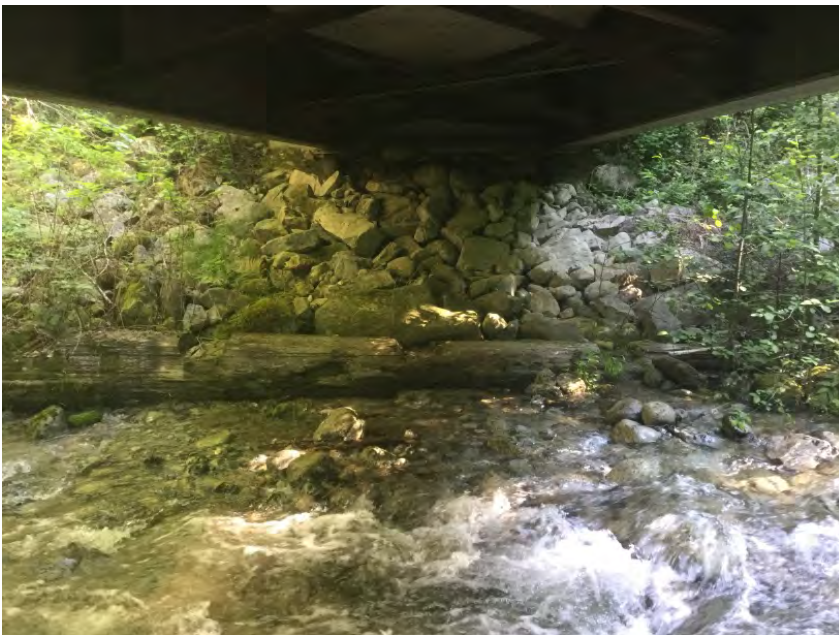
Right Bank Abutment when facing downstream

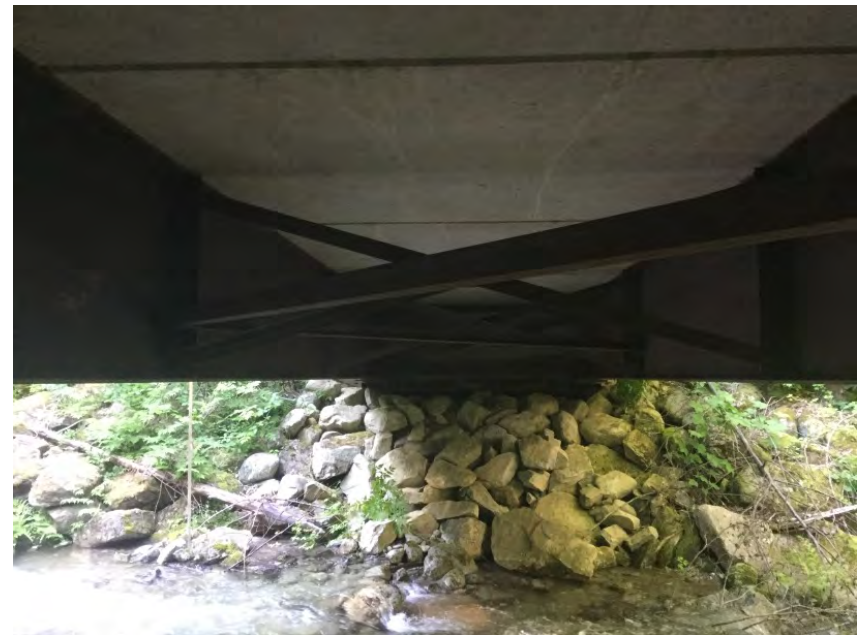
Superstructure
