CK-2072

BENCH 5.2km

2018 Inspection

| Crossing Name | Wells Ranch Creek | | |

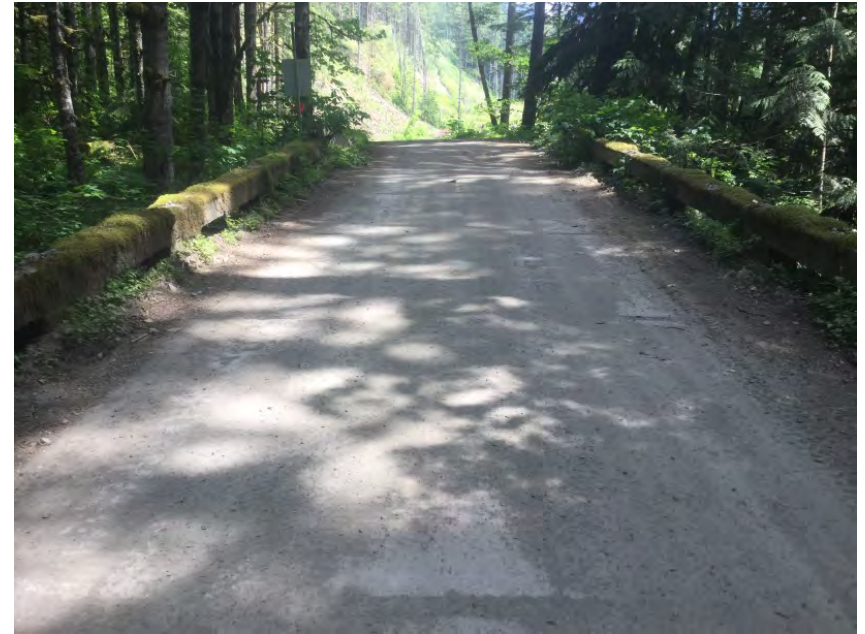
Curb Rail/Blocks/Posts Poor Rotten

Hardware Poor Loose rail bolts

Overall Deck Condition Poor Due to rail condition

| Repair Item | Priority | Repair Description |
|---|---|---|
| 1 | Medium | Replace guardrail, risers and blocks |

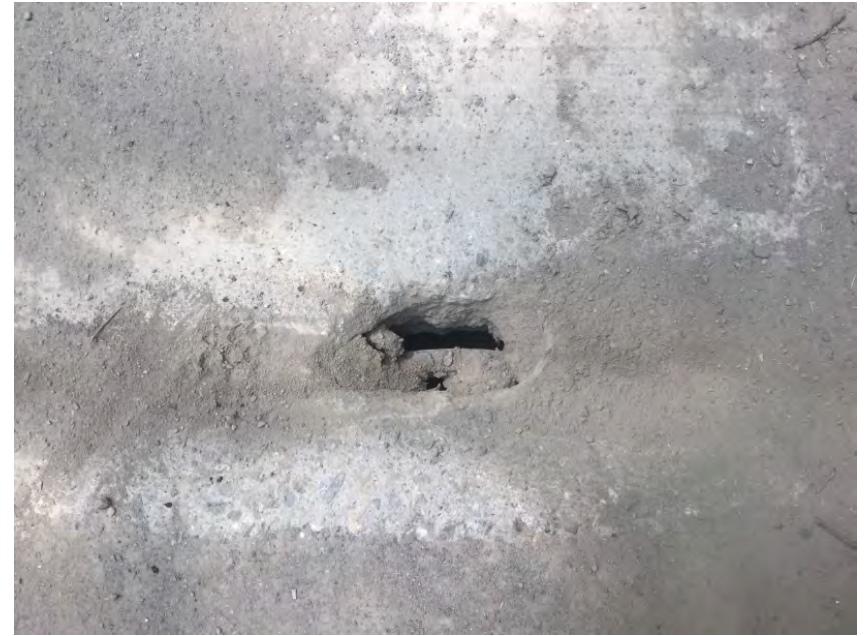
Ballast Wall Fair Damage noted to top and bottom of left abutment

Concrete Deck Fair Both approach panels have damage where rebar is exposed

Damage to ballast wall and deck panel at left approach

Replace guardrail, risers and blocks. Repair damage to concrete on both approach panels and the left abutment ballast wall, consistent with the Concrete Repair Guide for Concrete Bridge Components (FLNRO, 2017). Brush and grade approaches. Present load rating of L75 or 68 tonnes to continue.

| Repair Item | Priority | Repair Description |
|---|---|---|
| 2 | Medium | Repair both approach deck panels and left abutment ballast wall |

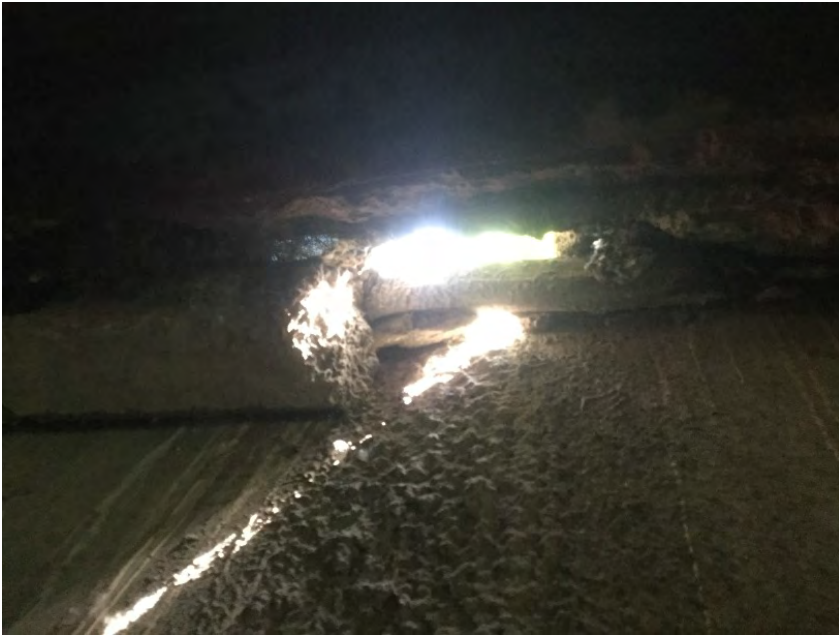
Damage to panel 1 at left approach

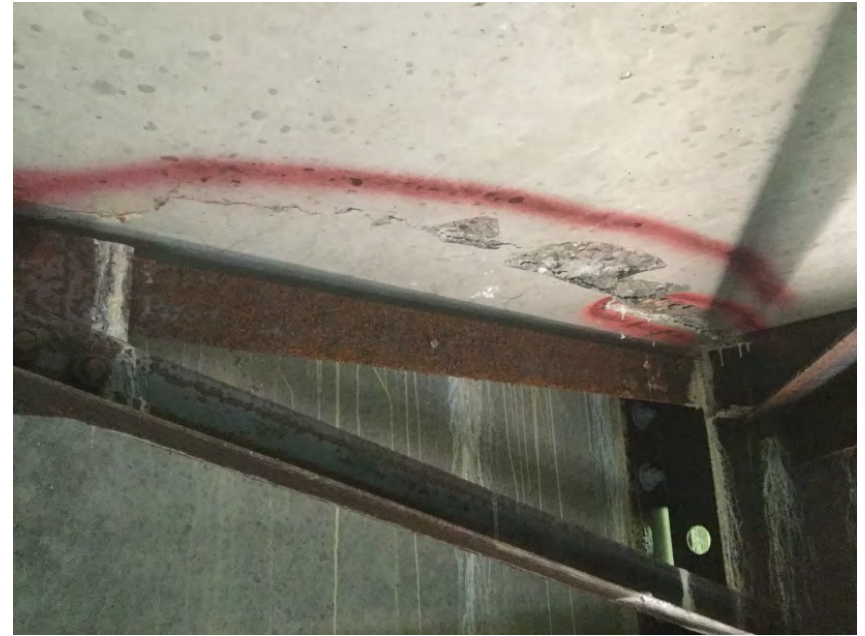
Damage to panel 1 at left approach

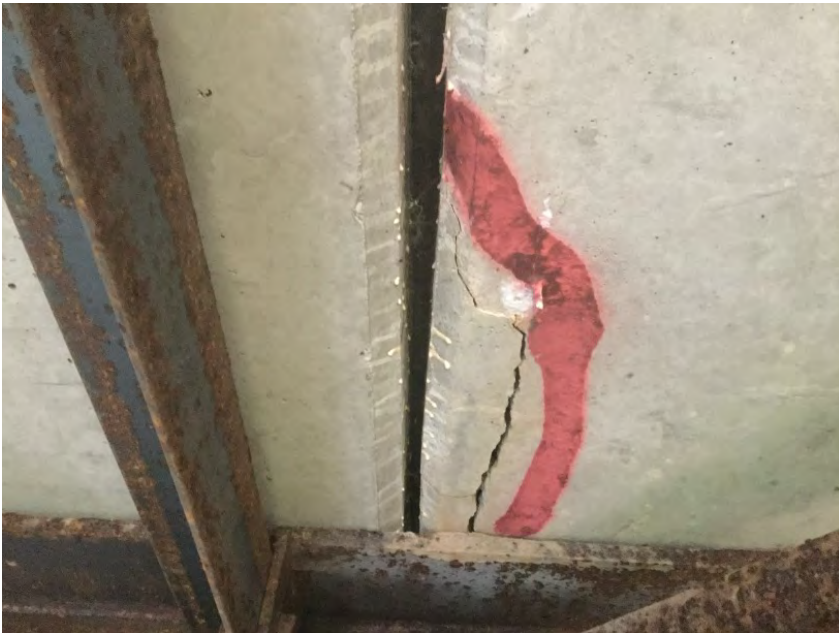
Damage to panel 1 at left approach

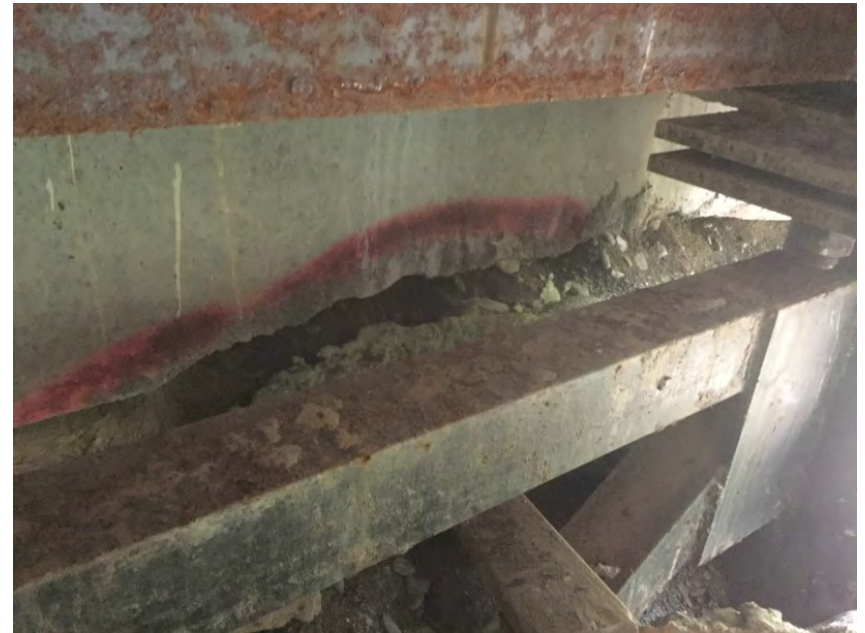
Damage to ballast wall at left approach

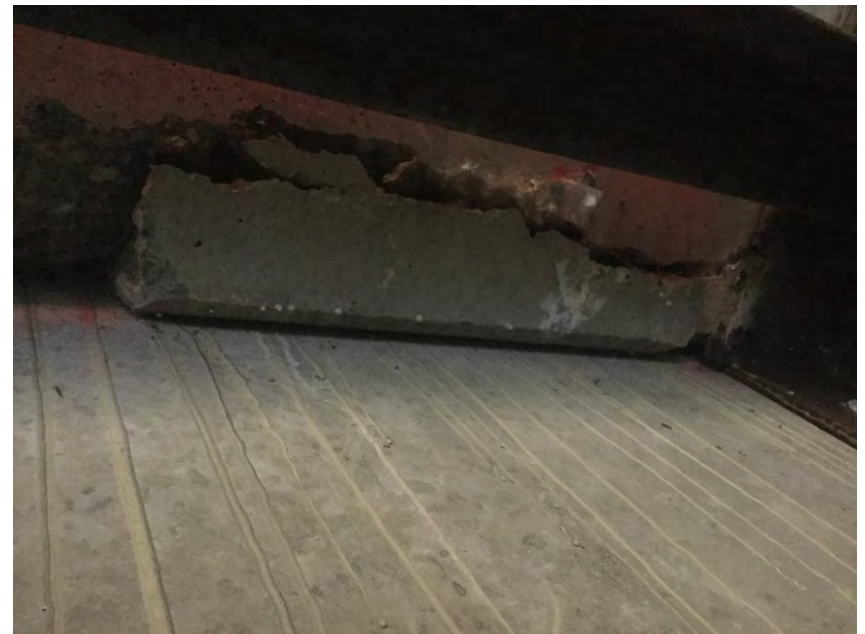
Damage to panel 1 at right approach
