CK-2074

CHIPMUNK 8.3km

2018 Inspection

| Crossing Name | Chipmunk Creek | | |

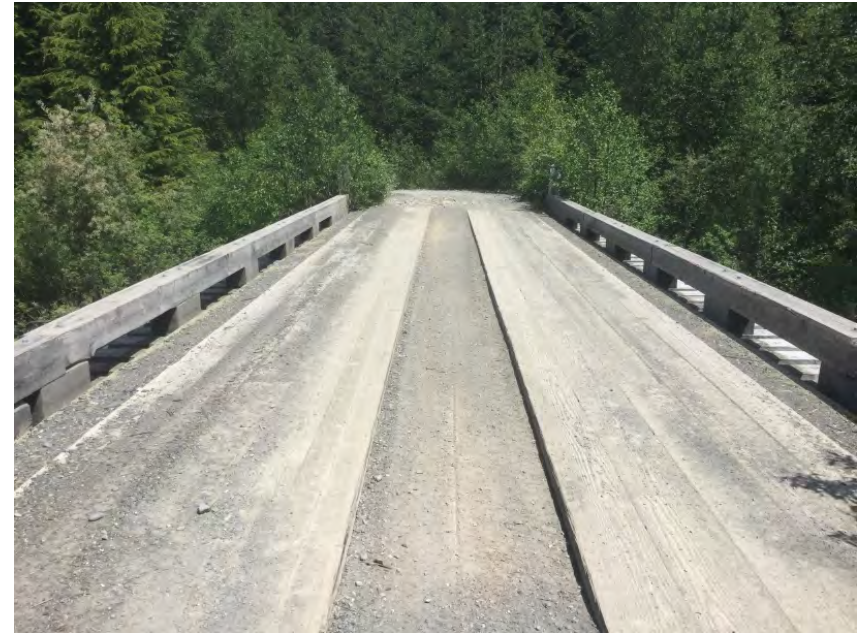
Deck

Large potholes

Poor

Fair

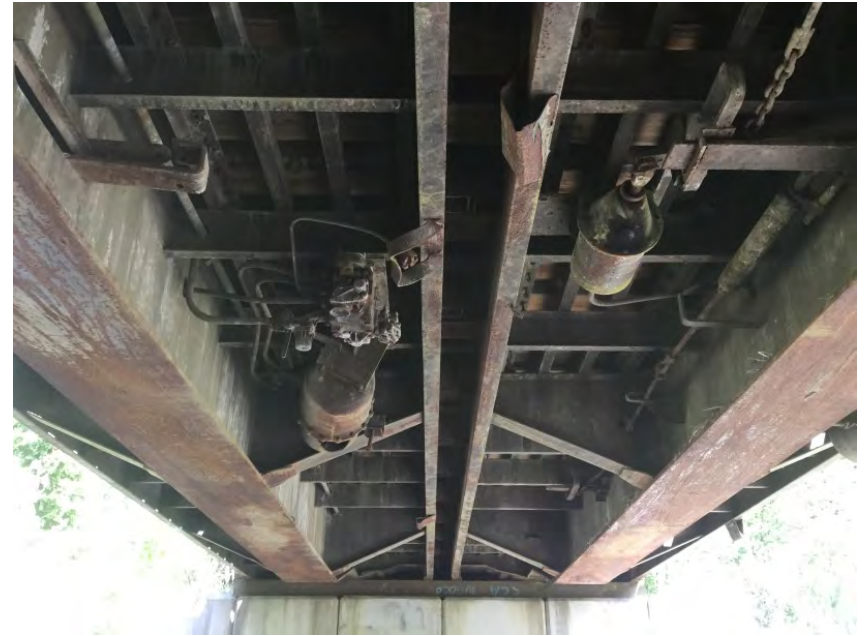
Superstructure

Girders Fair
