CK-2076

FOLEY 4.4km

2018 Inspection

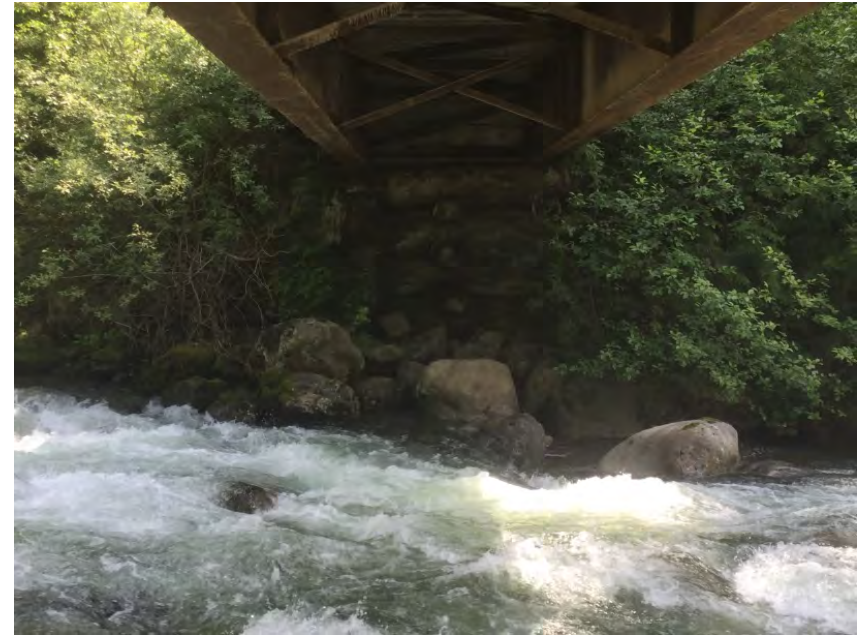
Left Bank Abutment when facing downstream

Log/Timber Cribs Fair 4x with up to 60mm sap rot

Tie Backs Fair 5x with some end splits

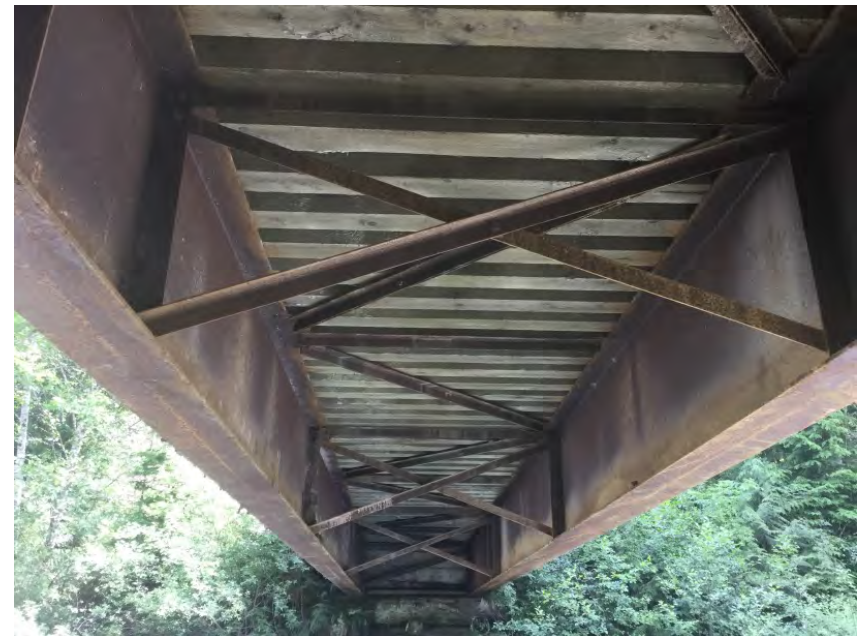
Superstructure

Girders Fair

Diaphragms Fair

Bracing Fair

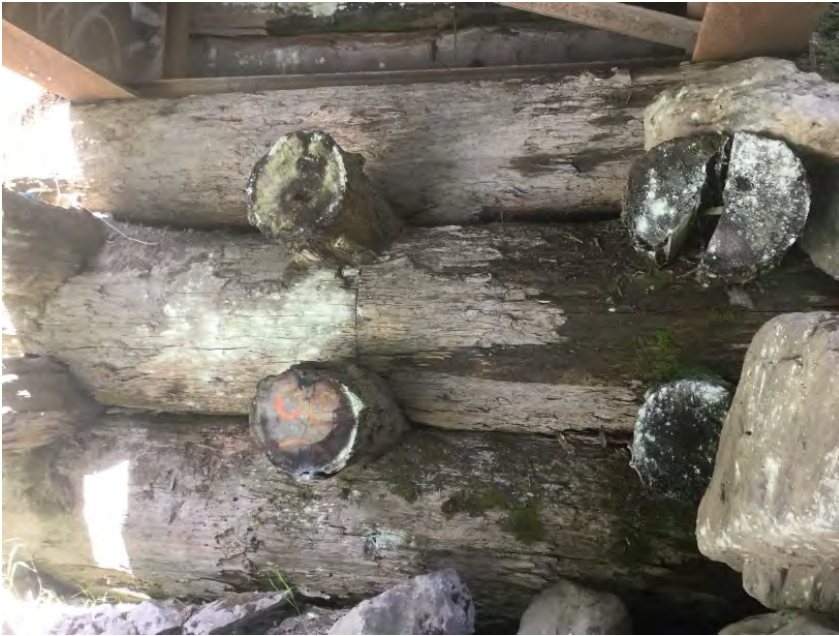
The crib appears old and nearing the end of its industrial life

Log crib condition

Brush and grade approaches. Post bridge ahead signs. According to the file the crib is 32 years old and is nearing the end of its industrial life - monitor its condition. Present load rating of L60 or 54 tonnes to continue.

| 1 | Crib condition | Routine Inspection |
