CK-2077

AIRPLANE 0.1km

2018 Inspection

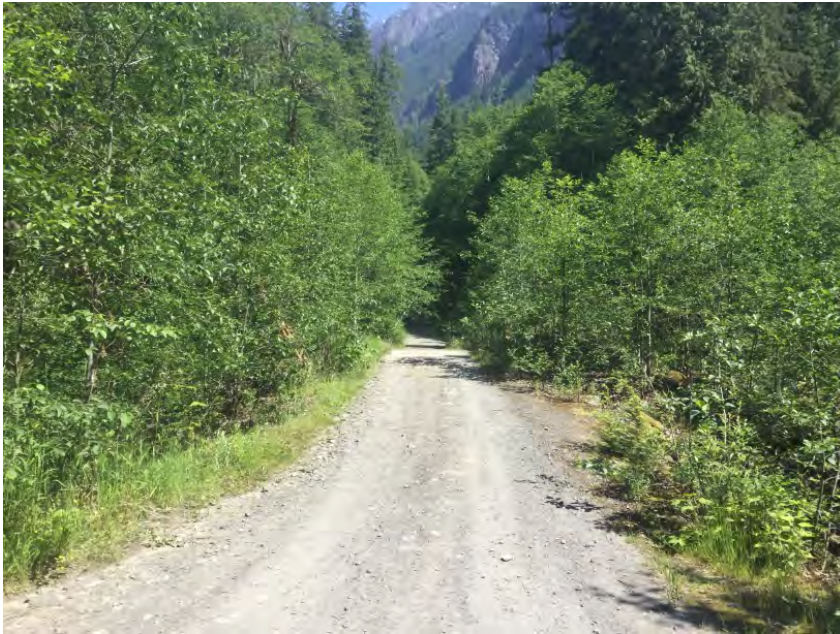
Approach from Left Bank when facing downstream

VC both approaches

Road Surface Fair

| 2 | Medium | Brush and grade approaches |

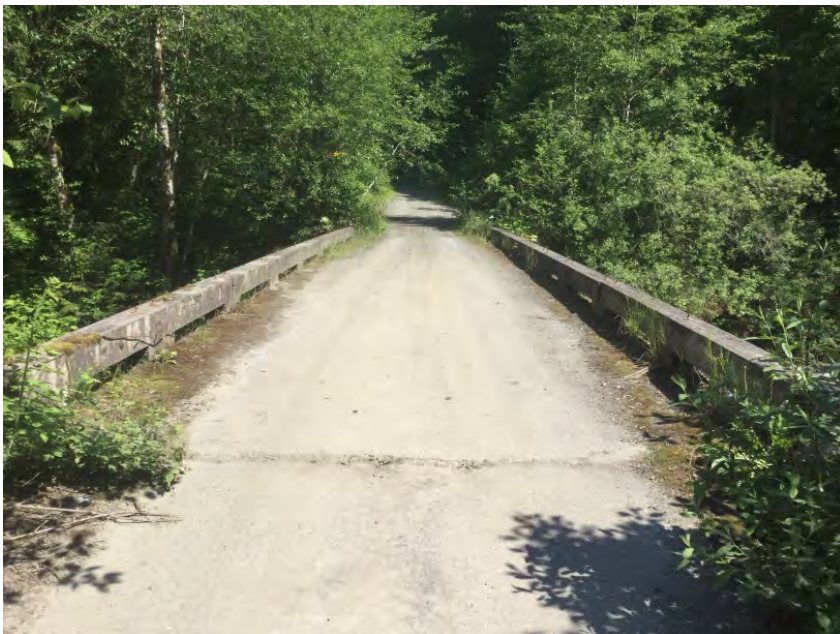
| Running Surface | Fair | Potholes at either approach |

| Curb Rail/Blocks/Posts | Poor | Rotten |

| Hardware | Poor | Loose rail bolts |

| Overall Deck Condition | Poor | Due to rail condition |

| 1 | Medium | Replace guardrail and risers |

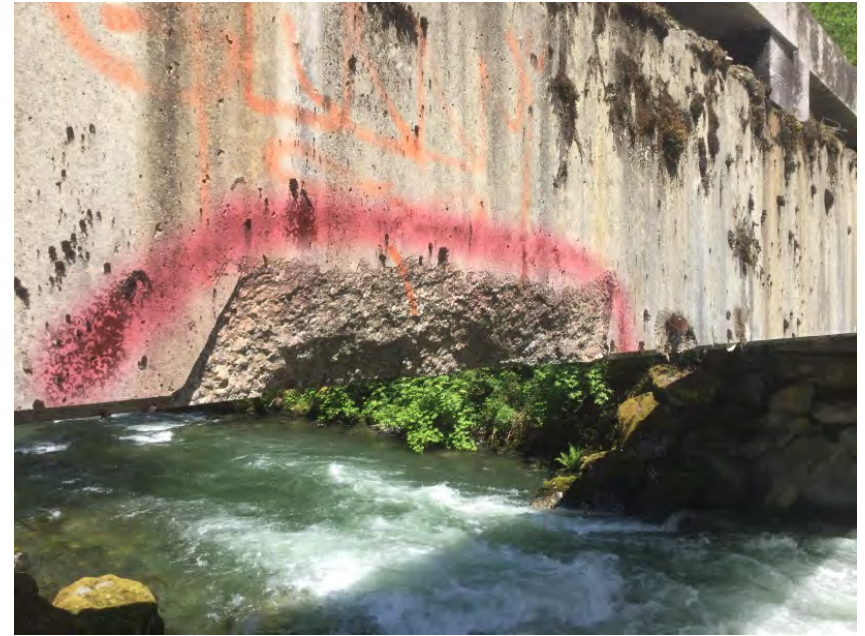
4 concrete slabs, minor damage noted upstream left bank

Upstream left bank girder damage

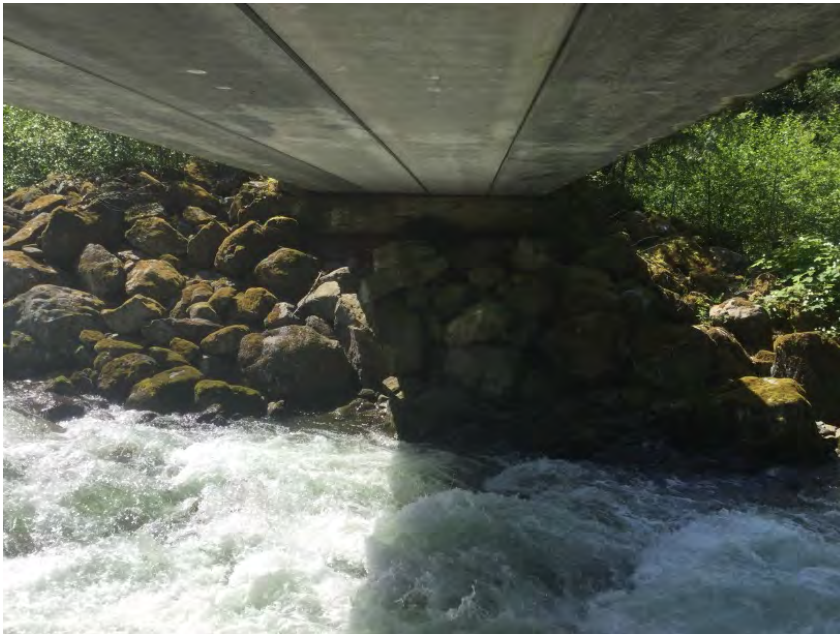
Left Bank Abutment when facing downstream

Log/Timber Cribs Fair 4x right bank, 2x left bank
