CK-2078

CENTRE 2.3km

2018 Inspection

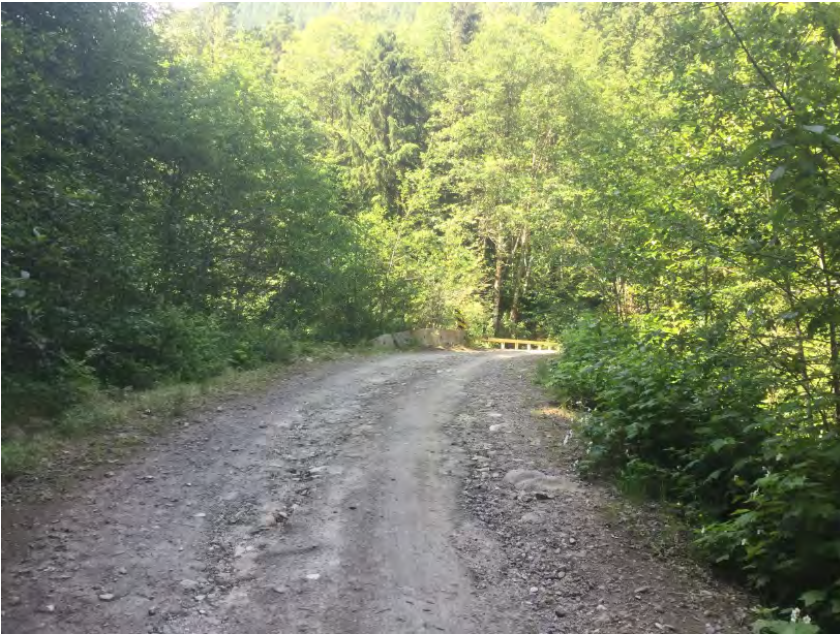
Approach from Right Bank when facing downstream

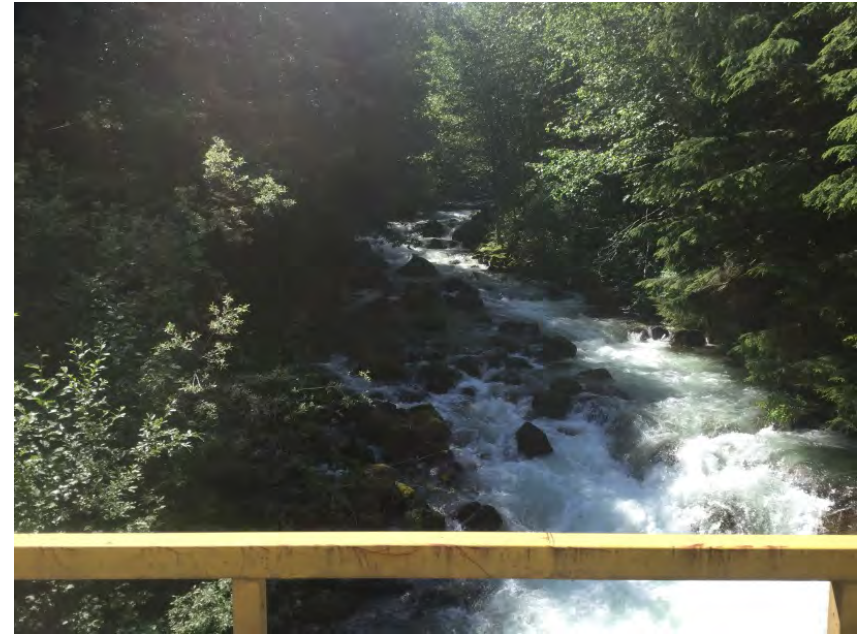
Upstream from Crossing

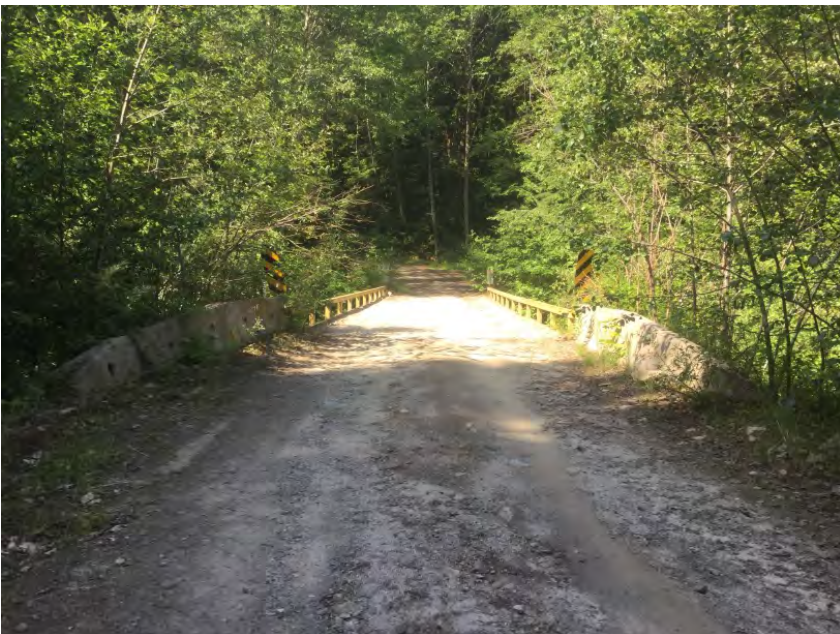
Approach from Right Bank when facing downstream

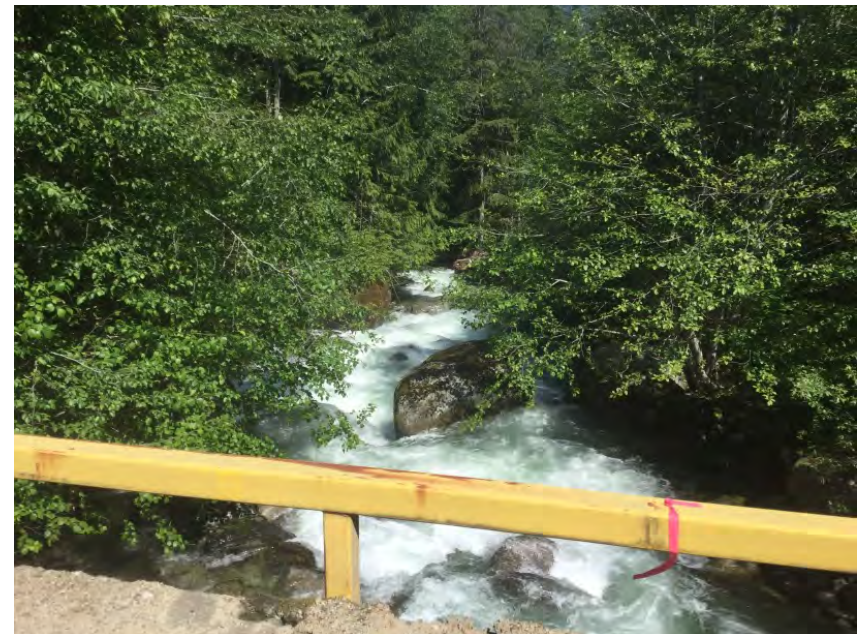
Downstream from Crossing

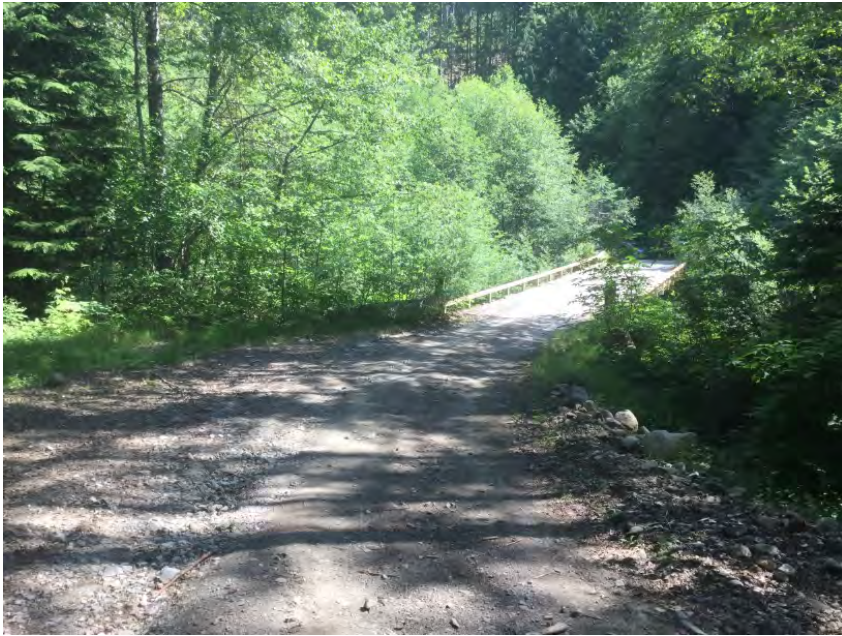
Approach from Left Bank when facing downstream

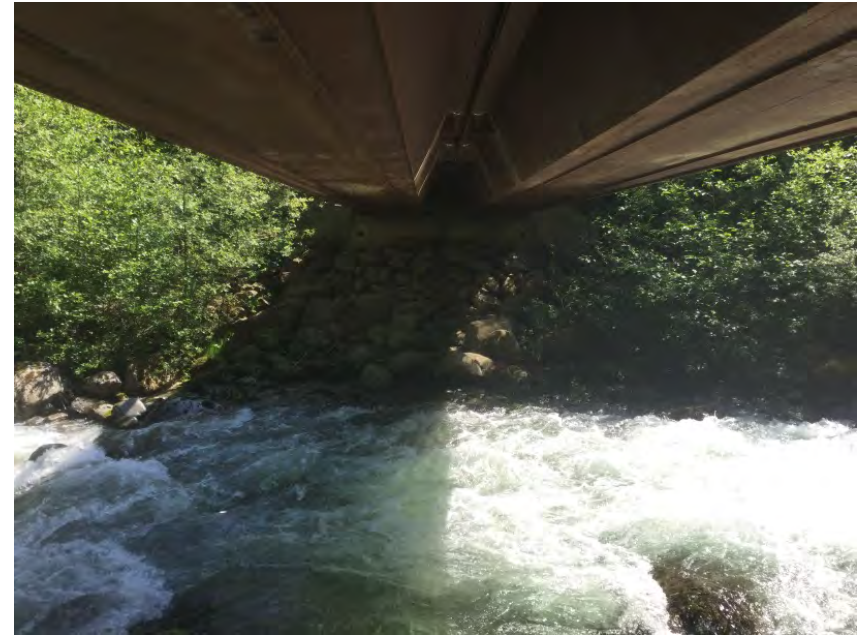
Right Bank Abutment when facing downstream

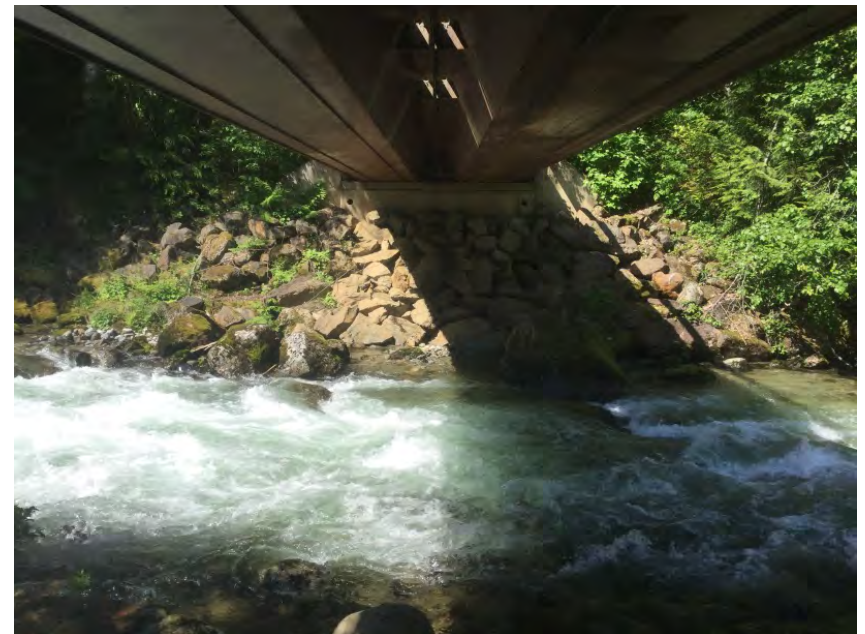
Left Bank Abutment when facing downstream

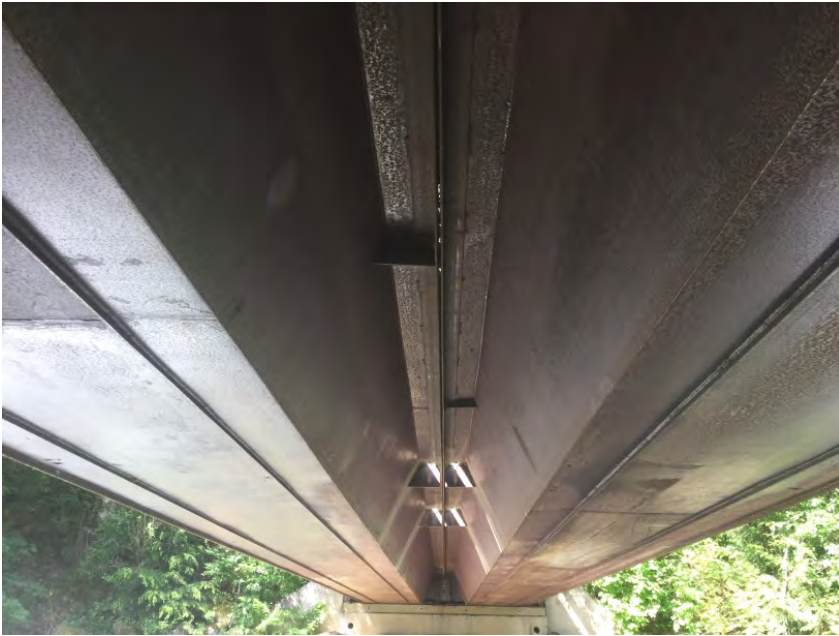
Superstructure
