CK-2084

CHILLIWACK SOUTH 0km

2018 Inspection

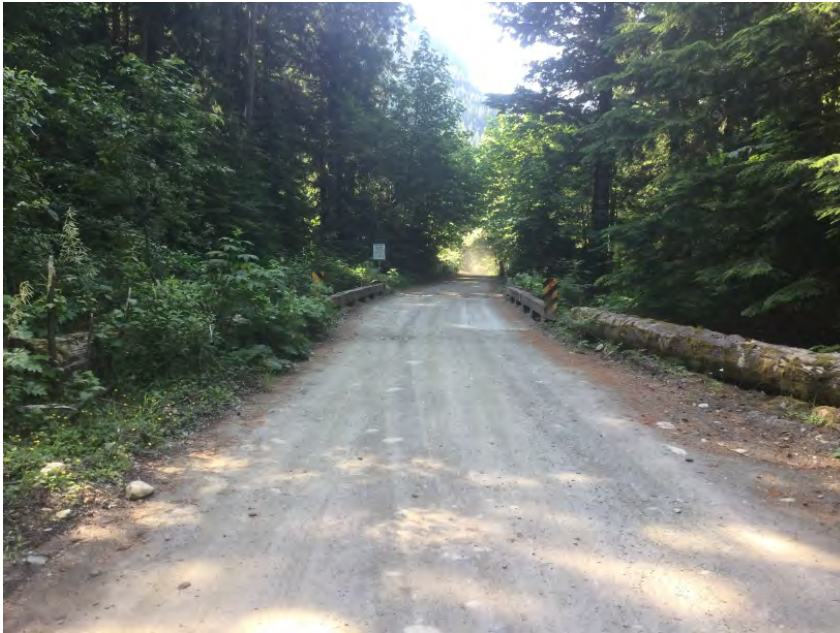
Approach from Right Bank when facing downstream

Bridge Ahead Signs  
Missing ☐ 0 ☐ 1 ☒ 2

Brushing Required Y

| Item | Priority | Repair Description |
|---|---|---|
| 2 | Medium | Grade and brush approaches and clean sediment from deck |

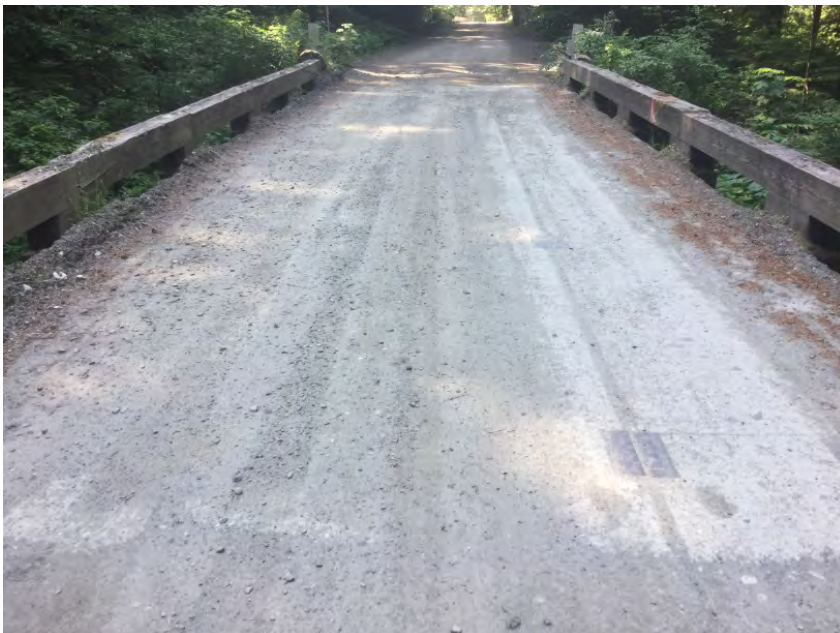
Concrete Deck Fair Wear noted on surface, most likely due to tracked machinery

Deck Joints Fair Paraseal all gone

| Item | Priority | Repair Description |
|---|---|---|
| 3 | Medium | Replace paraseal deck joints |

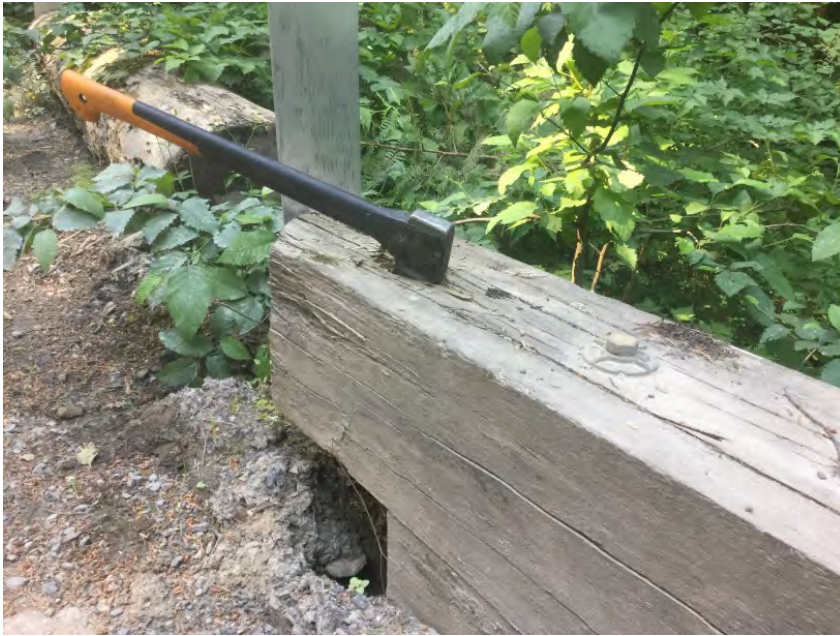
Guard Rail

Curb Rail/Blocks/Posts Poor Rotten

Hardware Poor Loose rail bolts

Overall Deck Condition Poor Due to rail condition

| Item | Priority | Repair Description |
|---|---|---|
| 1 | Medium | Replace guardrail, risers and blocks |

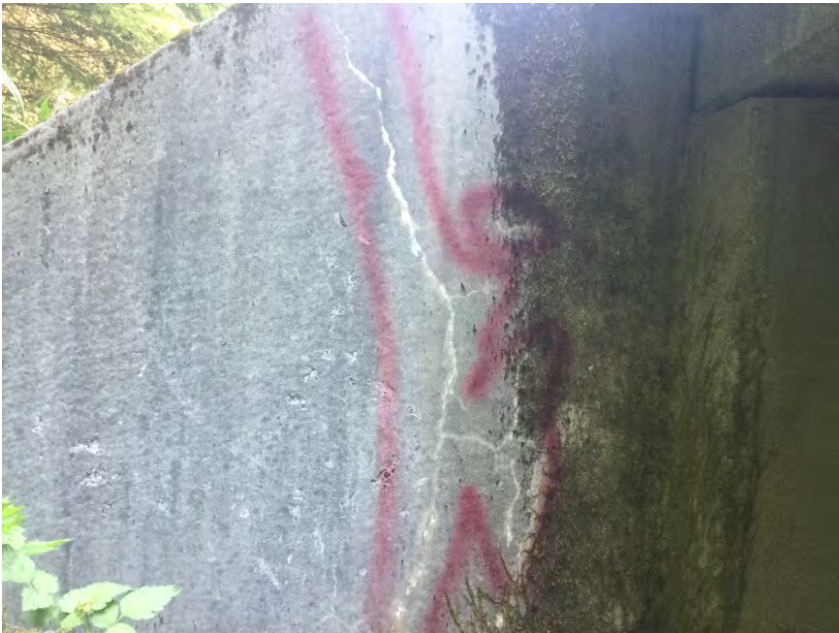
Ballast Wall Fair Hairline cracks noted on right abutment

Hairline cracks noted on right ballast wall
