CK-2085

CHILLIWACK SOUTH 0.1km

2018 Inspection

| Crossing Name | Chilliwack River |

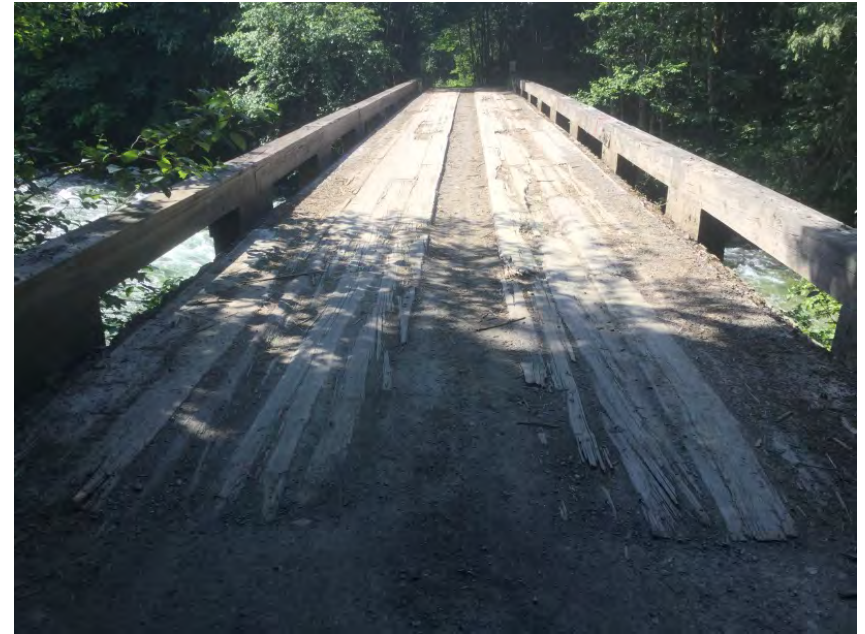
Deck

Running Planks

Poor

Rotten

Nails

Protruding

Loose rail bolts

Due to rail condition

| Item | Priority | Repair Description |
|---|---|---|
| 1 | High | Replace planks, guardrail and risers; and timber approach fenders |

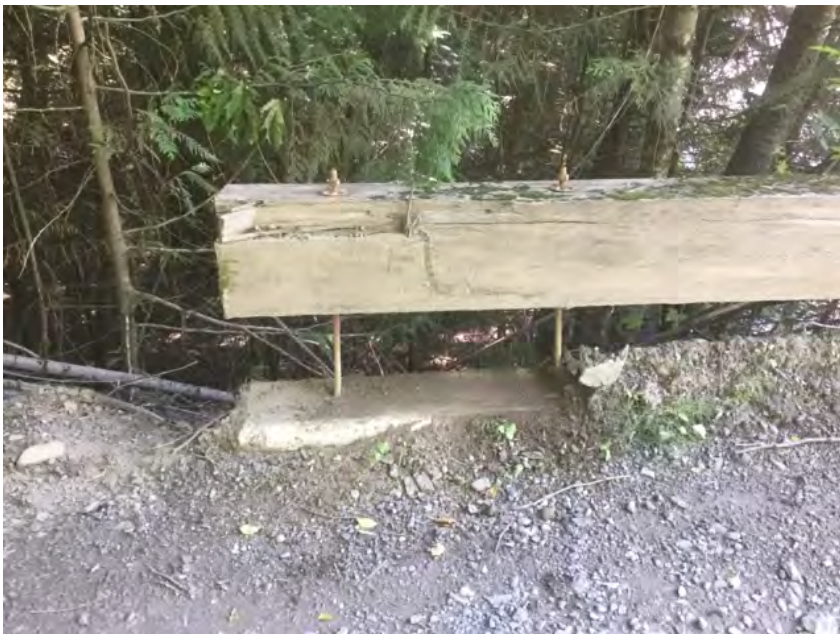
Missing riser at upstream right approach

Consider replacing risers (for the timber fenders) on CIP abutment with permanent ones

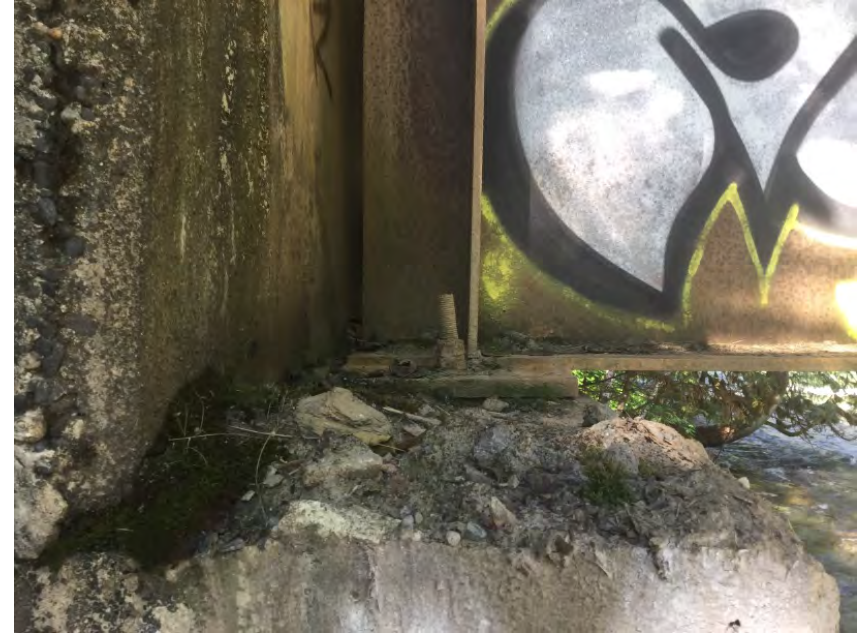
Bearing bolts bending on left abutment

Upstream left bearing bolt

| Item | Monitor Description | Frequency |
|---|---|---|
| 1 | Bearing bolts | Routine Inspection |
