CK-2090

DEWDNEY 0.2km

2018 Inspection

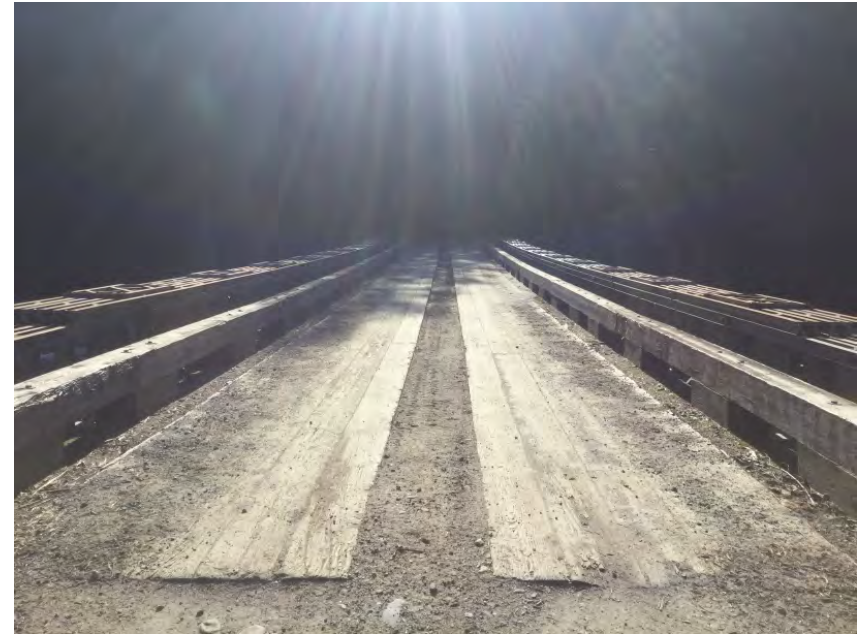
Overall Deck Condition Fair

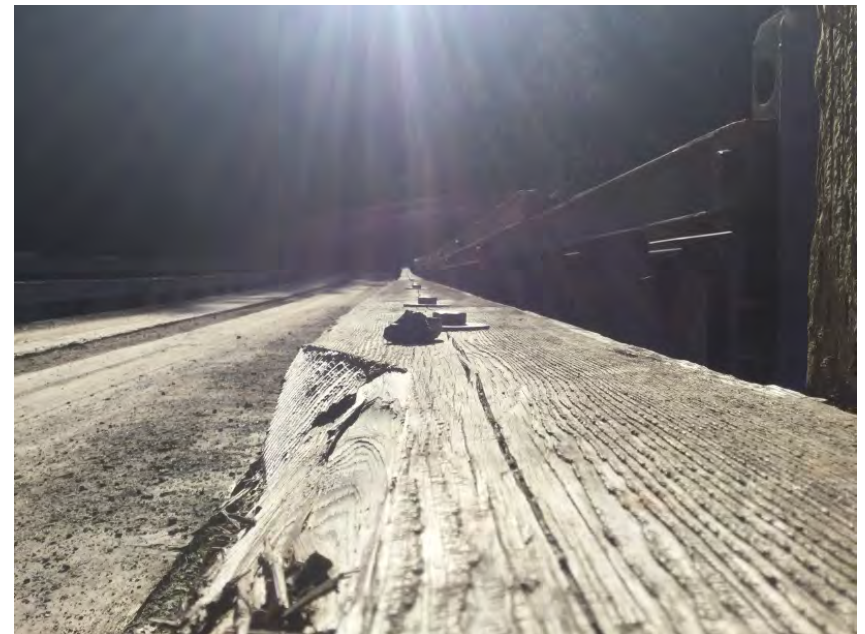
Deck sag - estimated at 200mm

This bridge is no longer required with the installation of structure CK-2546. Remove the entire structure and block the approaches. Limit loading to L30 or 27 tonnes. Post load rating sign.

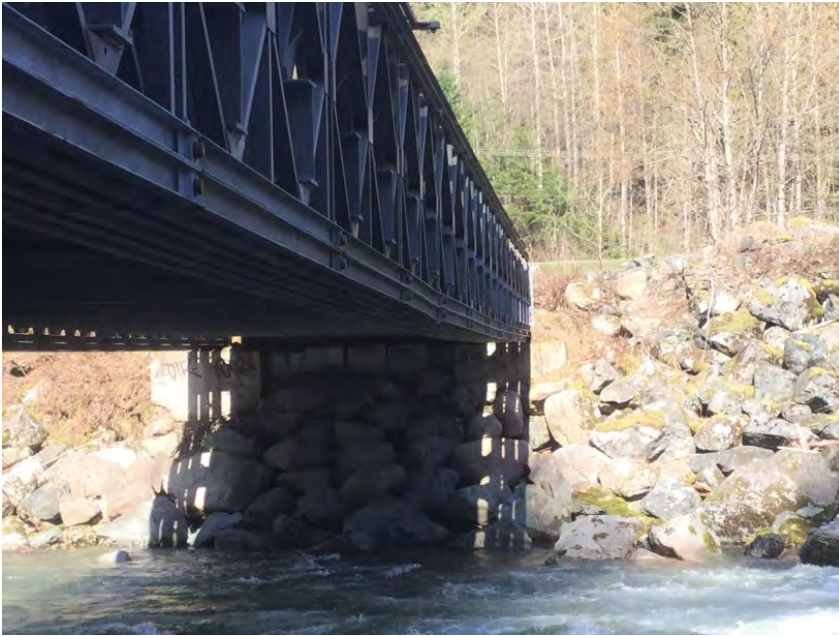
Midspan damage

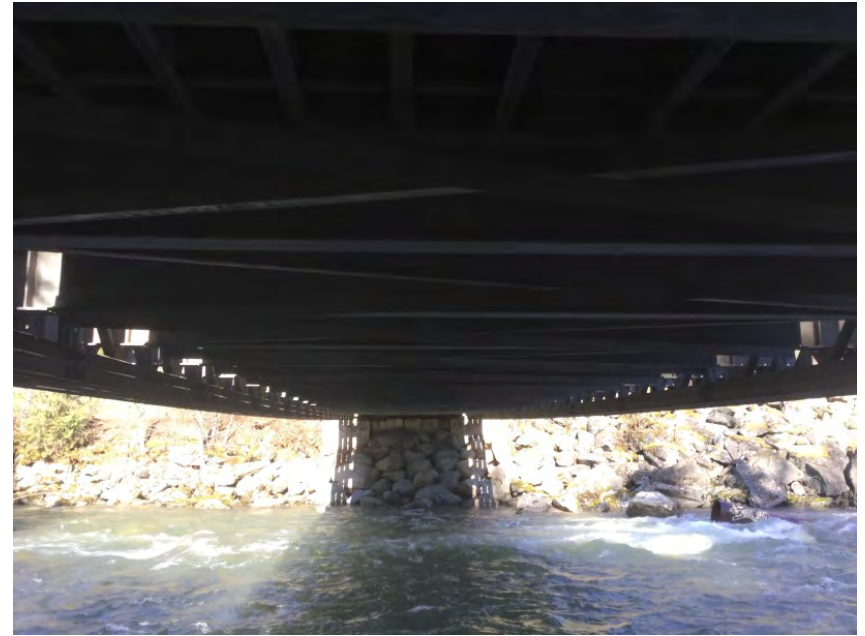
Superstructure

Girders Fair

Triple single reinforced Acrow panel - 13 panels

Bracing Fair

Hardware Fair
