CK-2091

FLORENCE LAKE 2.8km

2018 Inspection

| Crossing Name | Rolley Creek | | |

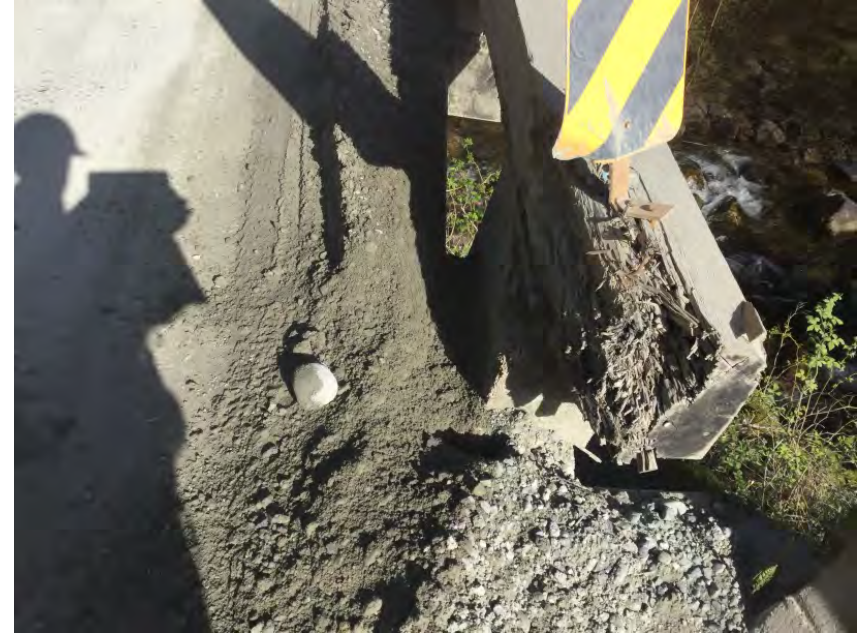
Damaged guardrail

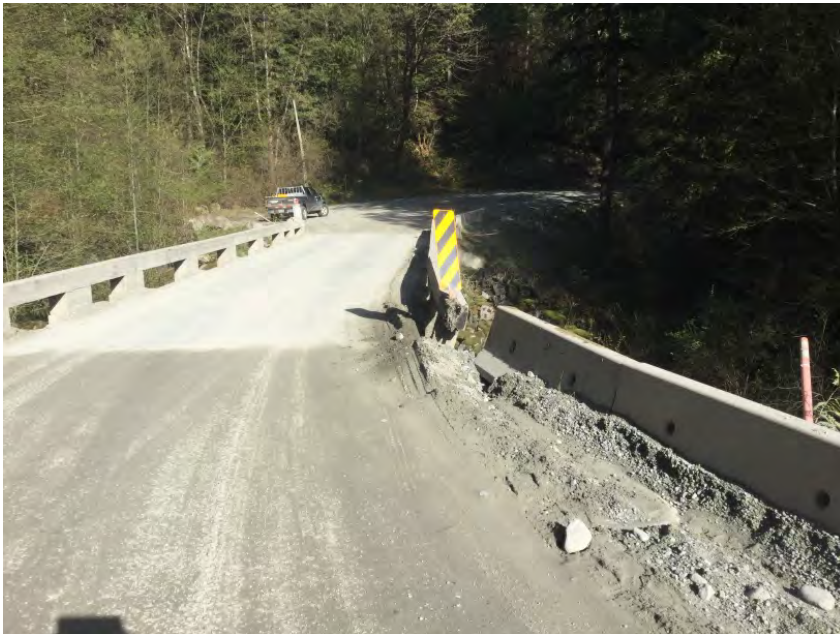
Damage to downstream right approach guardrail

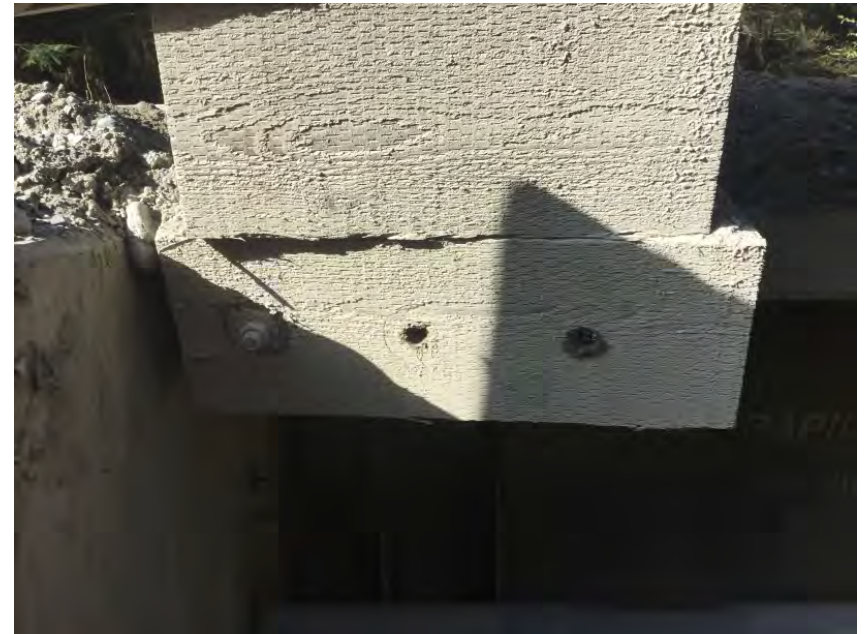
Curb Rail/Blocks/Posts      Fair      Missing 2 side block bolts

Side block bolts missing on damaged guardrail

Replace the missing side block bolts and clean sediment from the deck. Present load rating of L75 or 68 tonnes to continue. Monitor the deck joints.

| 1 | Medium | Replace 2 missing side block bolts |

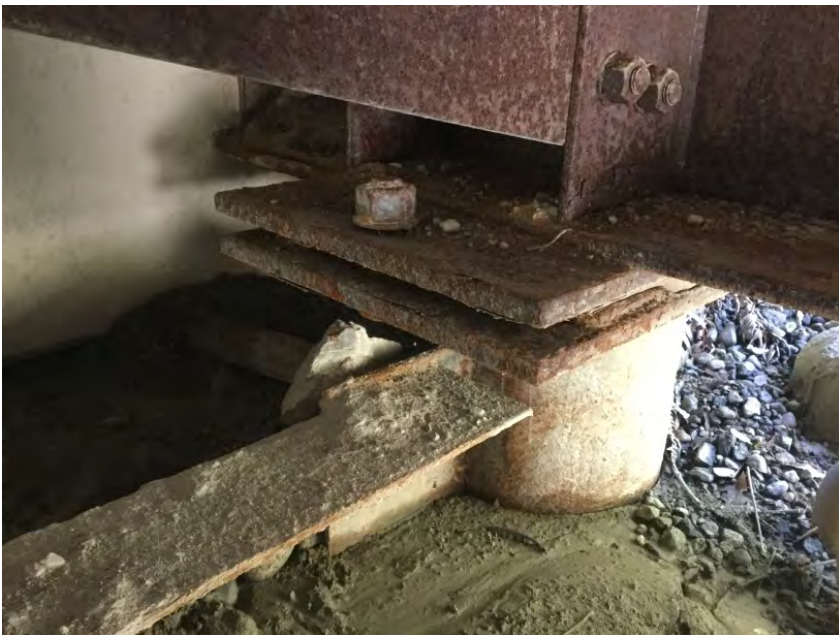
Minor corrosion

Corrosion Protection Fair

Minor corrosion noted on bearings

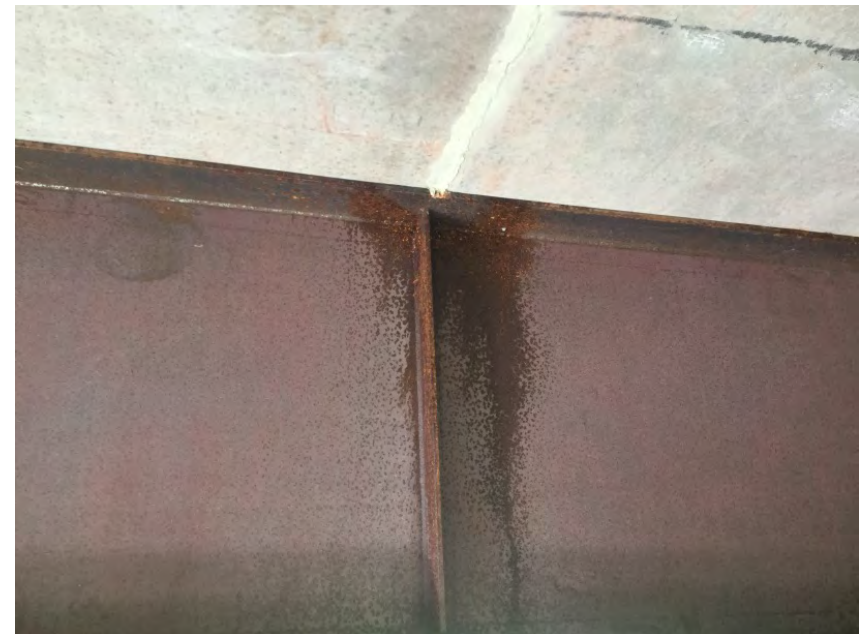
Deck Joints      Fair      Evidence that water is/has getting through

Evidence of water getting through deck joints

| Item | Monitor Description | Frequency |
|---|---|---|
| 1 | Deck joints | Routine Inspection |
