CK-2093

FLORENCE LAKE 7km

2018 Inspection

| Crossing Name | 79 Creek | | |

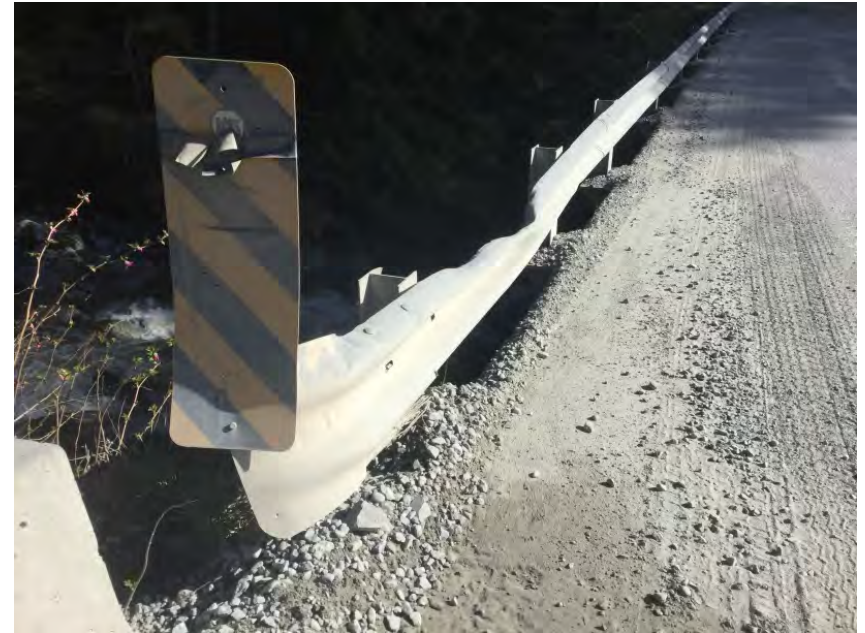
Curb Rail/Blocks/Posts      **Fair**      Minor damage noted in 2 locations but still functional

Guardrail damage upstream right bank

| Item | Priority | Repair Description |
|---|---|---|
| 2 | Medium | Repair/replace damaged sections of guardrail |

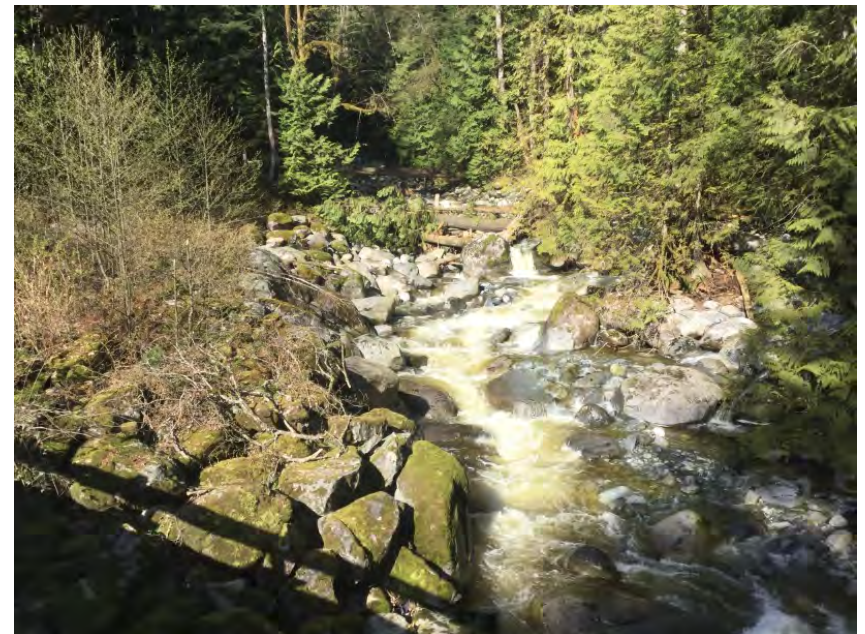
Looking upstream from deck - full length trees noted 40 meters upstream

| Item | Priority | Repair Description |
|---|---|---|
| 1 | Medium | Remove trees noted upstream or cut into small pieces so they will pass at high flows |

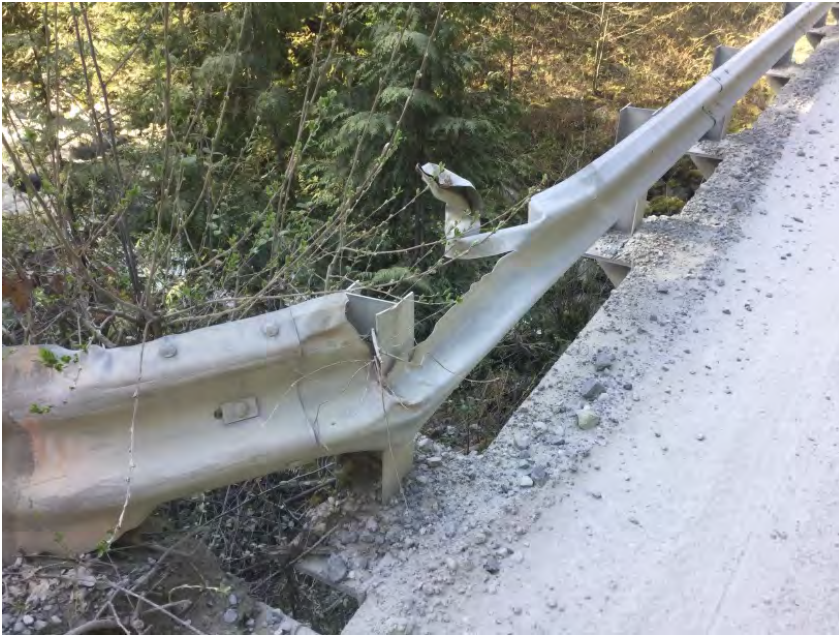
Damage noted to downstream left bank guardrail

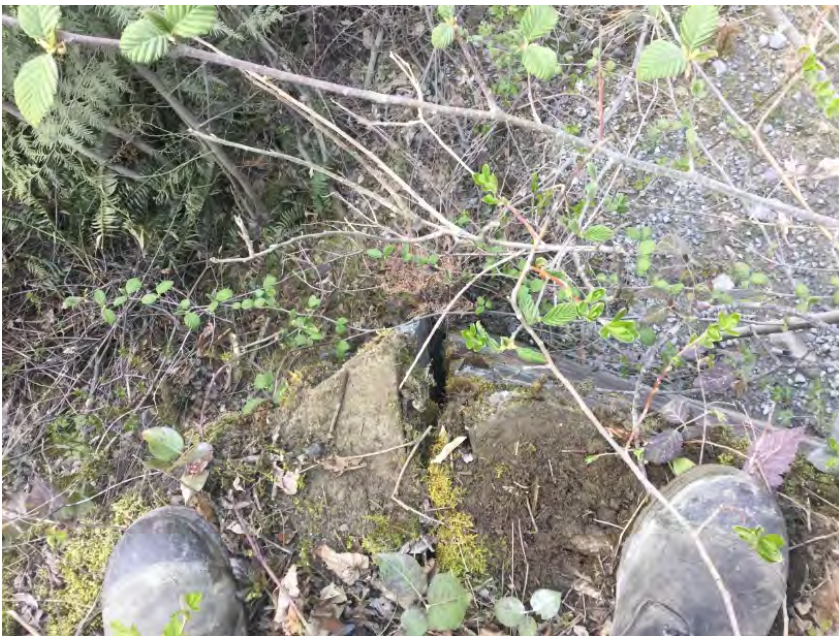
Downstream left bank precast wingwall - slight out of alignment with ballast wall

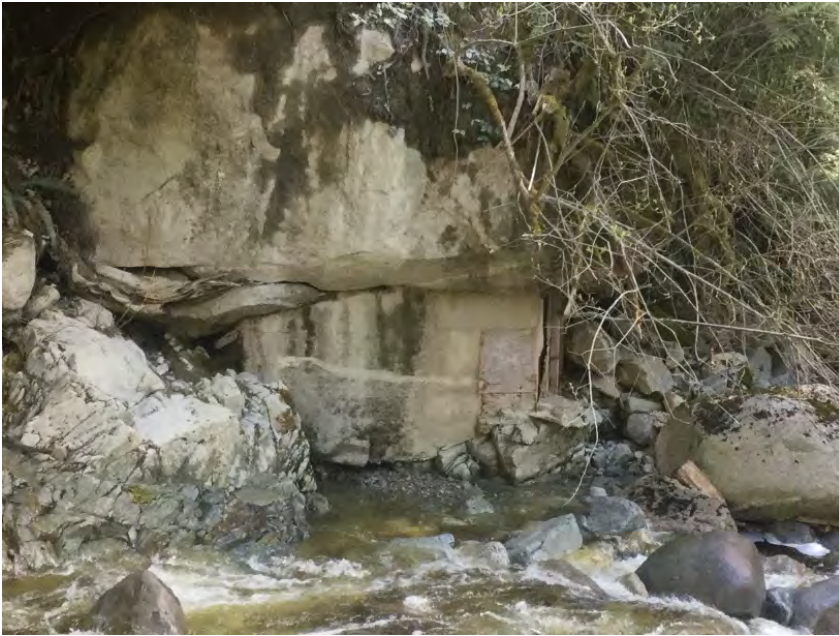
Riprap Fair Monitor CIP under boulder at left bank

CIP to support large boulder in front of abutment at left bank

| Item | Monitor Description | Frequency |
|---|---|---|
| 1 | CIP under large boulder at left bank | Routine Inspection |

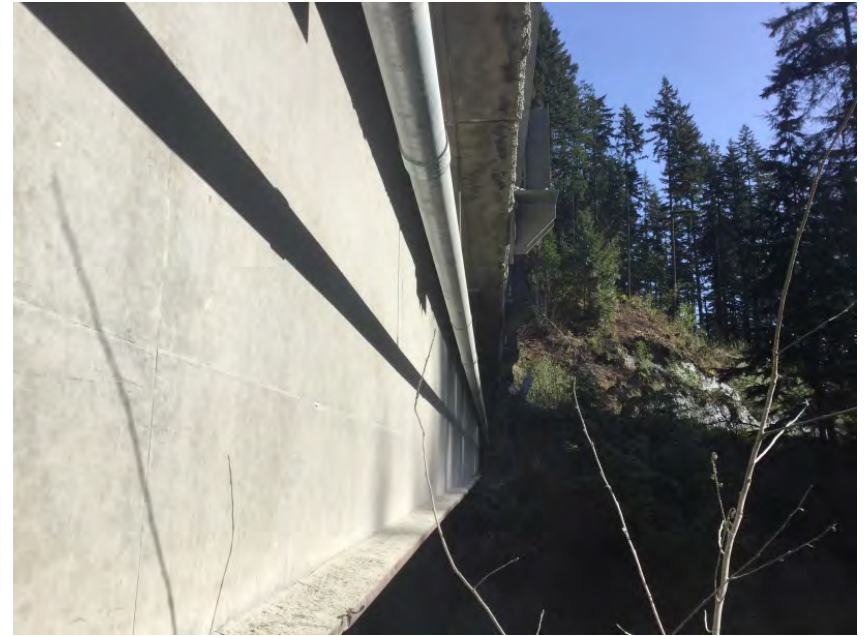
Utility hung fastened to underside of deck

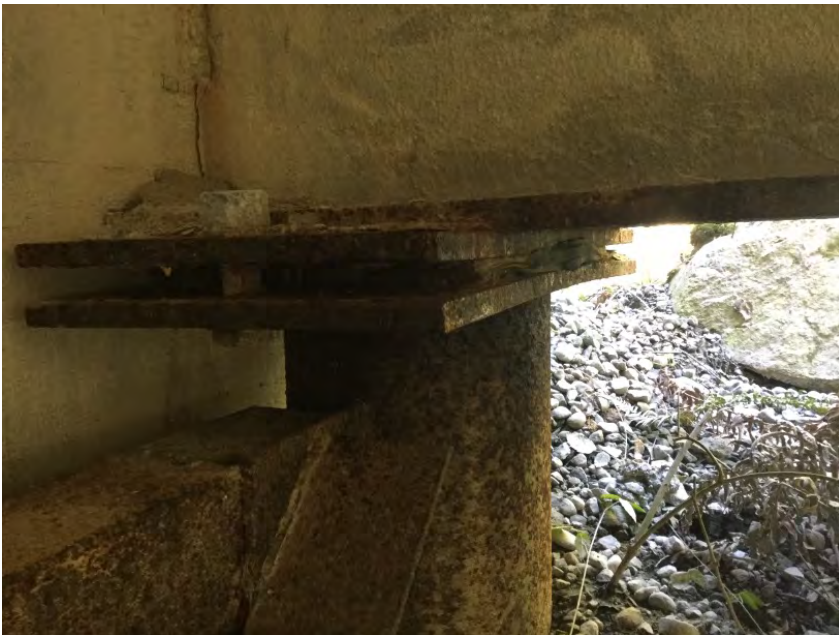
Bearings Fair

Minor bulging of bearing pads at right bank, and slight deformation noted
