CK-2096

FLORENCE LAKE 13.11km

2018 Inspection

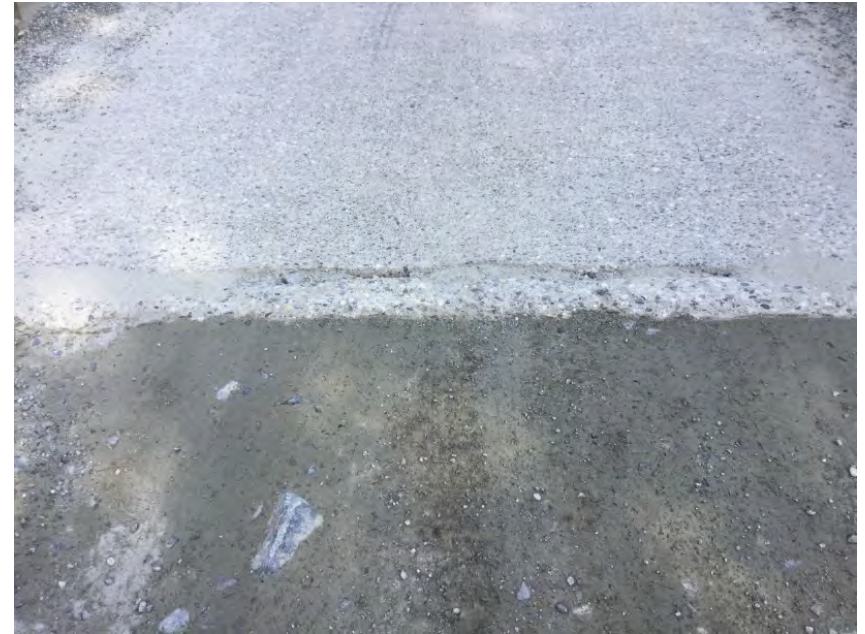
Minor wear damage noted to top of both walls

Concrete Deck      **Good**      Minor wear damage noted at either approach

Minor wear damage noted to ballast wall and deck at right bank

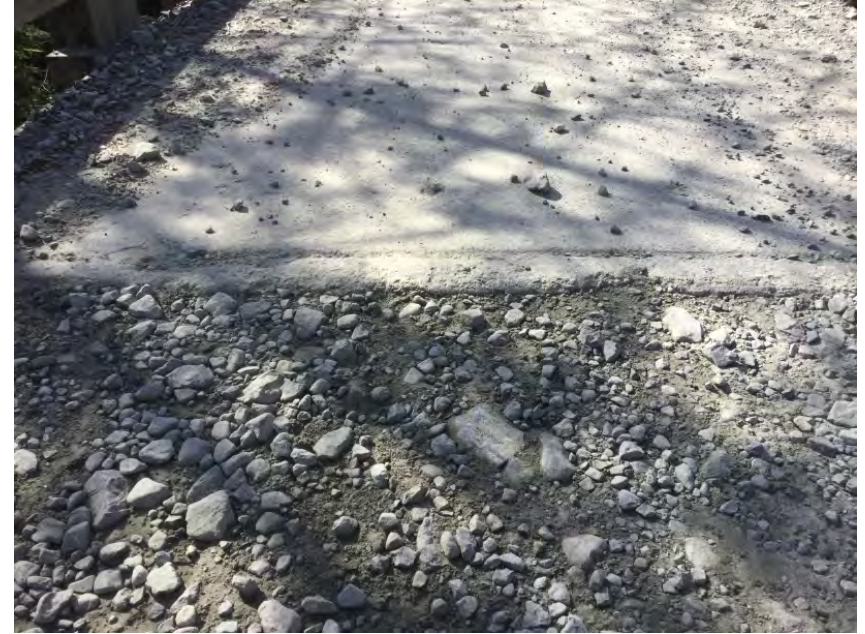
Minor wear damage noted to ballast wall and deck at left bank

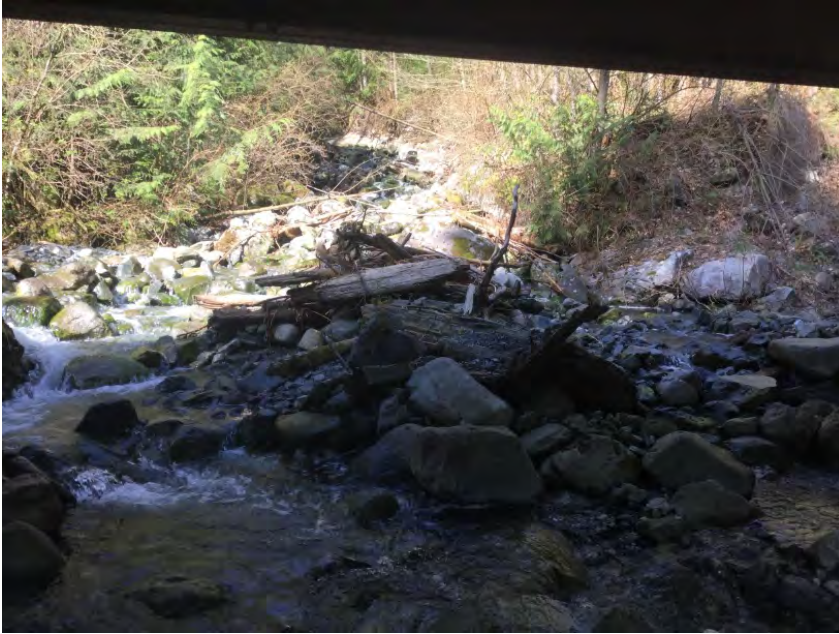
Inlet

| Item | Monitor Description | Frequency |
|---|---|---|
| 1 | Minor debris accumulations and stream aggrading at inlet | Routine Inspection |

| Repair Item | Priority | Repair Description |
|---|---|---|
| 3 | Low | Clean inlet |
