CK-2106

HARRISON EAST 15km

2018 Inspection

| Crossing Name | Bear Creek | | |

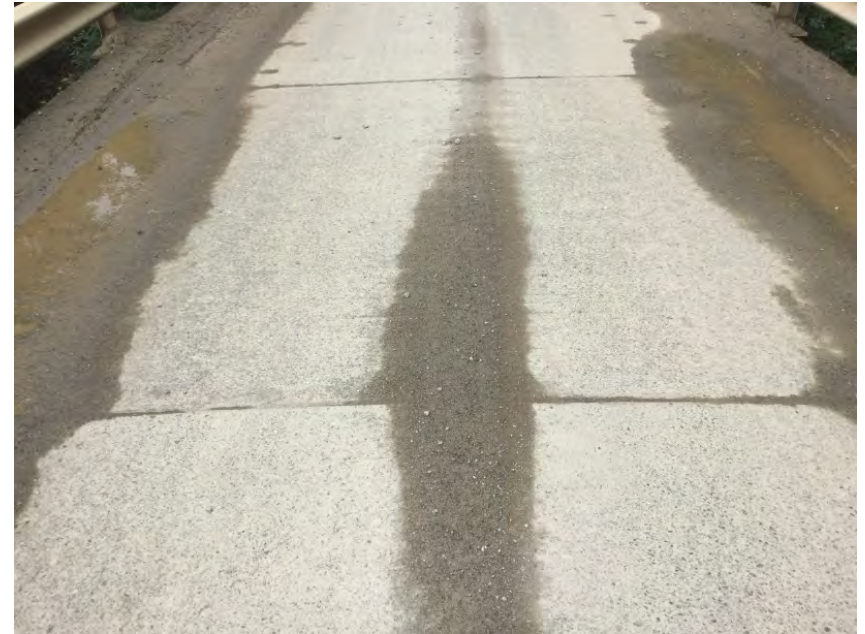
Concrete Deck      Fair

Grout Pockets      Fair

Deck Joints      Fair

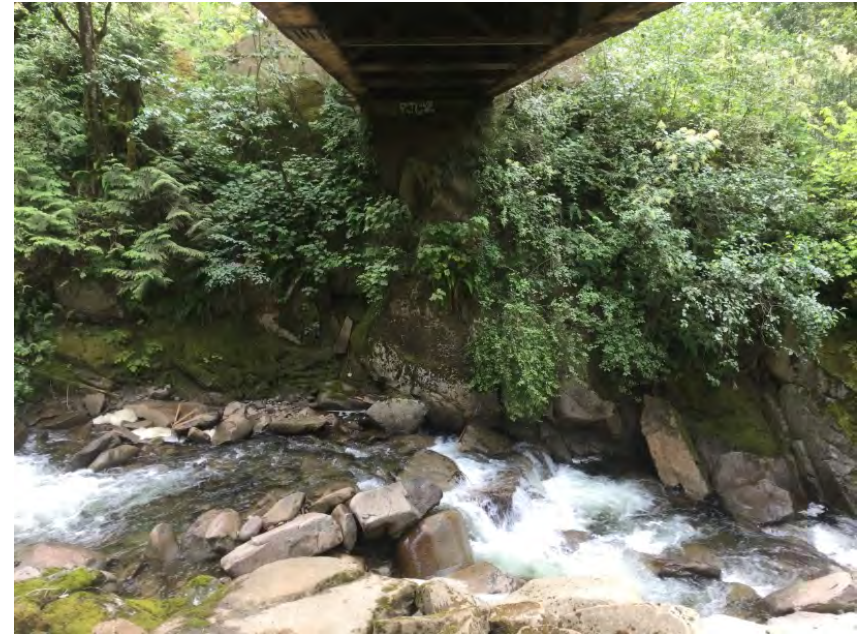
Left Bank Abutment when facing downstream

CIP left abutment

Minor damage to tops

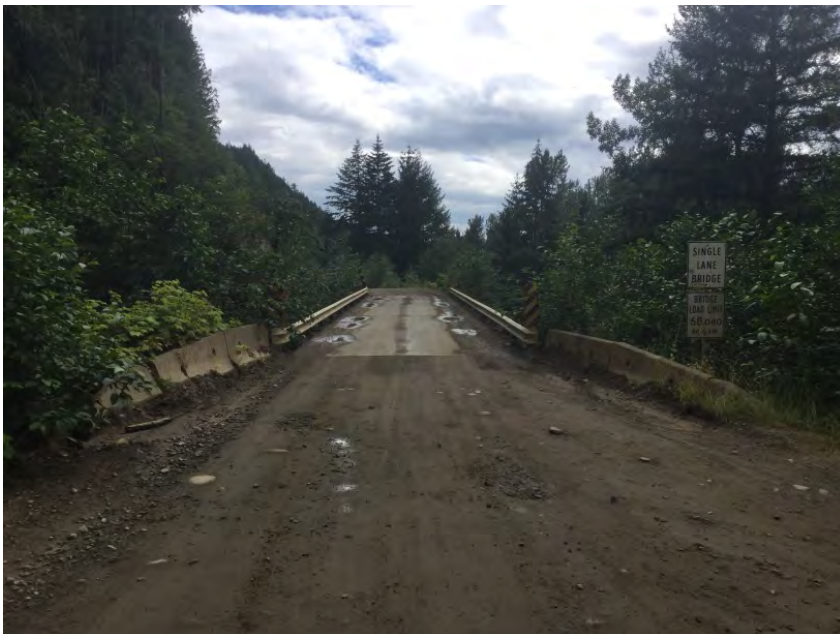
Approach from Right Bank when facing downstream

HC and VC right approach

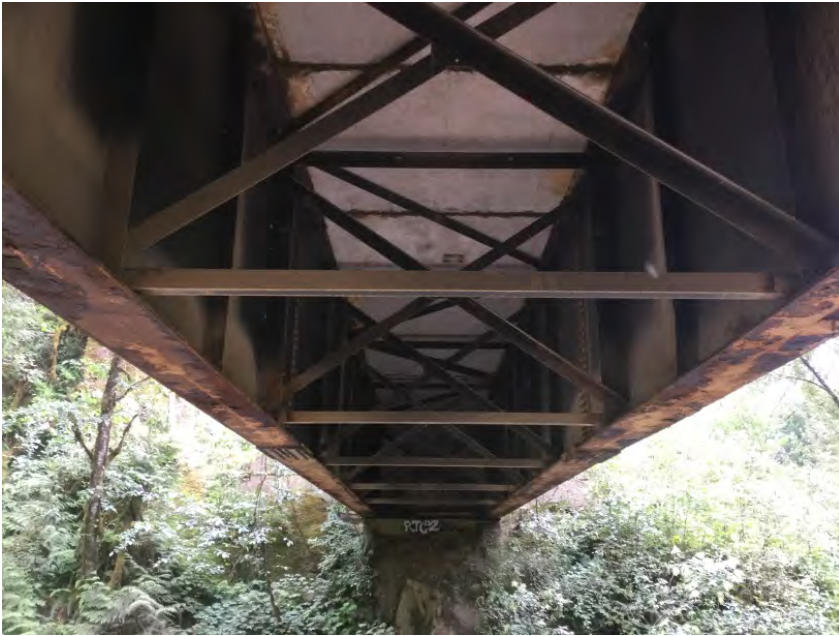
Superstructure

Deep and painted with minor corrosion
