# BC Ministry of Forests, Lands, and Natural Resource Operations

## Permanent Bridge Inspection Report

| Structure #: | CK-2107 | Site #: | CK-2107 | Road Name: | HARRISON EAST | Inspection Date: | 2018/06/19 |
| KM: | 24.80 | User km: | 24.10 | Crossing Name: | Cogburn Creek | Next Inspection Date: | 2021/06/19 |

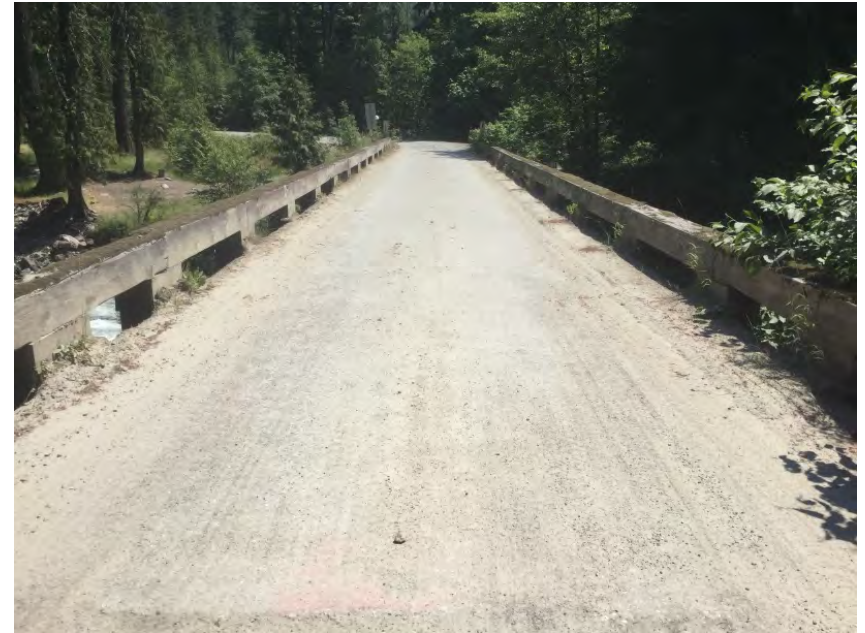
| Concrete Deck | Fair | Damage to wheel path, appears to damage sustained from walking tracked equipment across |

| Concrete Deck | Fair | Damage to wheel path, appears to damage sustained from walking tracked equipment across |

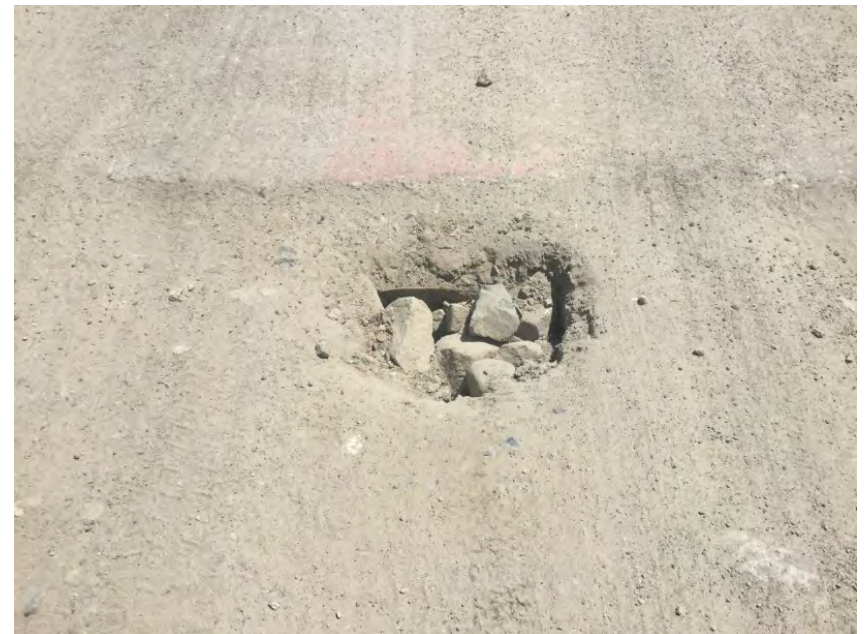
Hole at right approach

| | 2 | Required | Low | \$ | Brush approaches and fill hole at right approach | | | | | |

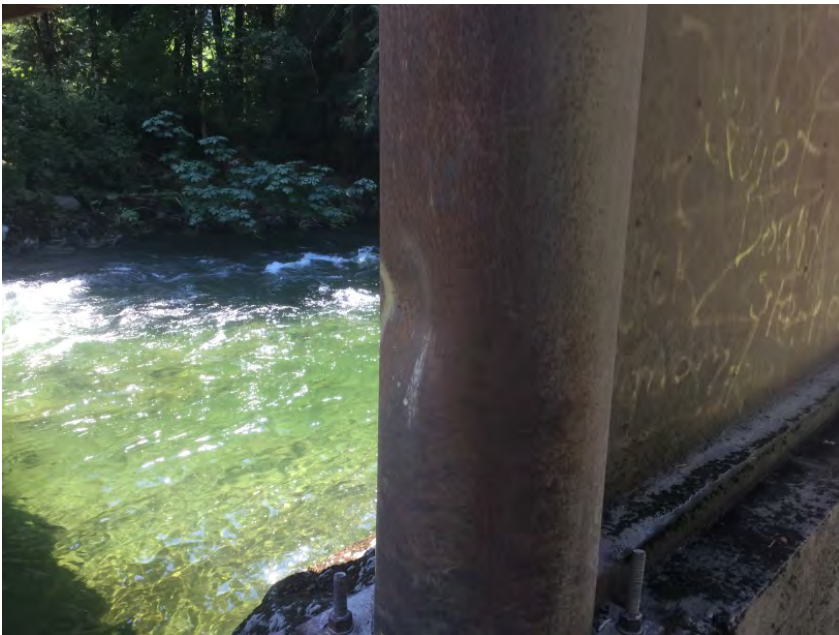
| Piles or Posts | Fair | minor damage noted to upstream column |

| | 1 | Damage to upstream pier column | | | | | | | | |

Damage to upstream pier column
