CK-2113

HARRISON EAST 51.8km

2018 Inspection

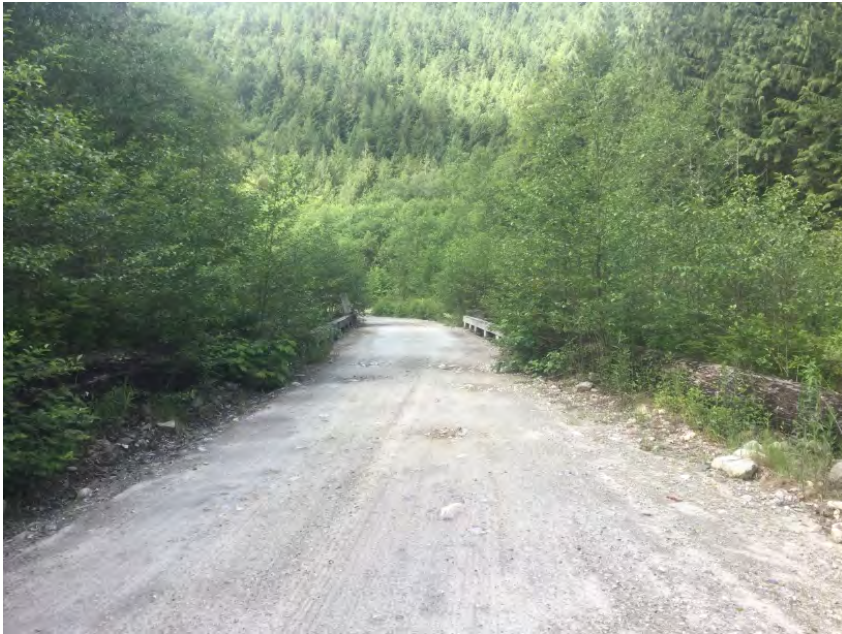
Approach from Left Bank when facing downstream

Brushing Required Y

Delineator Missing  
Left ☐ 0 ☐ 1 ☒ 2Delineator Missing  
Right ☒ 0 ☐ 1 ☐ 2

| 1 | Medium | Brush and grade approaches prior to activity |

| 2 | Medium | Replace missing delineators |

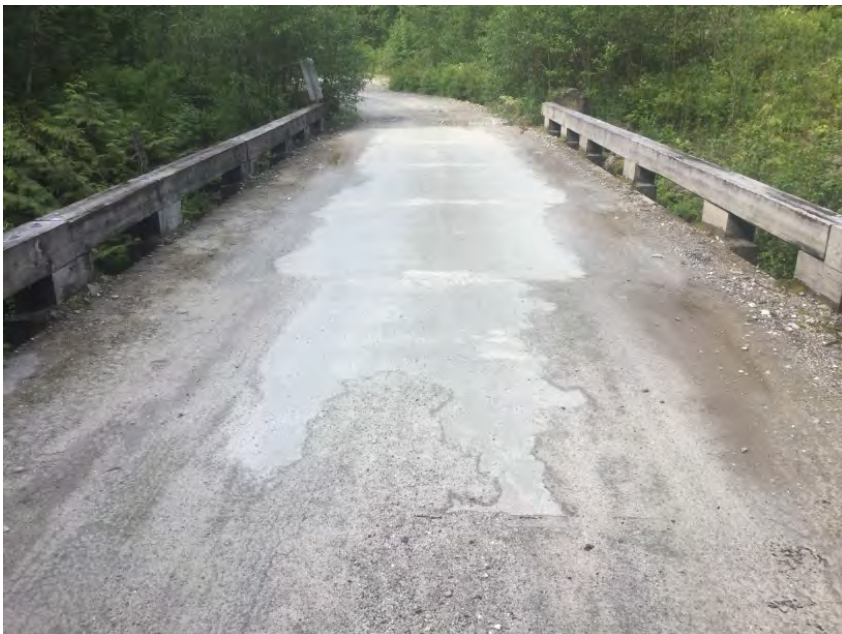
Concrete Deck      **Good**Grout Pockets      **Fair**      Minor Evidence of water getting through to girders belowDeck Joints      **Fair**      Minor evidence of water getting through to girders

Hardware      **Fair**Overall Deck Condition      **Fair**

| Item | Monitor Description | Frequency |
|---|---|---|
| 1 | Deck joints and grout pockets and girder condition | Routine Inspection |

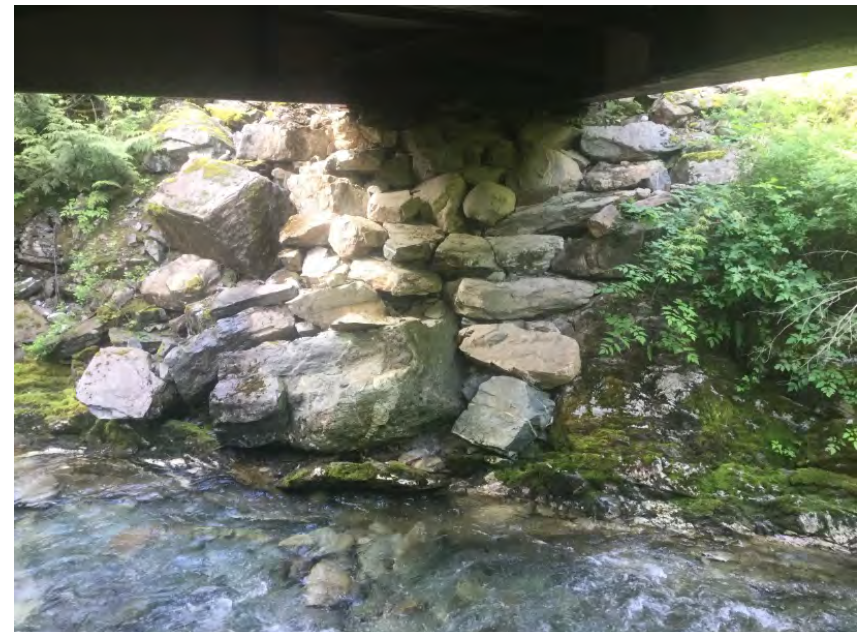
Right Bank Abutment when facing downstream

Bracing Good No bracing on right abutment
