CK-2115

HARRISON EAST 59.7km

2018 Inspection

| Crossing Name | Big Silver Creek | | |

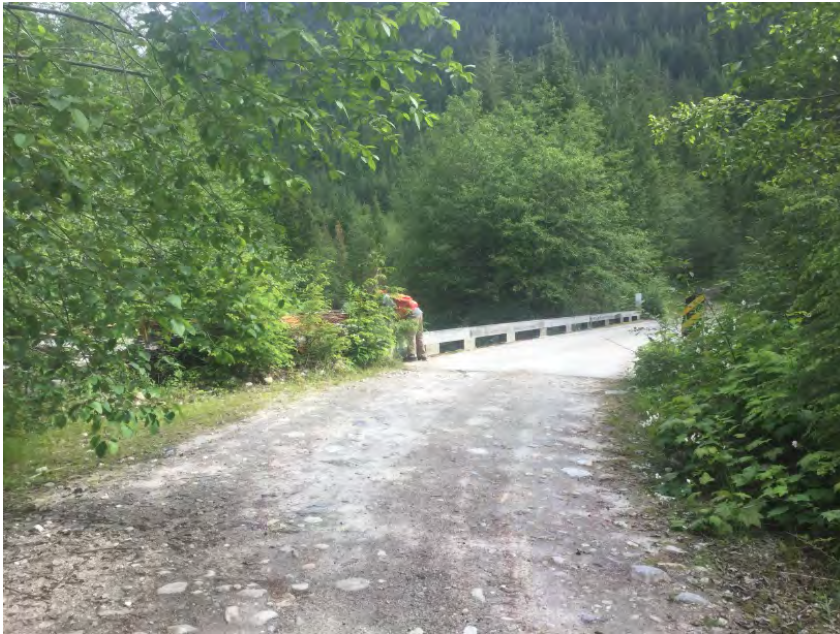
Approach from Right Bank when facing downstream

HC right approach

Brushing Required Y

| 1 | Medium | Brush and grade approaches when active |

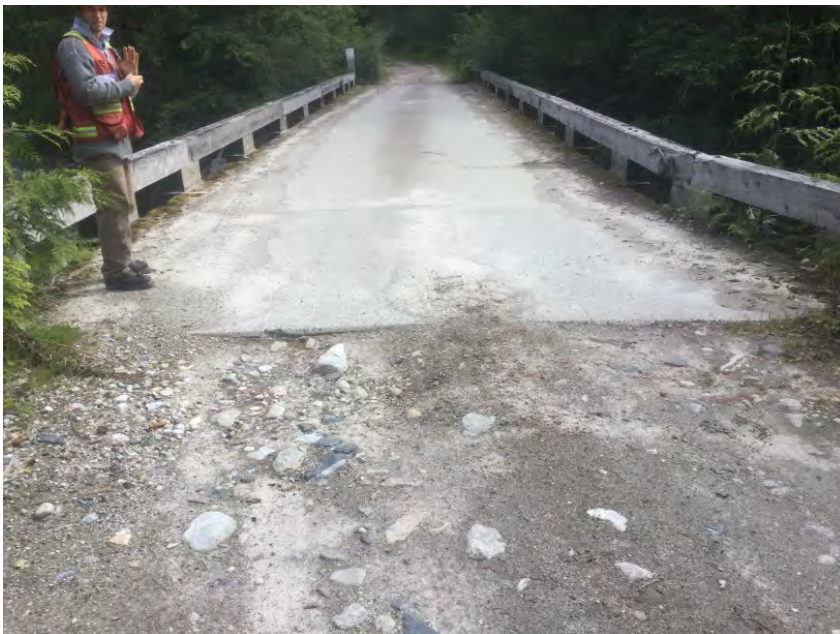
Overall Deck Condition      **Good**
