CK-2117B

COGBURN km

2018 Inspection

| Crossing Name | North Fork |

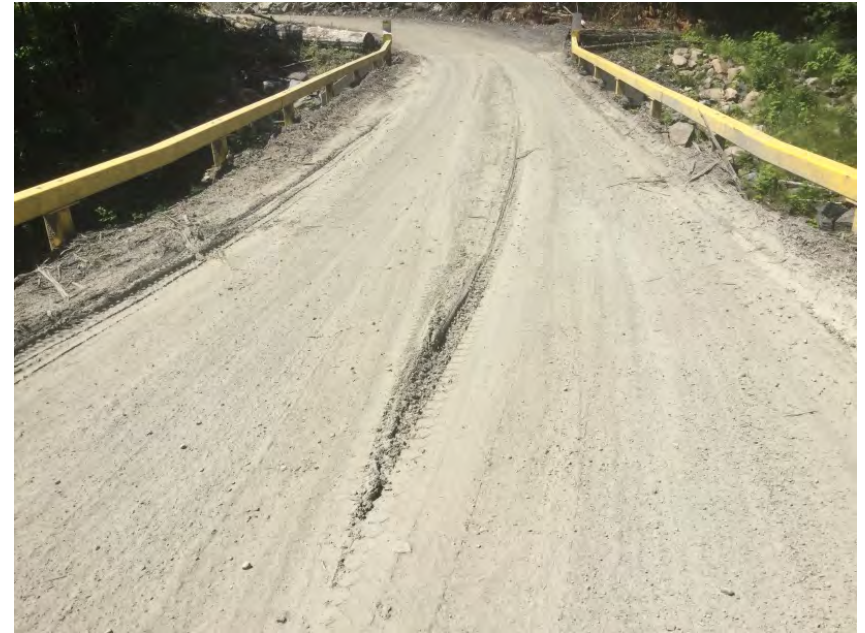
Running Surface      Poor

Concrete Deck      Unrated      Too much sediment to inspect

Grout Pockets      Unrated      Too much sediment

Deck Joints      Unrated      Too much sediment

Overall Deck Condition      Fair

Clean sediment from deck. Underside of deck panels appear good, therefore present load rating of L100 or 91 tonnes to continue.

| 1 | High | Clean sediment off deck |

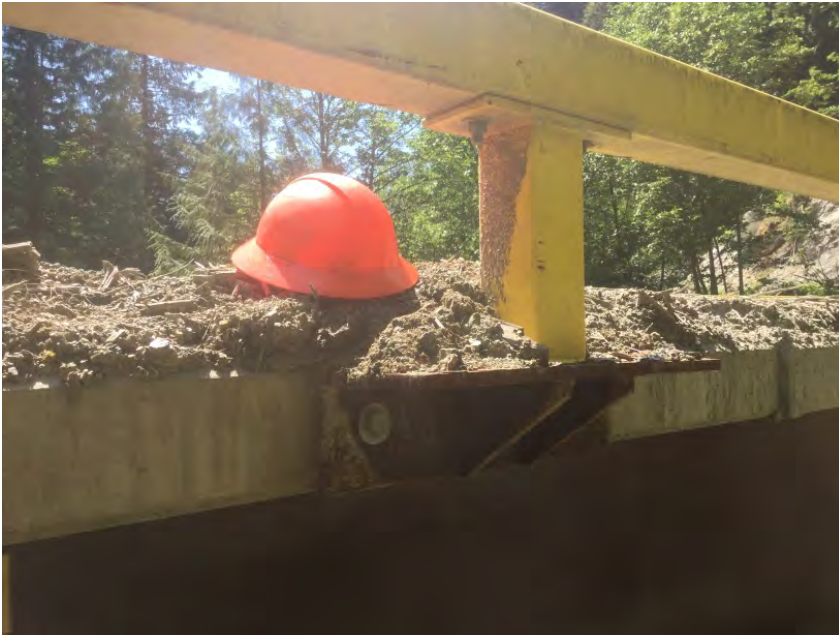
Amount of sediment on deck
