CK-2118

COGBURN 8km

2018 Inspection

| Crossing Name | Hut Creek | | |

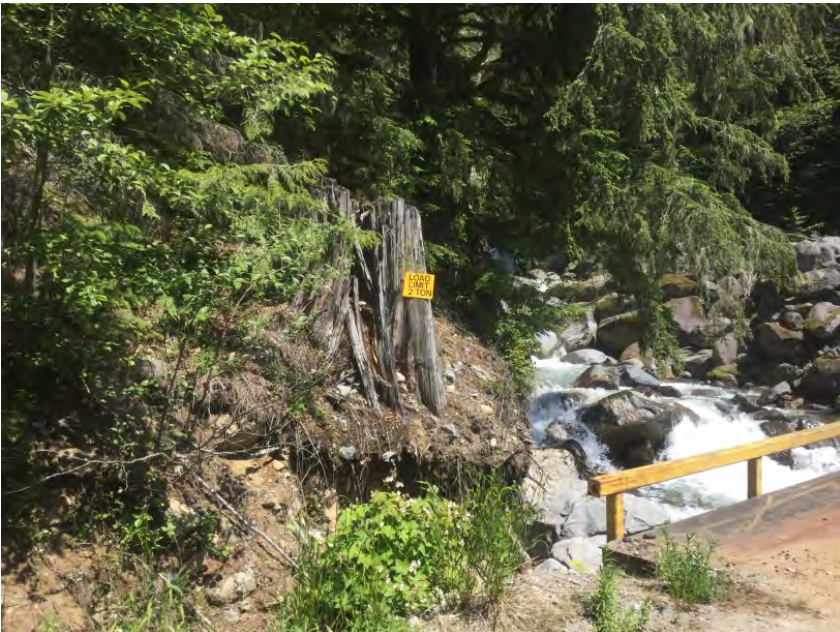
Load Rating Sign

Posted Load Rating 2

See picture

This is a temporary install to allow for development to occur. Limit loading to 5 tonnes. Replace the entire structure prior to industrial activity.

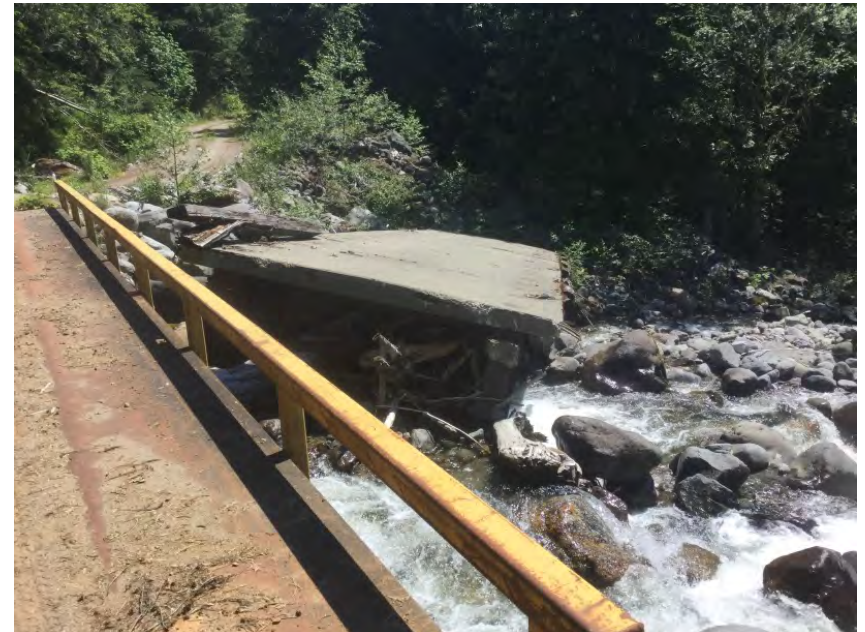
Old structure still remains in stream

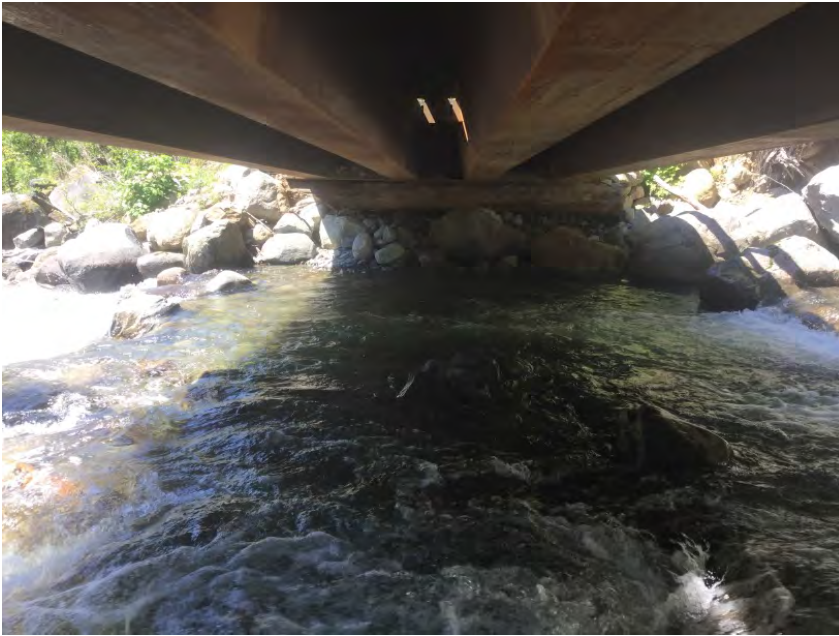
Right Bank Abutment when facing downstream

Scoured away under right abutment

None on right end

Not complete bearing at right abutment

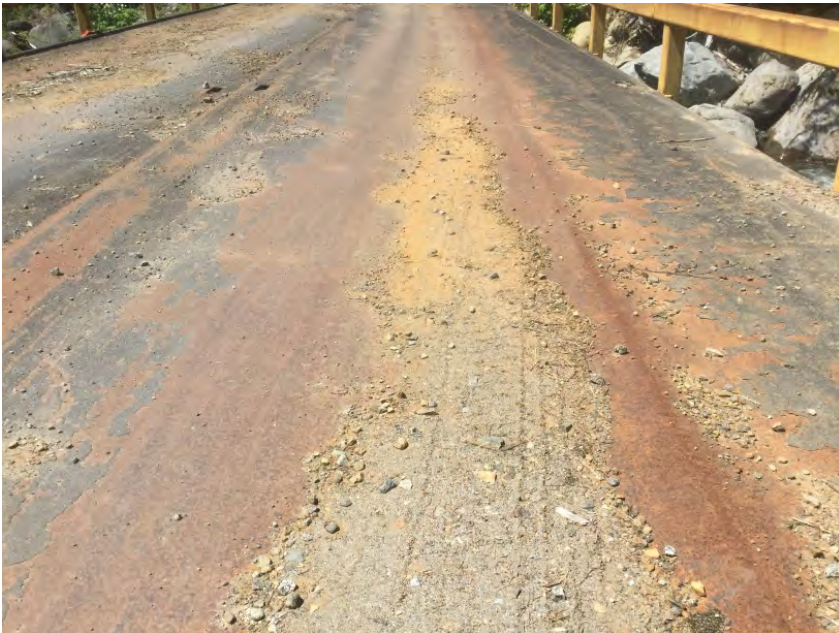
Steel deck plate deformation

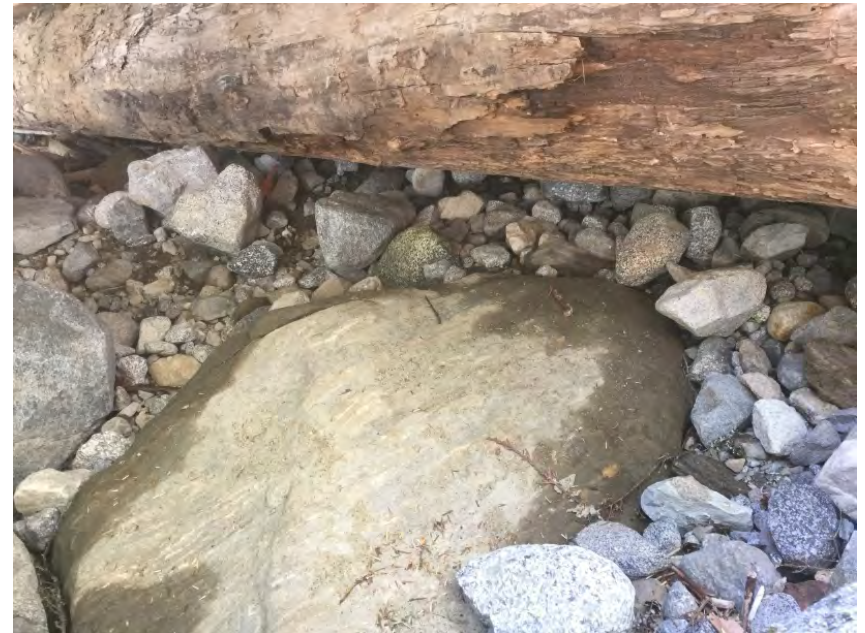
Right bank sill log scoured and only bearing downstream 2m length and 0.5m length at upstream wheel path location

| Item | Priority | Repair Description |
|---|---|---|
| 1 | High | Replace prior to industrial activity |
