CK-2120

BEAR 7km

2018 Inspection

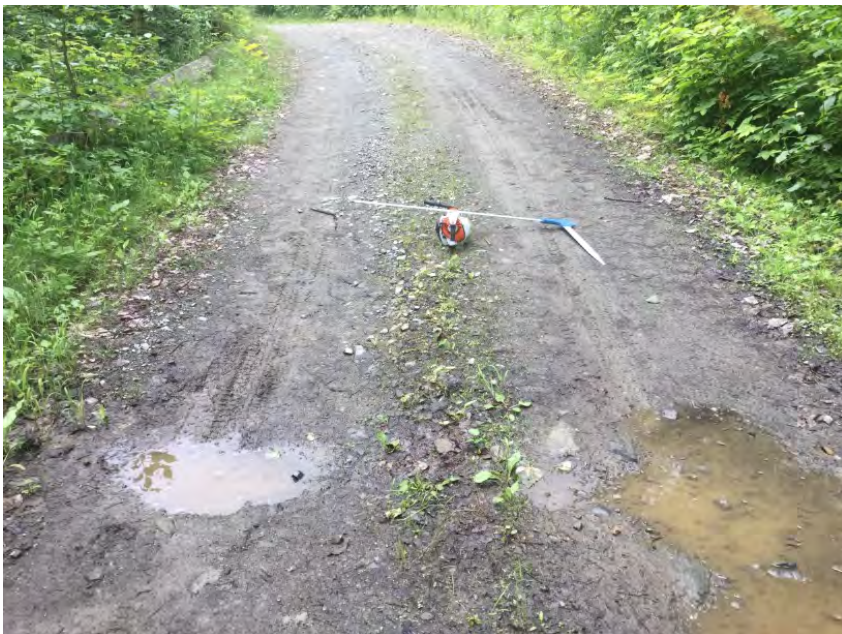
Curb Rail/Blocks/Posts Poor do not appear to be attached to stringers

Overall Deck Condition Poor do to rail

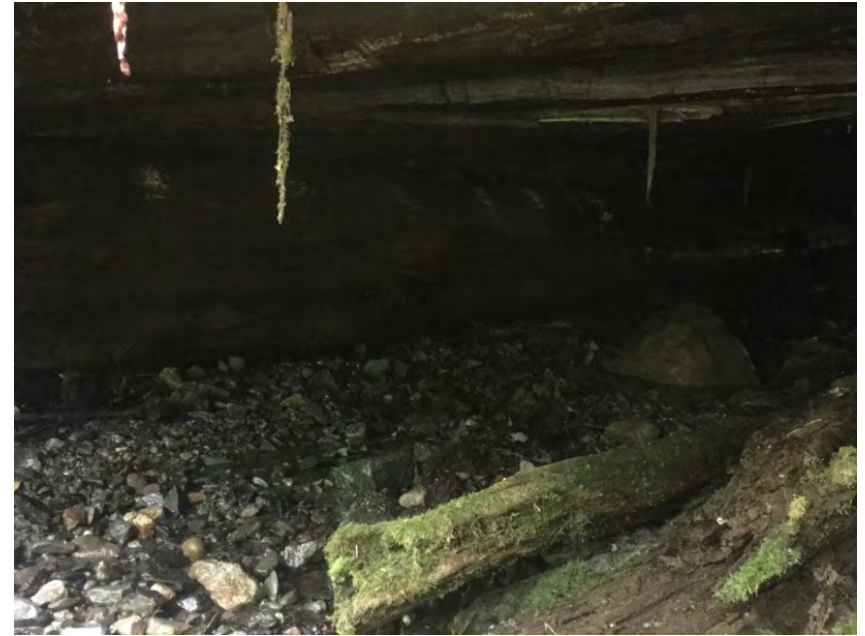
Right Bank Abutment when facing downstream

Caps or Sills Fair Large log sill both abutments - Cw

Riprap Poor None in front of sills

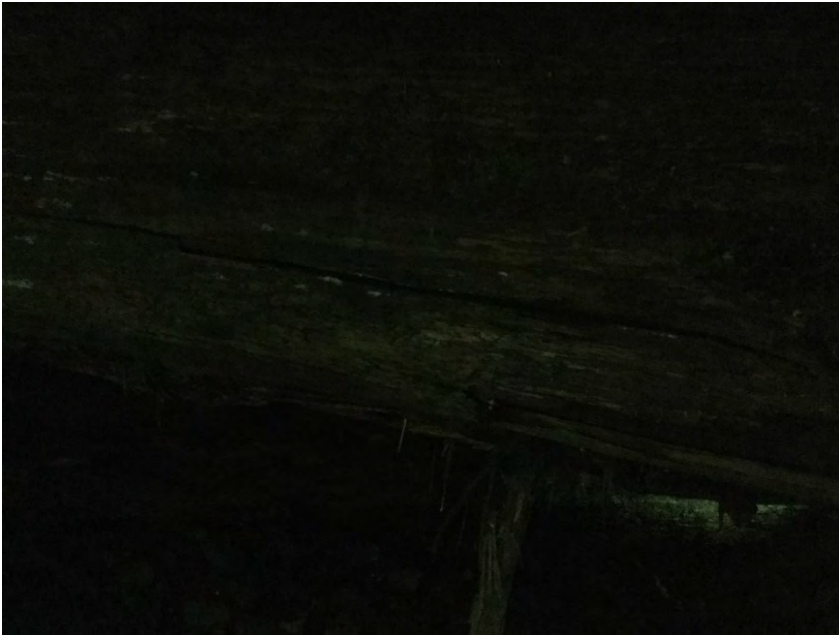
| 2 | Cy | Y | 690 | 50 | | horizontal crack, appears to be limited to sap wood |

Stringer 2 crack at midspan but only appears to be in sap wood
