CK-2121

BEAR 7.4km

2018 Inspection

Crossing Name Bear Creek

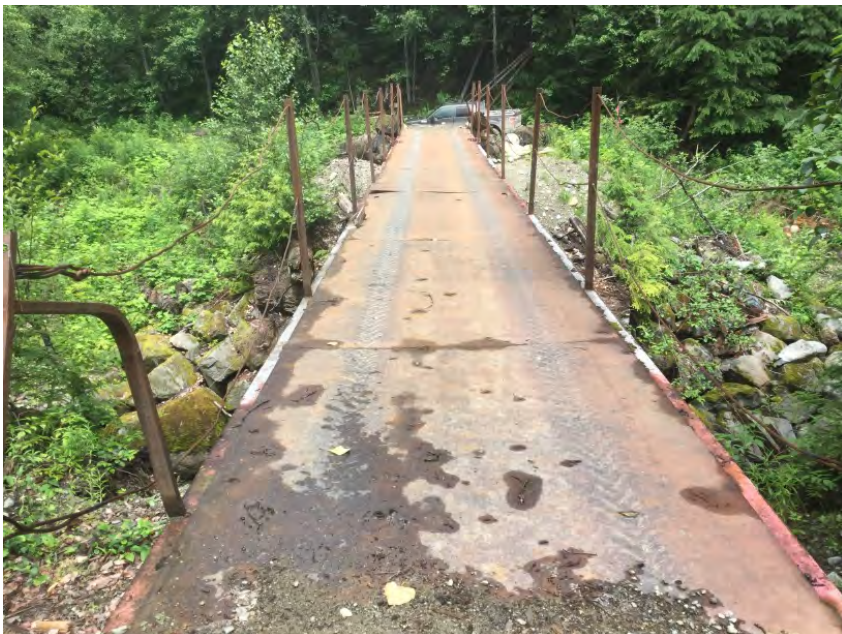
Hand Rails/Walkouts Poor Cables are extremely loose and should be tightened, consider adding additional cables

Overall Deck Condition Poor Due to rail condition

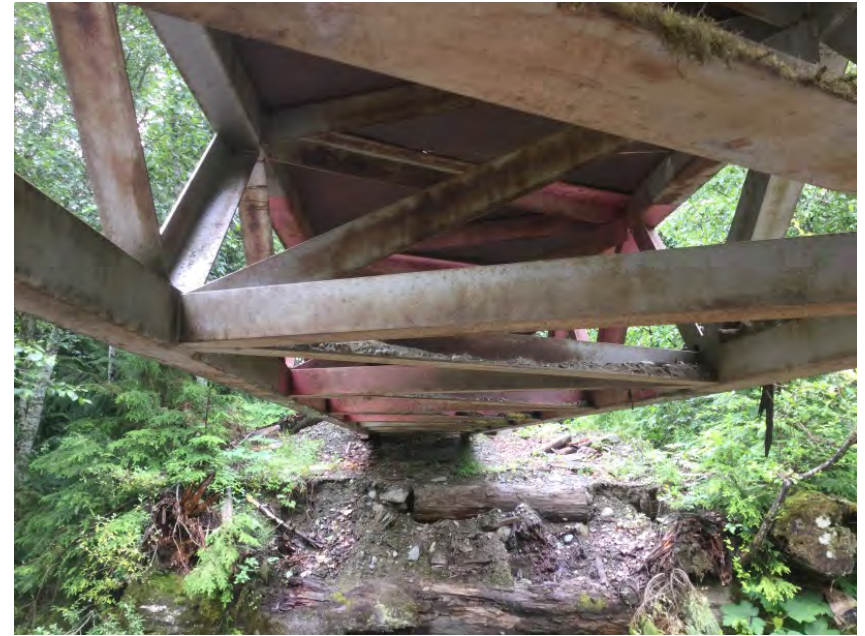
Superstructure

The Ministry does not have any documents pertaining to the steel structure; therefore the bridge is assigned a 0 tonnes load rating. Post load rating sign and send in record and structural drawings for an updated load rating.

| 1 | High | Post load rating sign |
| 2 | High | Send in record and structural drawings for steel structure |

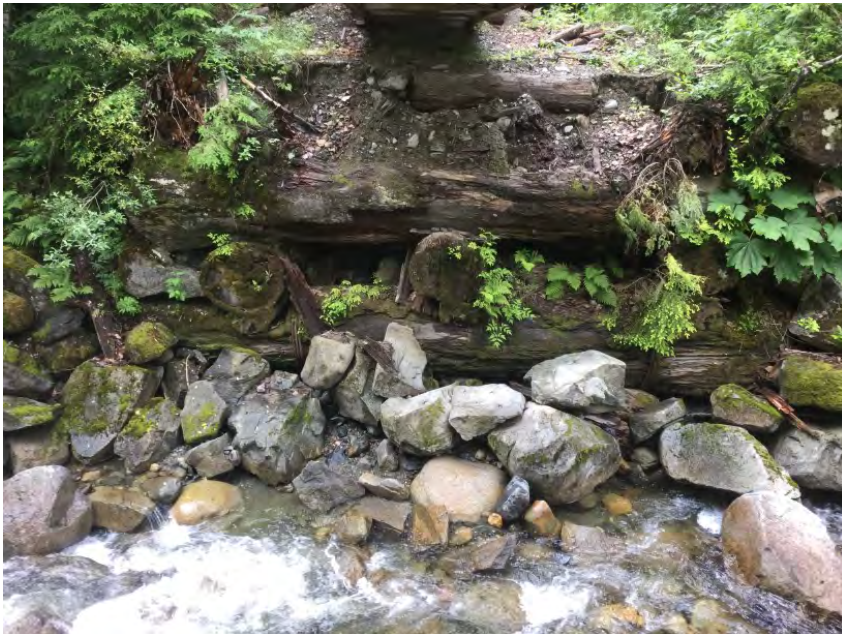
Left Bank Abutment when facing downstream

Fair to poor for original structure face logs, up to 80mm sap rot

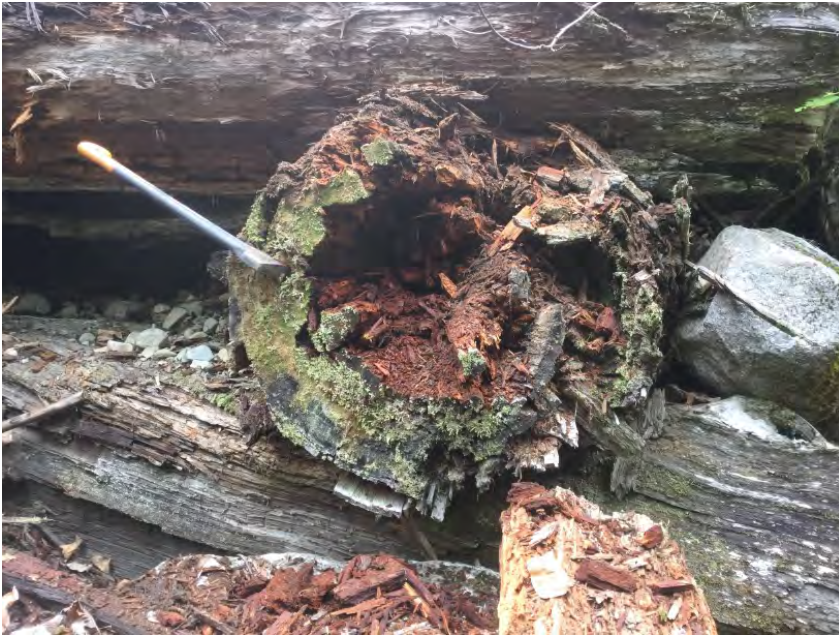
Original crib condition is rated as poor due to tieback condition

Tie Backs Poor

Rotten for the original substructure

Tieback condition
