CK-2126

BEAR 7500 0.1km

2018 Inspection

Crossing Name Bear Creek

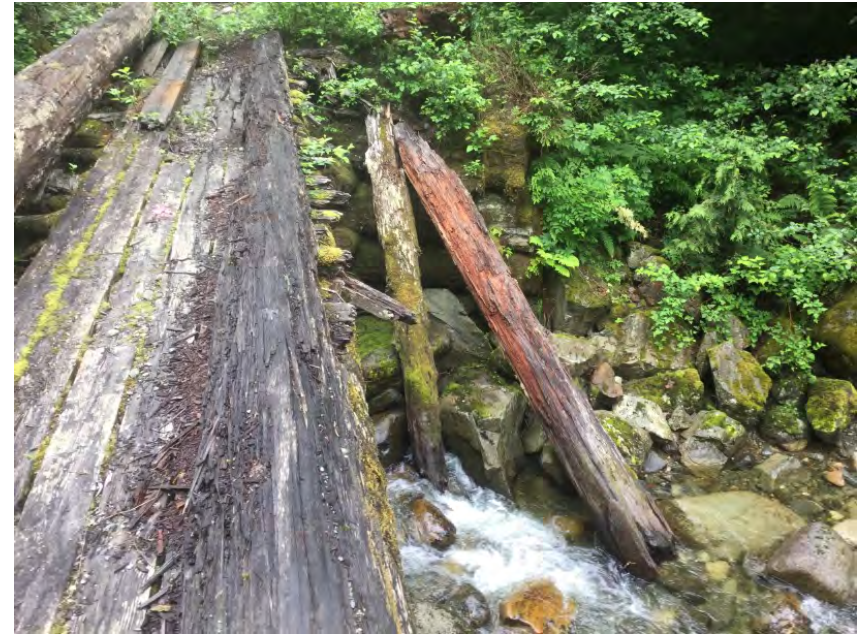
Stringers are rotten, 3 have broken and lie in stream  
Access is restricted by gate however road access to the site still exists

All remaining stringers are visually rotten

Stringers failing

Remove the remaining structure components, completely block access, and post the bridge as closed/deactivated. Bridge condemned, 0 tonnes load rating.

| Item | Priority | Repair Description |
|---|---|---|
| 1 | High | Remove remaining structure from site, completely block access, and post the bridge as closed/deactivated |

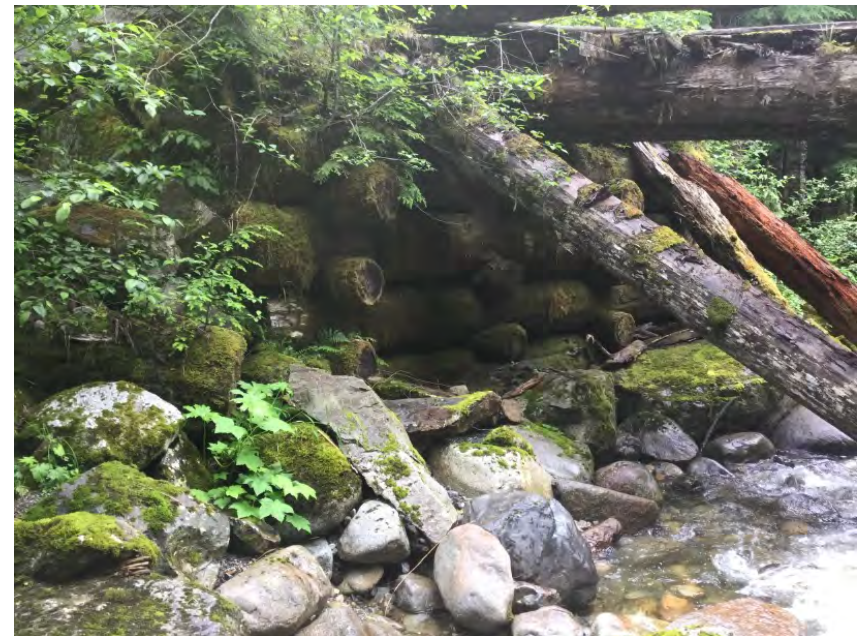
Left Bank Abutment when facing downstream

4x and up to 80mm sap rot

4x, rotting

Very little in front of crib
