CK-2128

STS'AILES (WEST) 5.9km

2018 Inspection

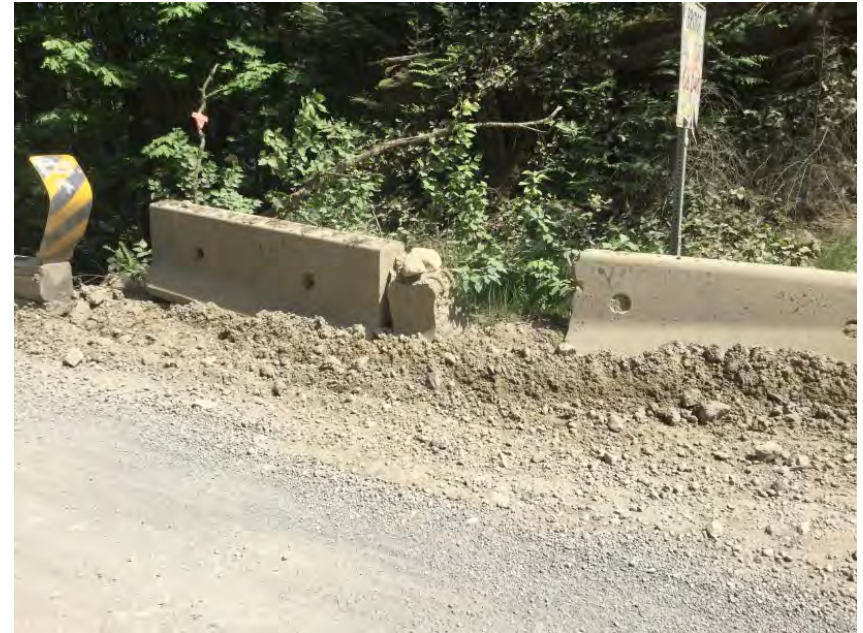
Concrete no post barriers, right approach damage noted

Downstream right approach barrier damage

Repair/replace and realign the concrete no post barriers and clean sediment from deck. The current load rating of L75 or 68 tonnes to continue.

| Item | Priority | Repair Description |
|---|---|---|
| 1 | Medium | Repair and/or replace damaged concrete no post barriers and realign |

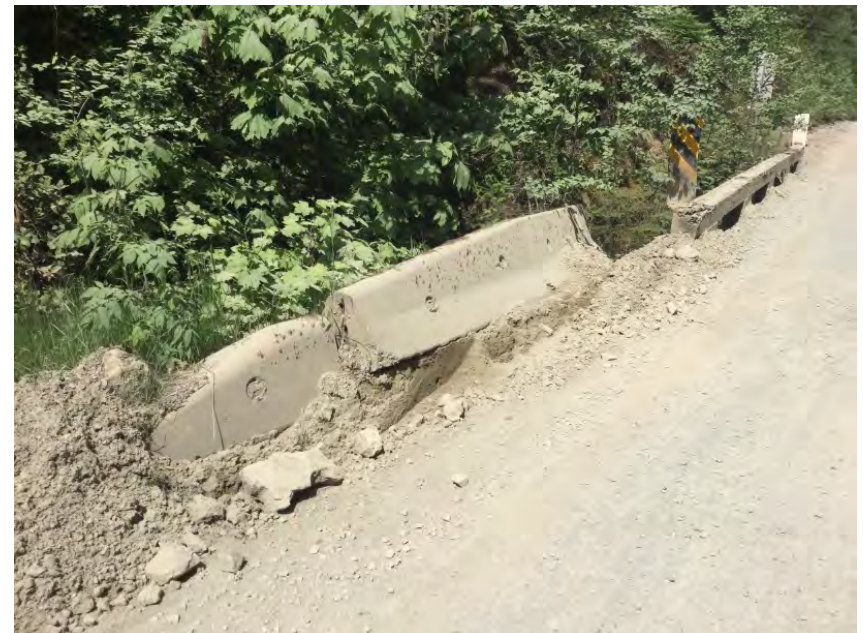
Upstream right approach misalignment

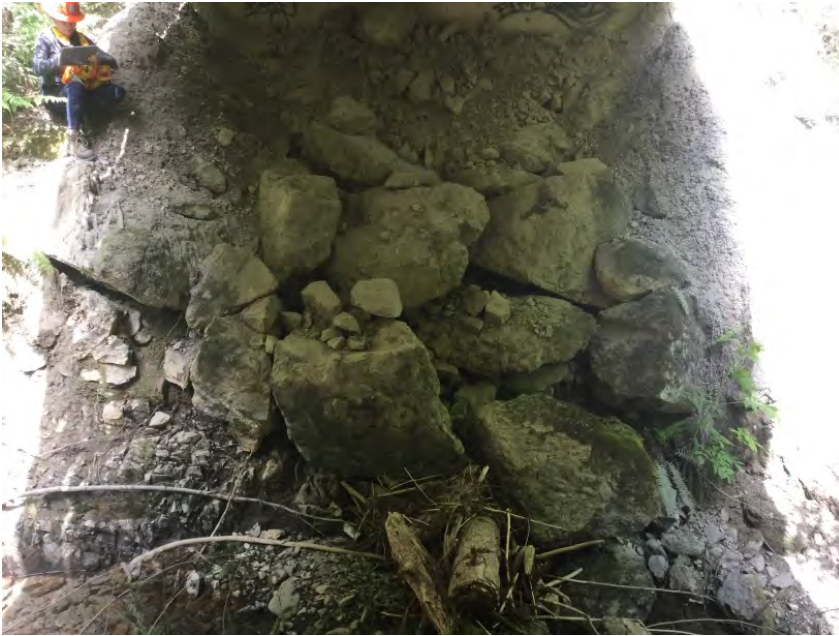
Left Bank Abutment when facing downstream

Sloughing on left bank

Some movement noted on left bank, BR right bank
