CK-2132

STS'AILES (WEST) 16.8km

2018 Inspection

| Crossing Name | Simms Creek | | |

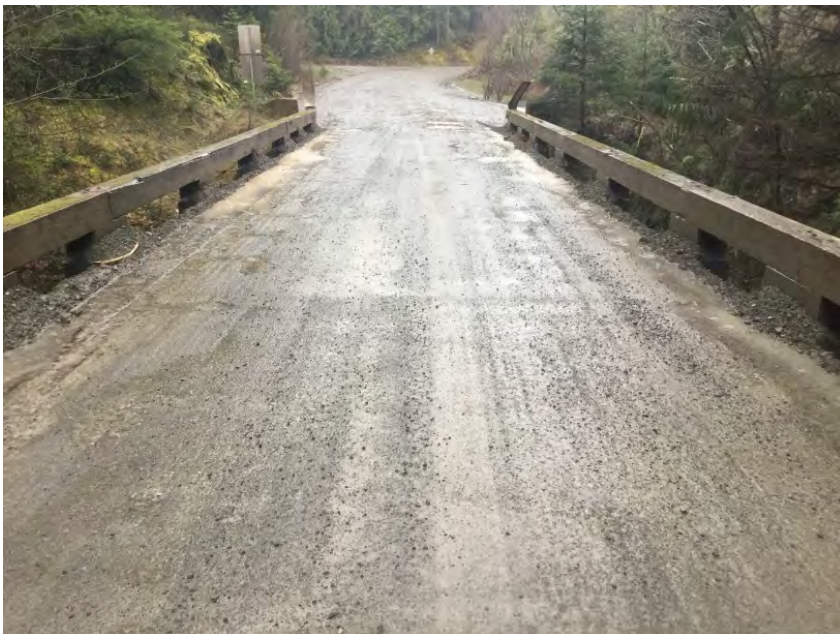
Running Surface      Fair

Grout Pockets      Fair

Overall Deck Condition      Fair

Clean sediment from deck. The current load rating of L75 or 68 tonnes to continue.

| 1 | Low | Clean sediment from deck |

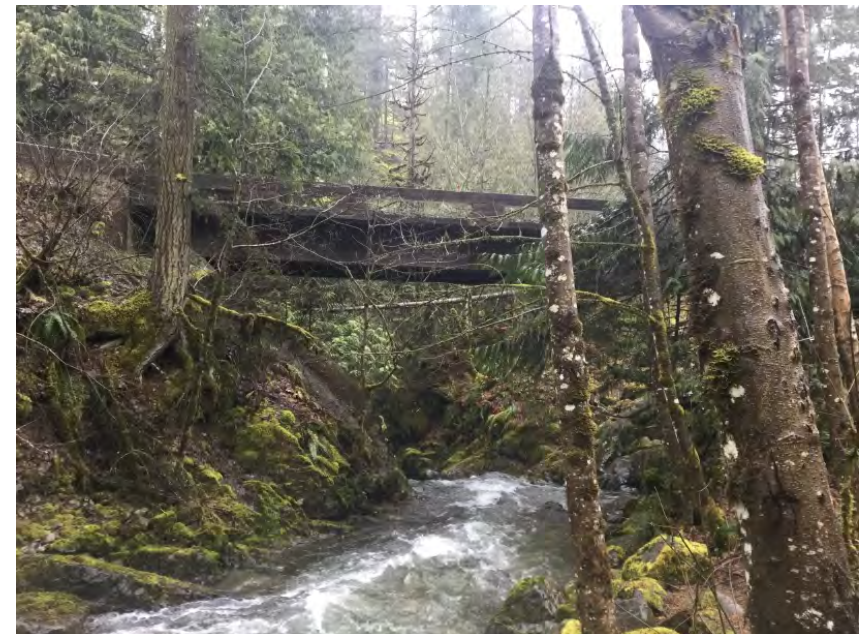
Upstream Profile

Comments    **Bedrock controlled crossing**

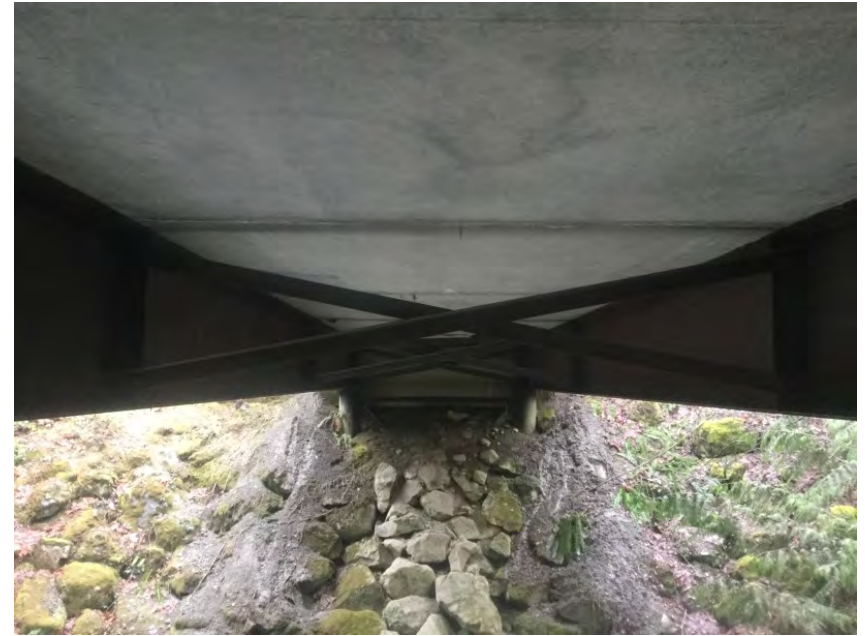
Superstructure

Girders Fair minor corrosion

Diaphragms Fair 4 bolted bays

Bracing Fair
