CK-2133

STS'AILES (WEST) 18.7km

2018 Inspection

Crossing Name Walian Creek

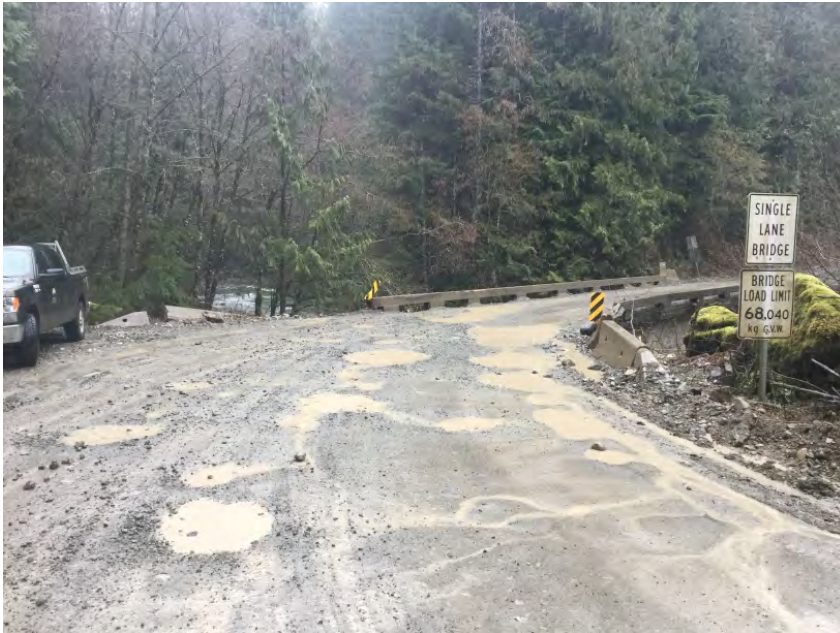
Approach from Right Bank when facing downstream

Heavy HC at right approach

No posts knocked off road at upstream right bank

| Repair Item | Priority | Repair Description |
|---|---|---|
| 2 | High | Realign no post barriers at upstream right approach |

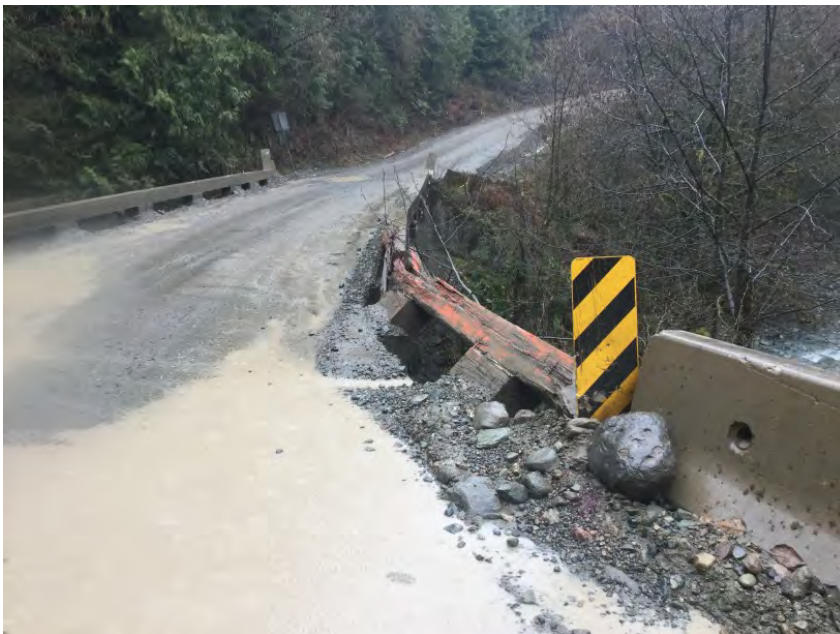
Curb Rail/Blocks/Posts Poor Downstream right approach damaged

Overall Deck Condition Poor Due to damaged guardrail section

Dam aged guardrail

| Repair Item | Priority | Repair Description |
|---|---|---|
| 1 | High | Replace damaged section of guardrail |

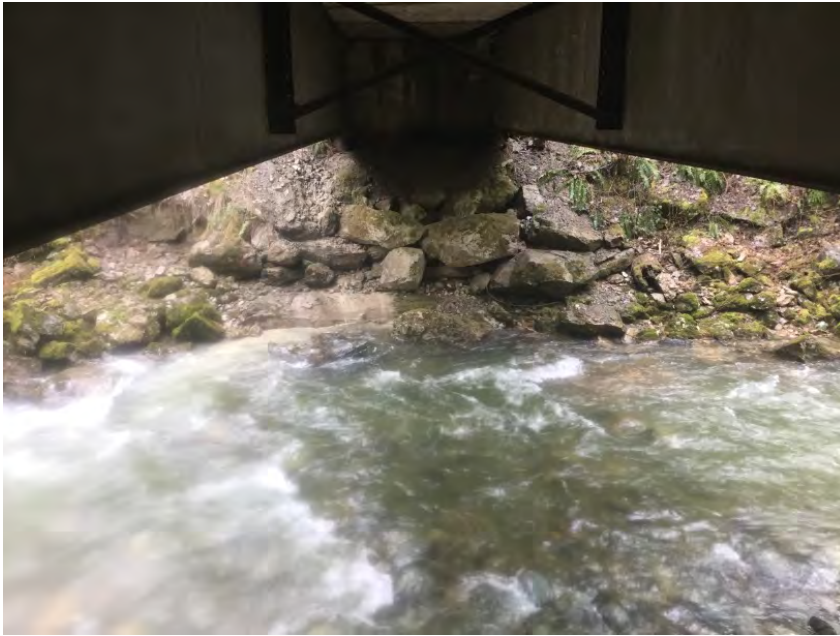
Right Bank Abutment when facing downstream

Large, not well graded on right bank

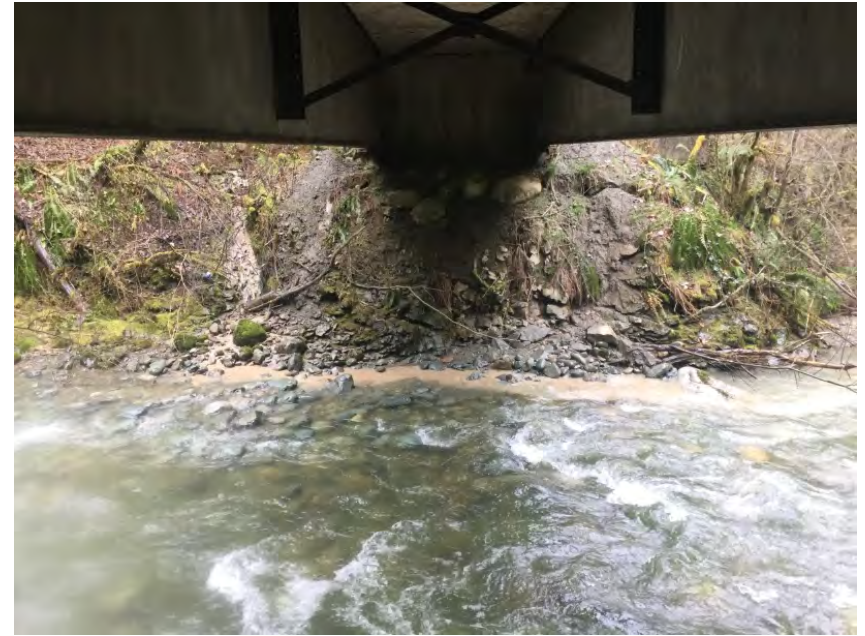
Left Bank Abutment when facing downstream

None on left bank due to limited height
