CK-2136

STS'AILES (WEST) 30km

2018 Inspection

| Crossing Name | Mystery Creek | | |

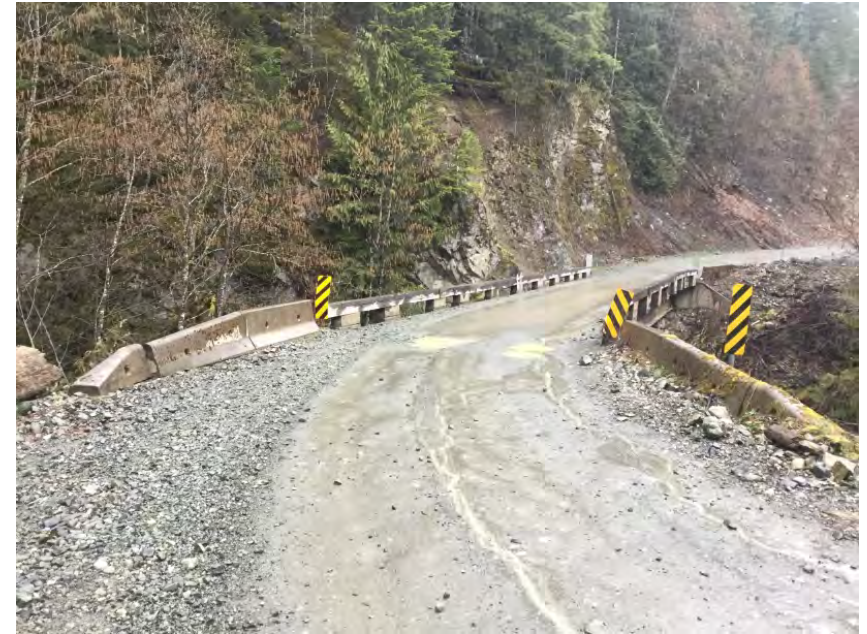
Approach from Right Bank when facing downstream

HC right approach

| Repair Item | Priority | Repair Description |
|---|---|---|
| 3 | Low | Switch delineators at right approach and grade approaches |

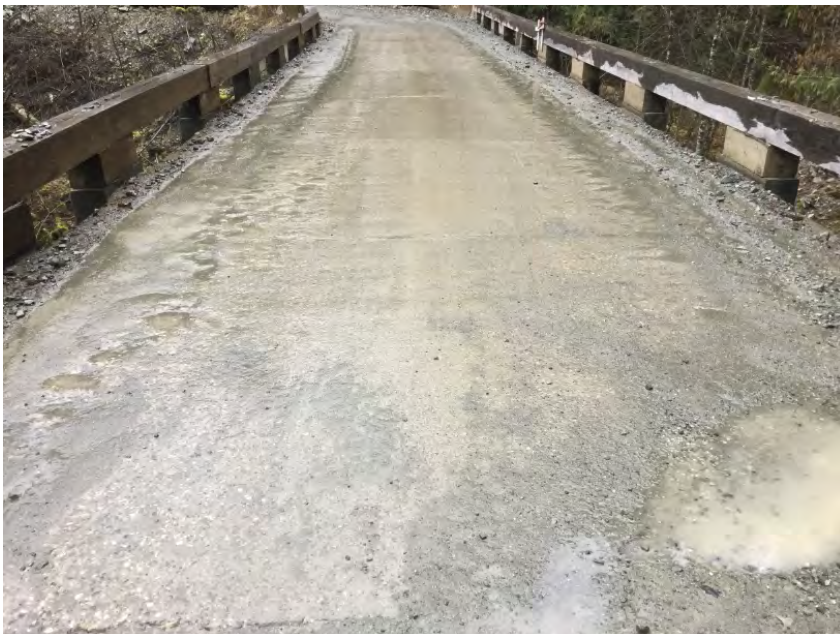
Concrete Deck Fair Some damage due to tracked equipment

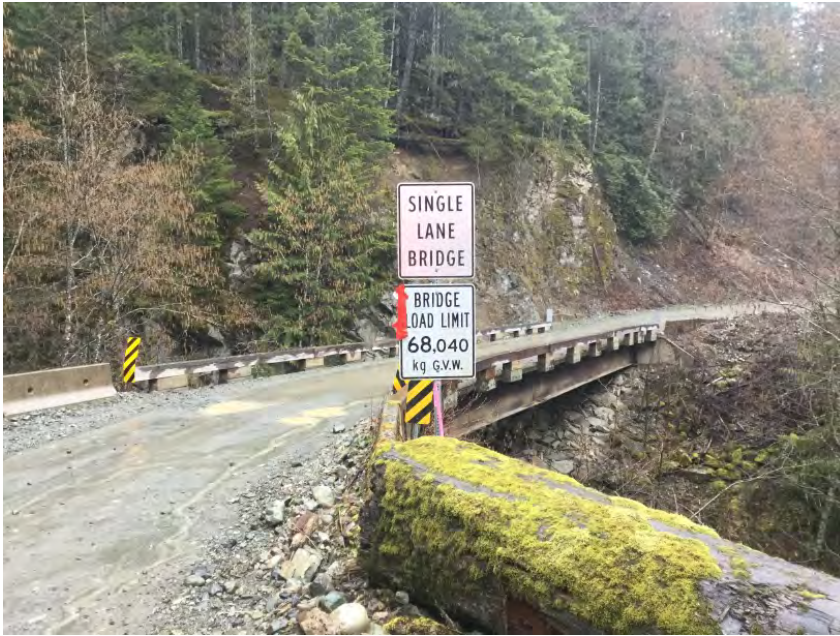
Load Rating Sign

Posted Load Rating 68030

| Repair Item | Priority | Repair Description |
|---|---|---|
| 1 | High | Remove incorrect load posting sign |

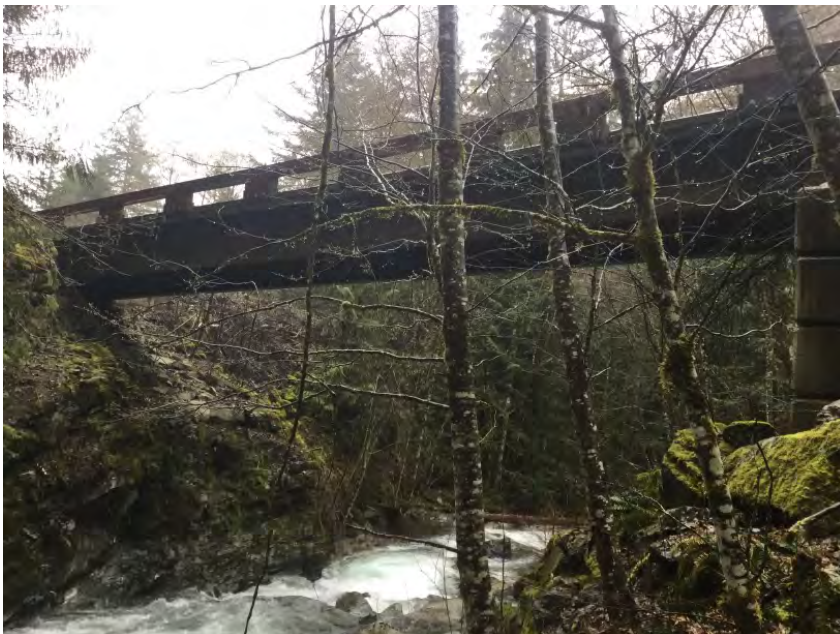
Upstream Profile

Steep at right upstream

| Item | Monitor Description | Frequency |
|---|---|---|
| 1 | Riprap at upstream right bank | Routine Inspection |

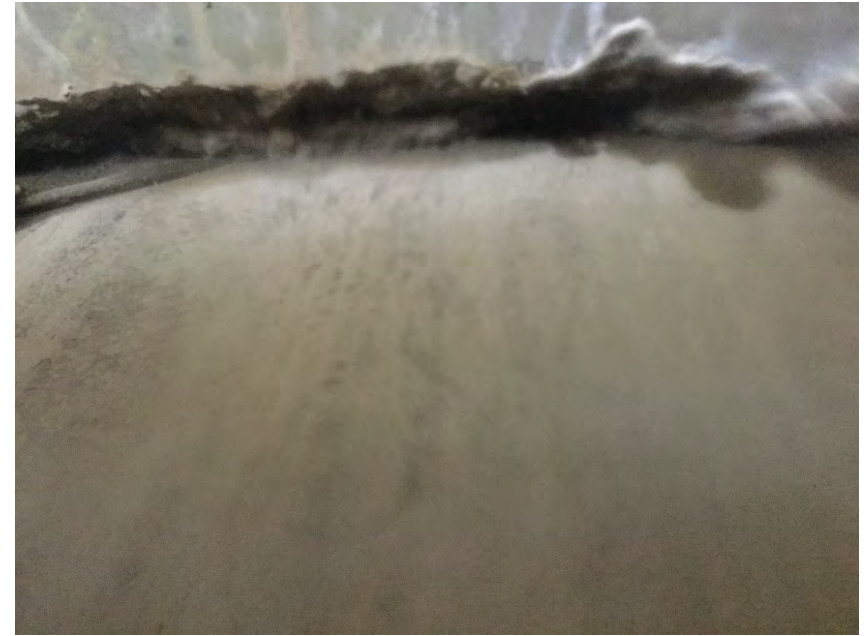
Deck panel damage

| Repair Item | Priority | Repair Description |
|---|---|---|
| 2 | Medium | Repair damage noted to deck panels consistent with the Concrete Repair Guide for Concrete Bridge Components |

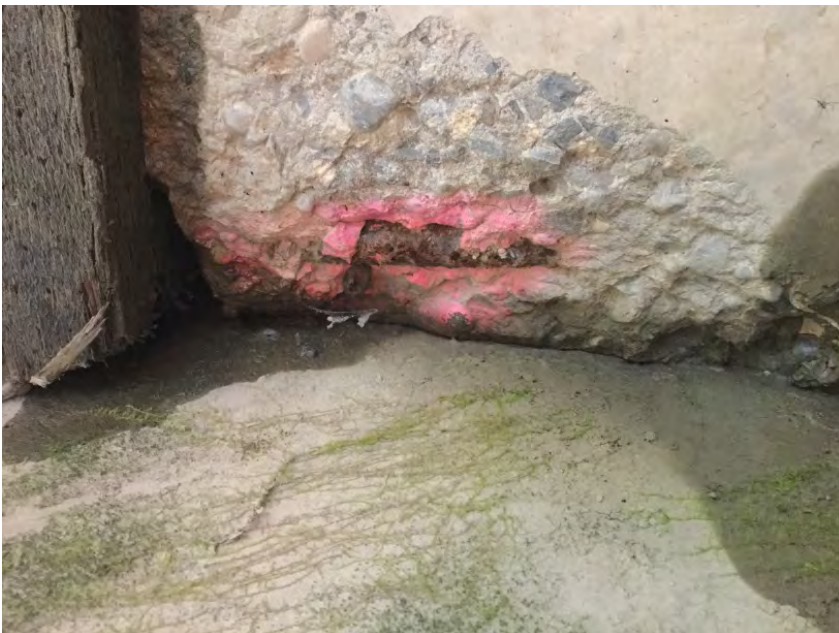
Deck panel damage with rebar exposed

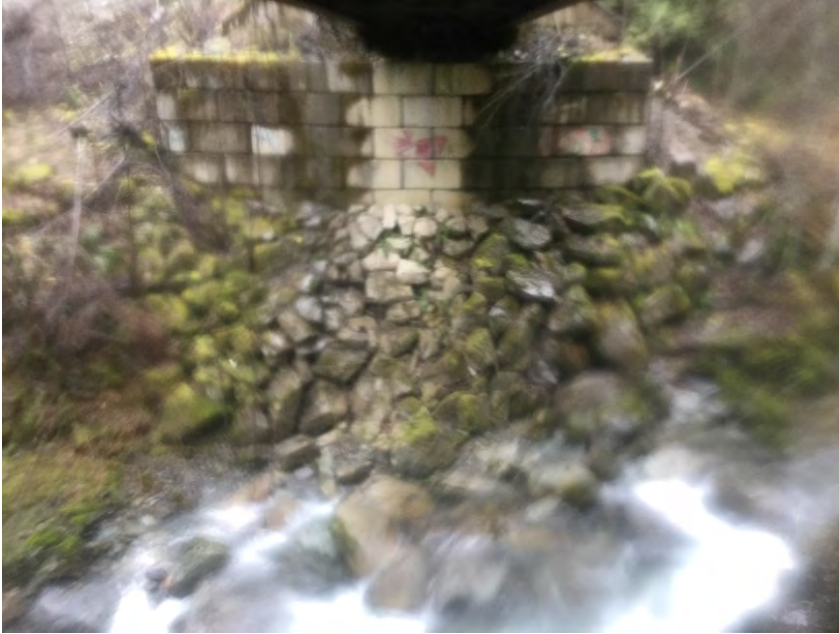
Right Bank Abutment when facing downstream

Lock blocks on right side, 5 rows
