CK-2148

SIMMS 8.6km

2018 Inspection

| Crossing Name | Simms Creek | | |

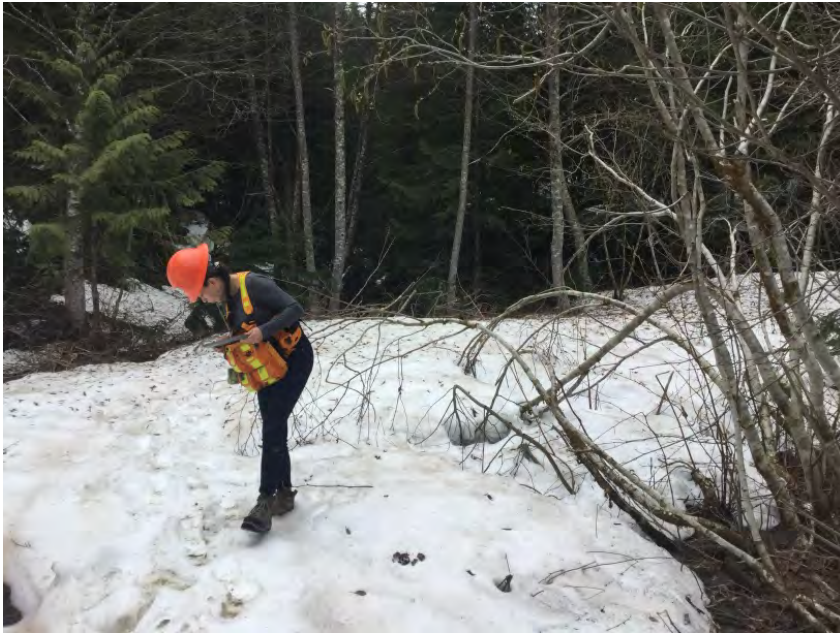
Approach from Right Bank when facing downstream

HC both approaches

Road Surface Poor

ATV acces only

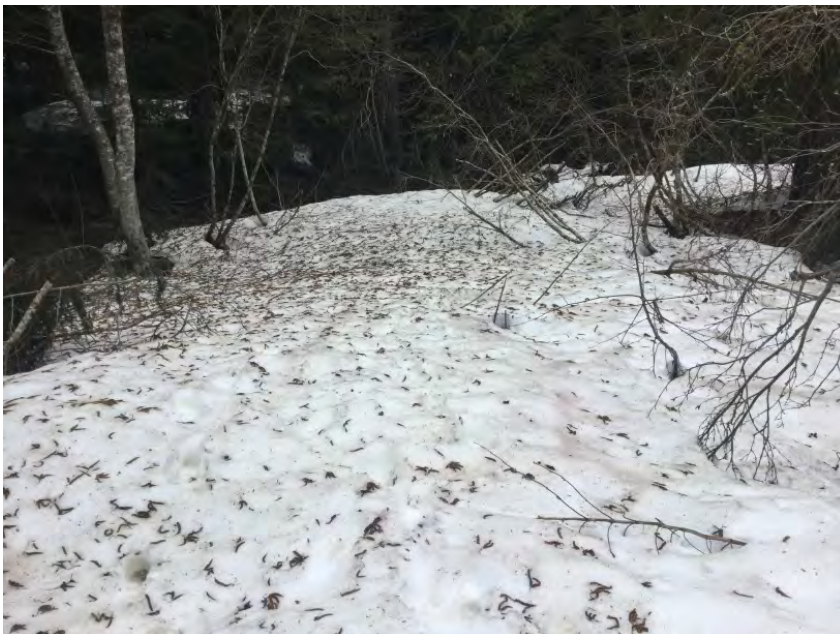
Due to snow accumulations on deck it has not been completely assessed; however holes were noted at the surface extending through deck to the stream, making it a safety concern to users

ATV acces only, snow at the time of inspection; however a hole at the surface extended down through the deck to the stream presenting a safety issues even to ATVs

Deck, cannot be assessed due to snow

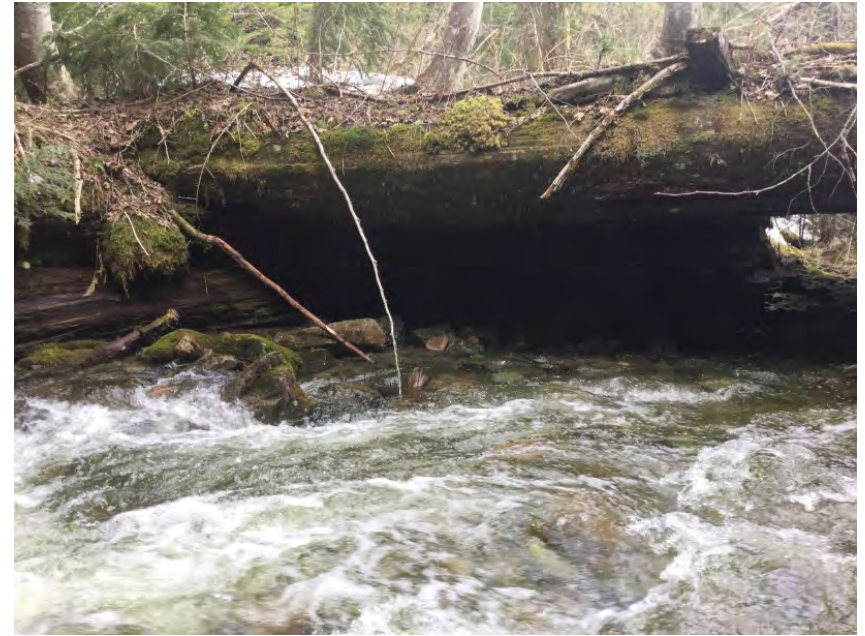
Left Bank Abutment when facing downstream

Log/Timber Cribs Poor

Rotten and crushing

Tie Backs Poor

Rotten and splitting

Failing through face logs

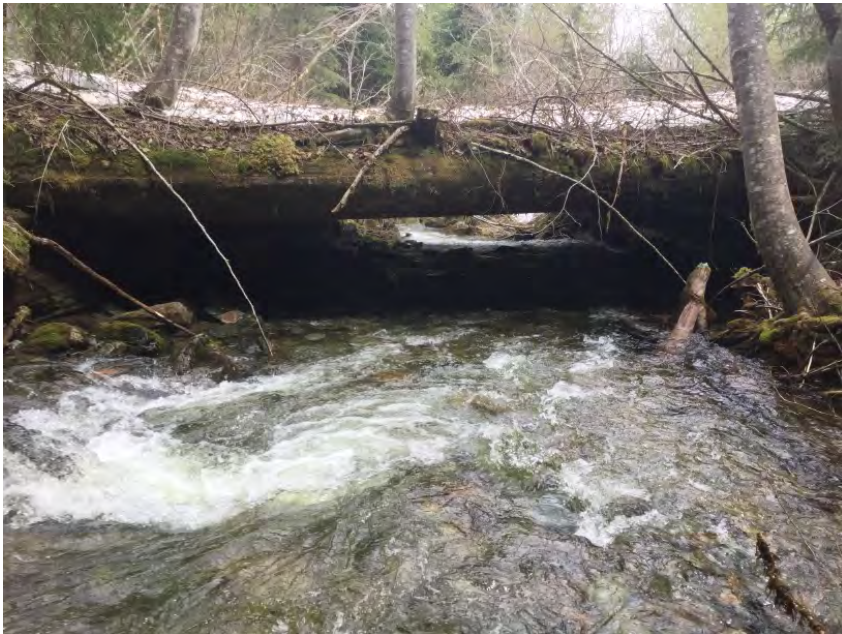
Upstream Profile

The entire structure is in poor condition and recommend complete removal prior to failure

| 1 | High | Remove structure and block access |

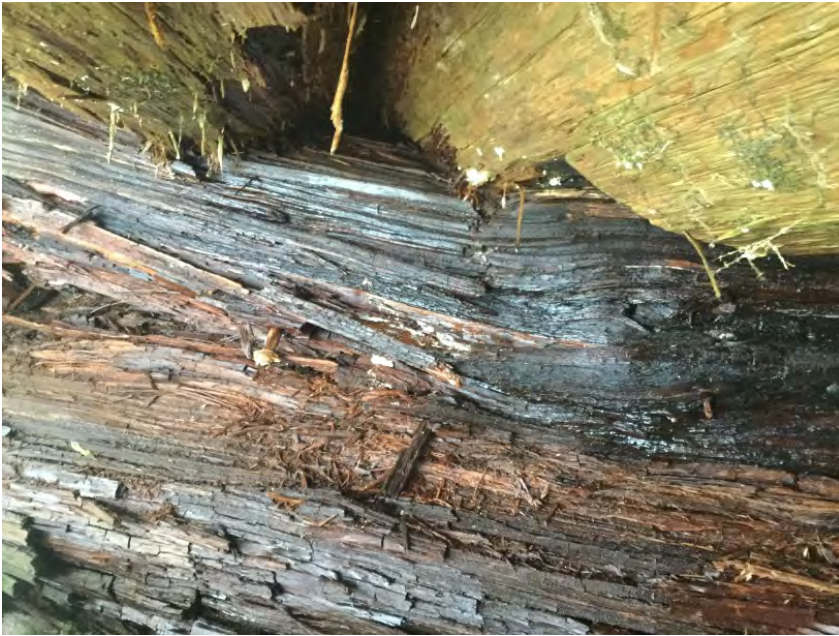
Top crib log failed at left bank

Crushed top crib log at upstream left bank

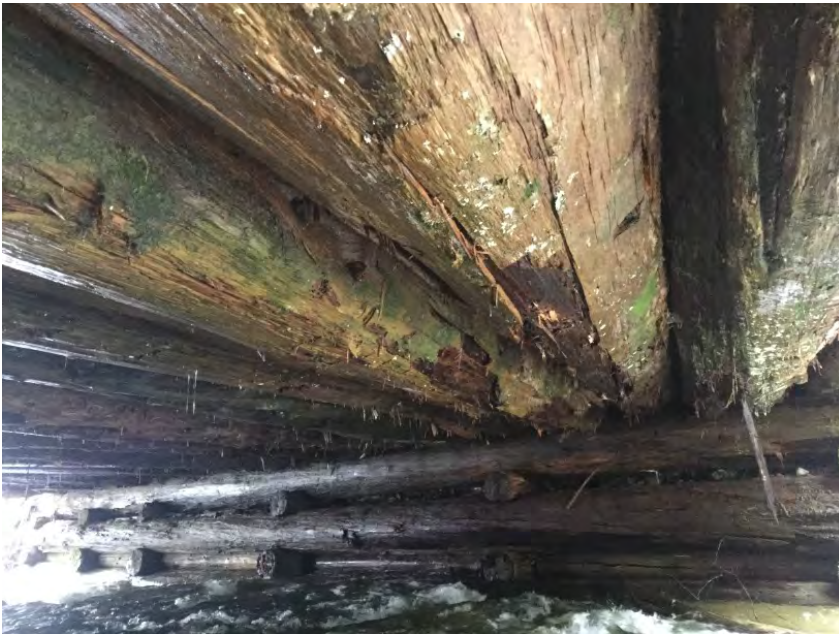
Stringers

All stringers in poor condition
