CK-2152

JONES LAKE 3.9km

2018 Inspection

| Structure Class | Permanent Bridge | | |

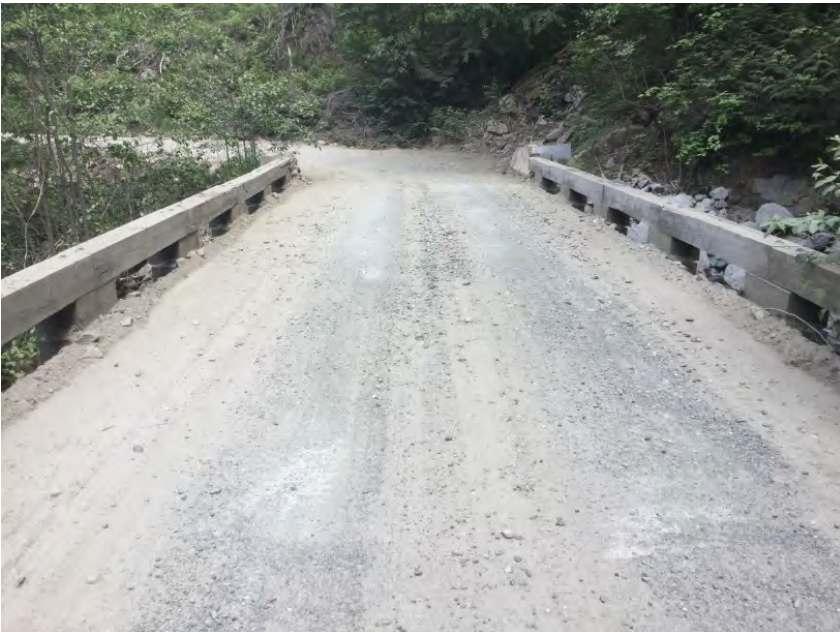
Concrete Deck Fair typical wear on wheel path

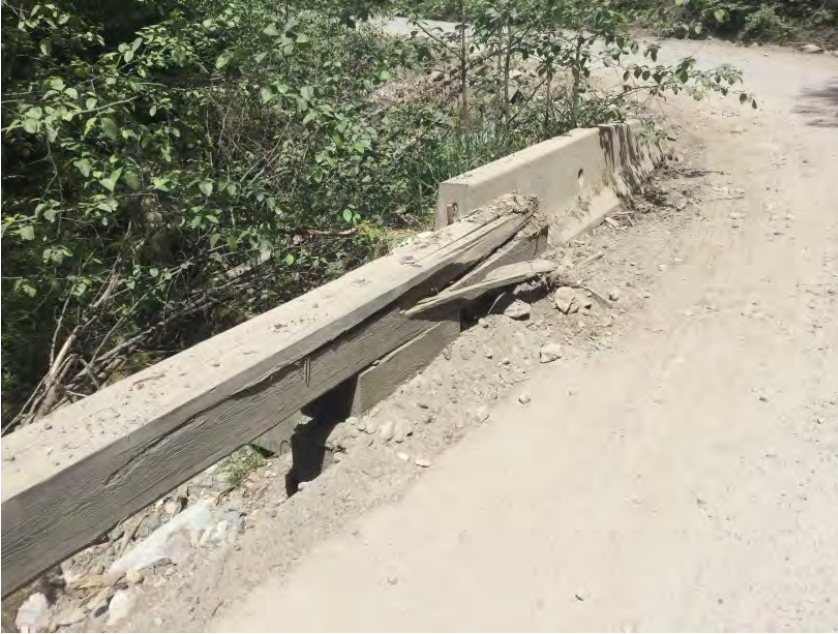
Curb Rail/Blocks/Posts Fair some damage noted at downstream right bank

Damaged guardrail downstream right bank

| 2 | Medium | Replace damaged section of guardrail and replace missing delineators |

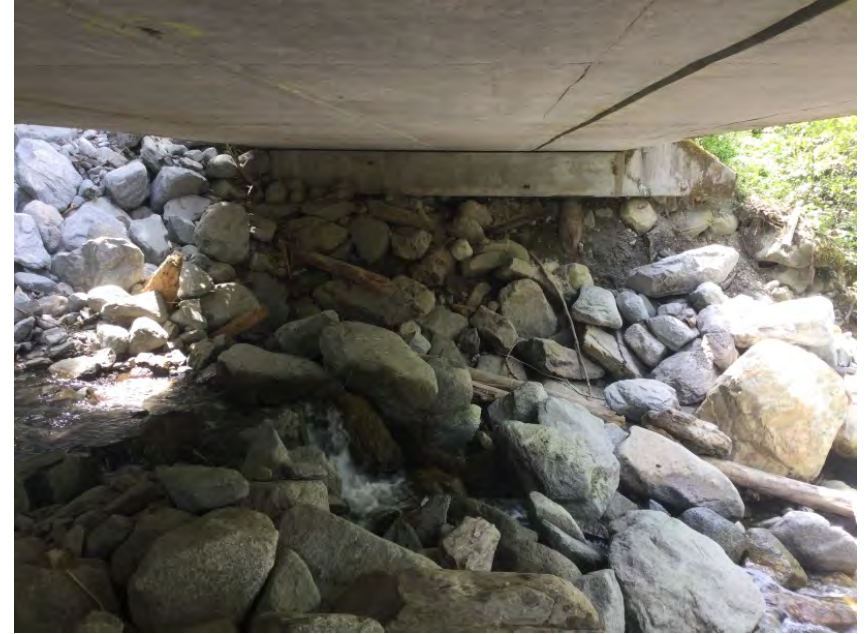
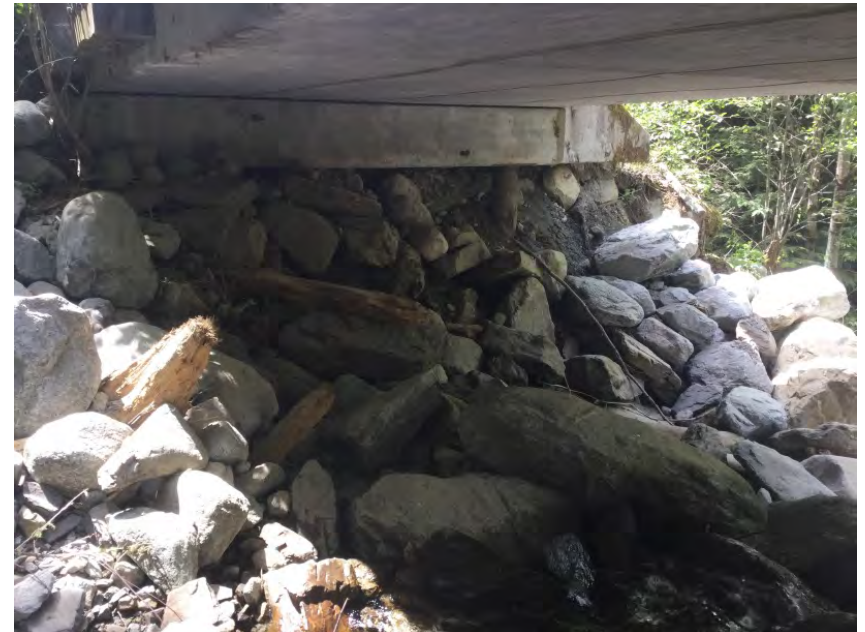
Left Bank Abutment when facing downstream

The abutments have sustained damage by previous high flows leaving the footings partially exposed. The riprap in front of both abutments is not adequate for permanent infrastructure.

Both abutments require additional riprap for proper protection. Until this is properly done monitor for further erosion especially following heavy precipitation events; consider replacing the structure with a longer span. Replace the damaged section of guardrail and replace the missing delineators. Present load rating of L75 or 68 tonnes to continue.

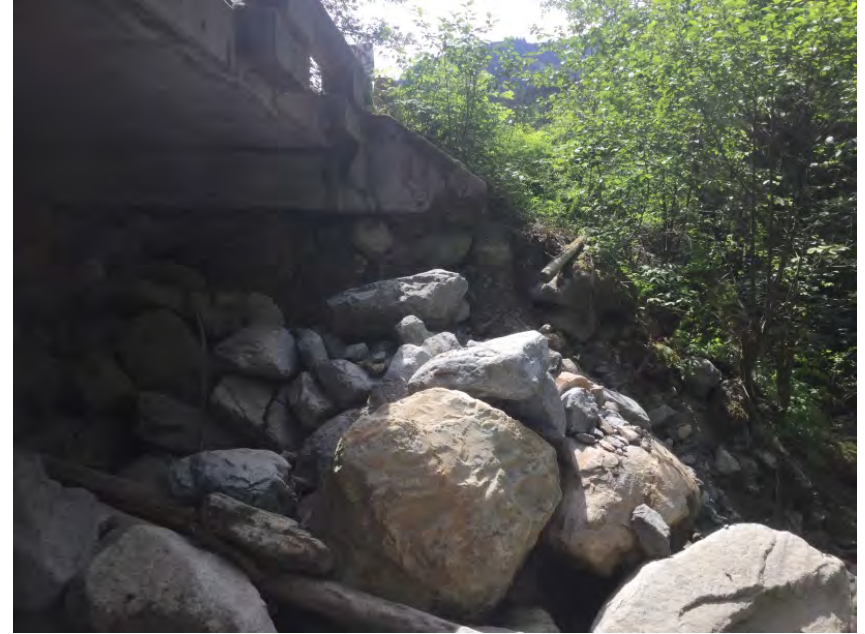
Poor at downstream left bank as it's eroding

Downstream left bank fill erosion

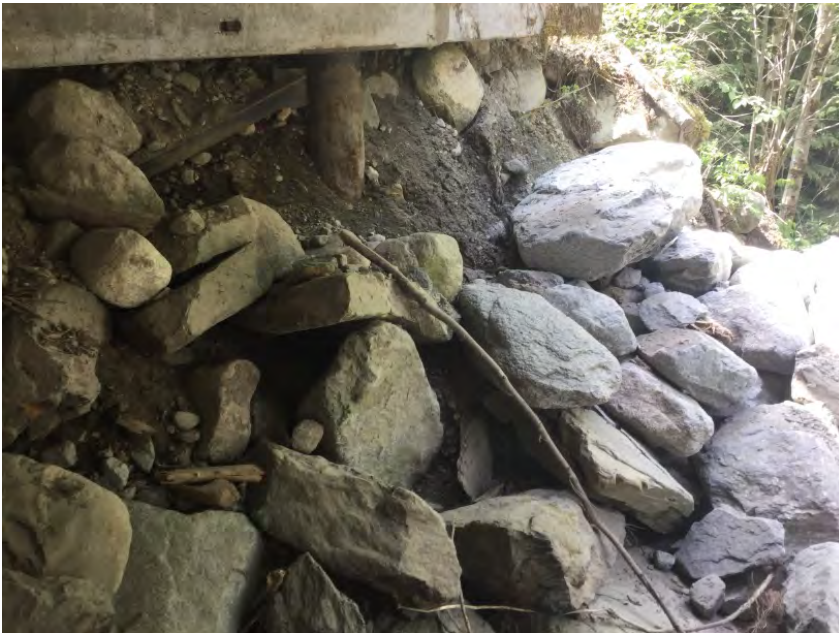
Very little in front of both abutments and round and not keyed in

Downstream left pipe column partially exposed with little riprap in front

| Item | Priority | Repair Description |
|---|---|---|
| 1 | High | Replace riprap in front of both abutments |

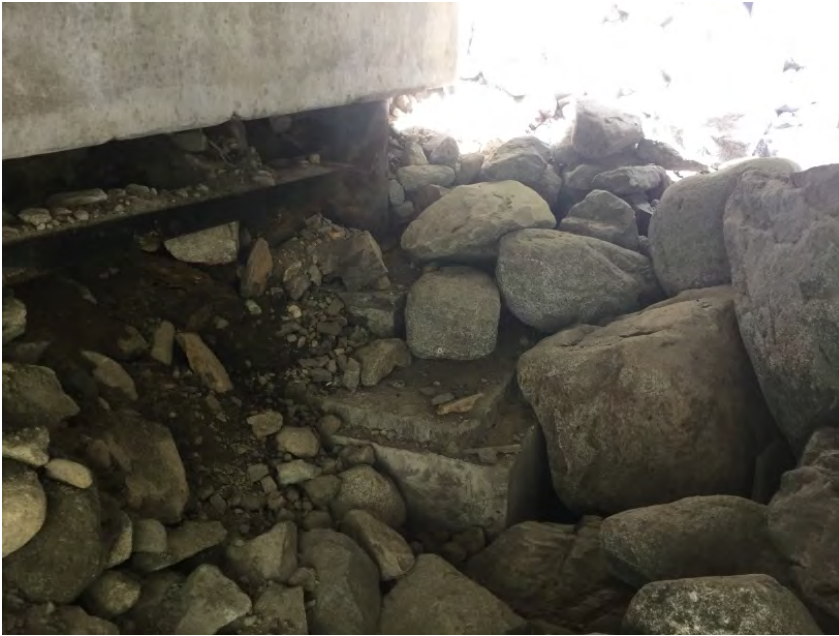
Upstream right bank footing partially visible - concrete added below precast for complete bearing

Upstream right bank pipe column and footing partially exposed

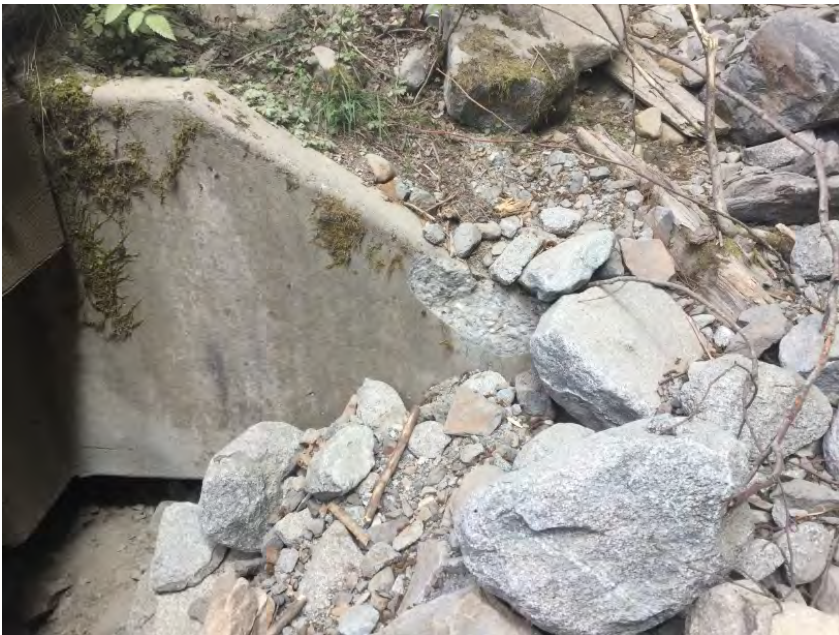
Minor damage noted to upstream right bank ballast wall
