CK-2167

LOST CREEK 8km

2018 Inspection

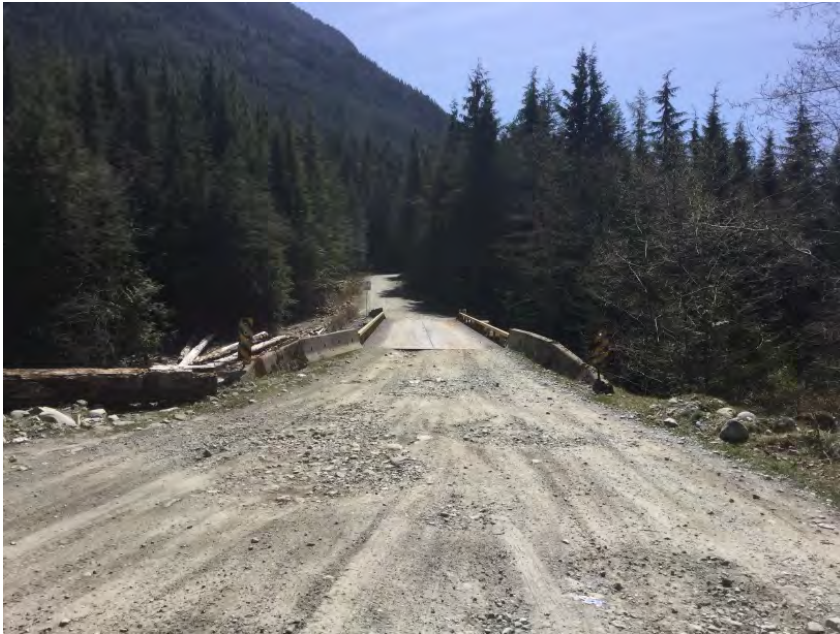
Approach from Right Bank when facing downstream

Road Surface Poor Potholes

Running Surface      **Good**      Potholes at both approaches

Grade approaches. Present load rating of L75 or 68 tonnes to continue.

| 1 | Medium | Grade approaches |

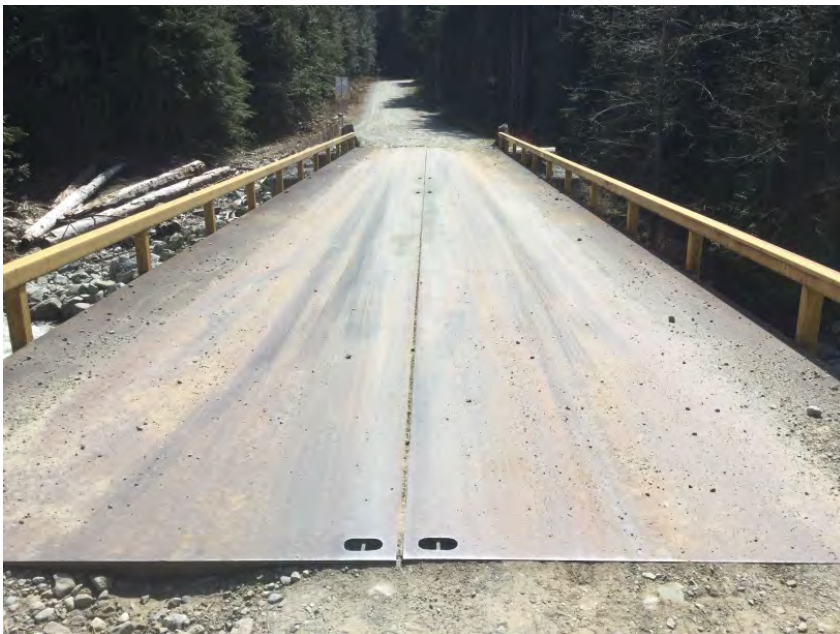
Steel Deck Plate      **Good**

Overall Deck Condition      **Good**

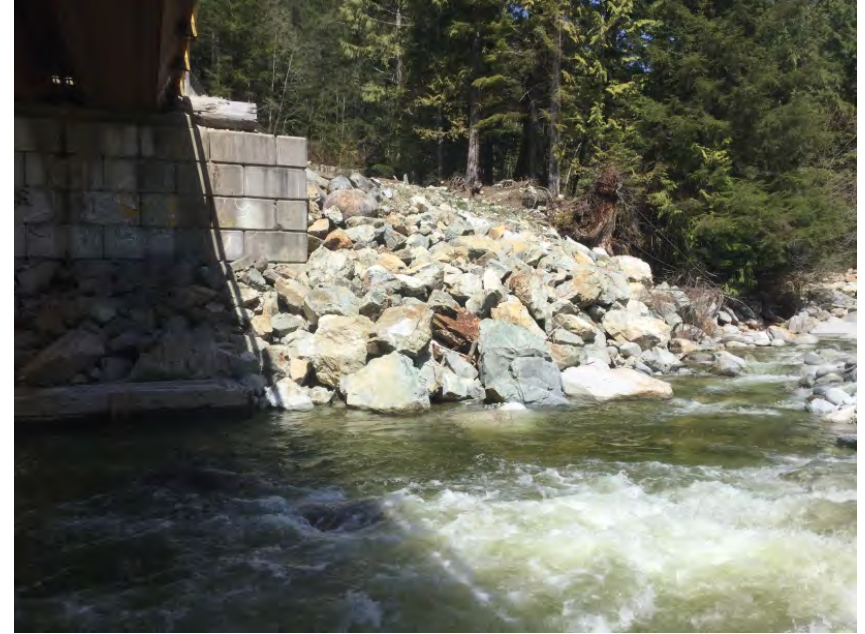
Upstream right bank riprap

Riprap Good

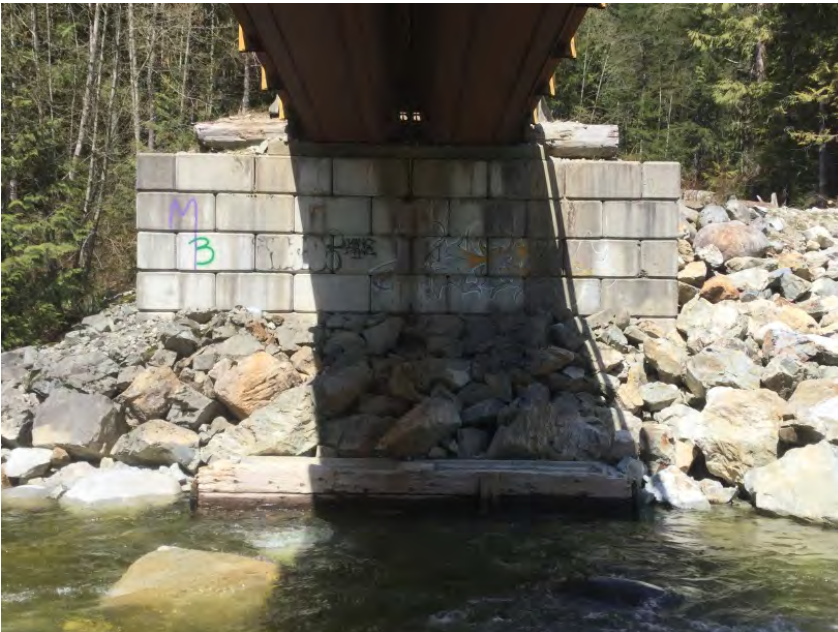
Right Bank Abutment when facing downstream

Caps or Sills Good 2 treated 200mm x 250mm timbers bolted together for each cap

Ballast Wall Good Logs

Wing Wall Good Lock blocks
