CK-2171

LOST CREEK 17.8km

2018 Inspection

| Crossing Name | Kenyon Creek | | |

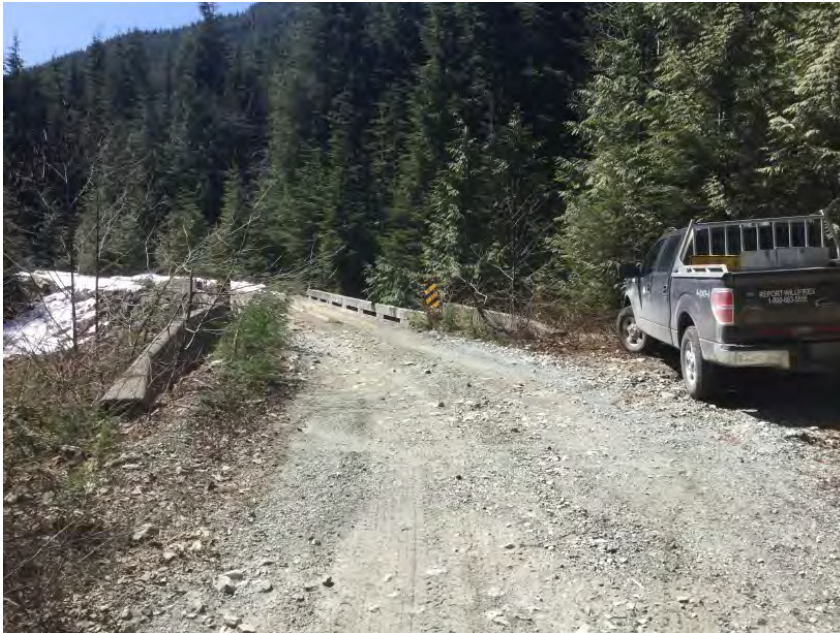
Approach from Left Bank when facing downstream

Alignment Fair

HC both approaches

Road Surface Poor

No surfacing material

| Item | Priority | Repair Description |
|---|---|---|
| 2 | Medium | Brush, surface, ditch and grade with activity |
| 4 | Medium | Post bridge ahead signs |

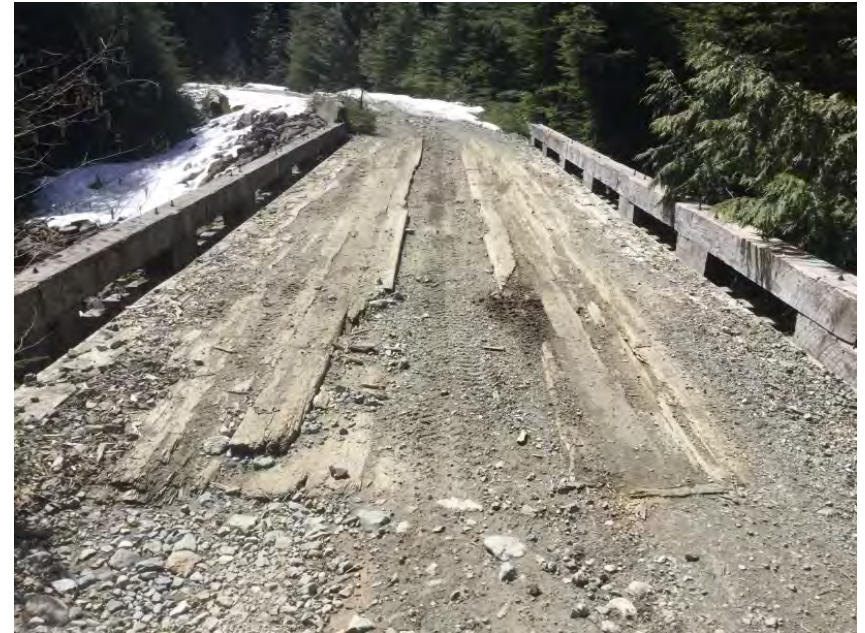
Running Planks

Poor

Rotten

Overall Deck Condition

Replace entire deck assembly when active

| Item | Priority | Repair Description |
|---|---|---|
| 1 | High | Replace ties, subdeck, planks, guardrail and risers with activity |

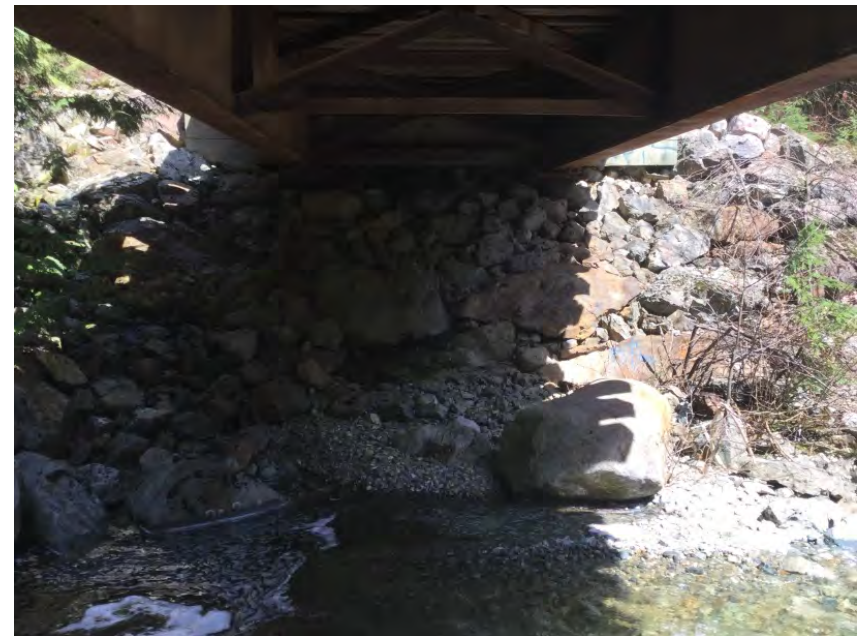
Left Bank Abutment when facing downstream

Piles or Posts Good

Ballast Wall Good Treated timbers

Bearings Fair

Corrosion Protection Fair

Does not appear as though steel was coated

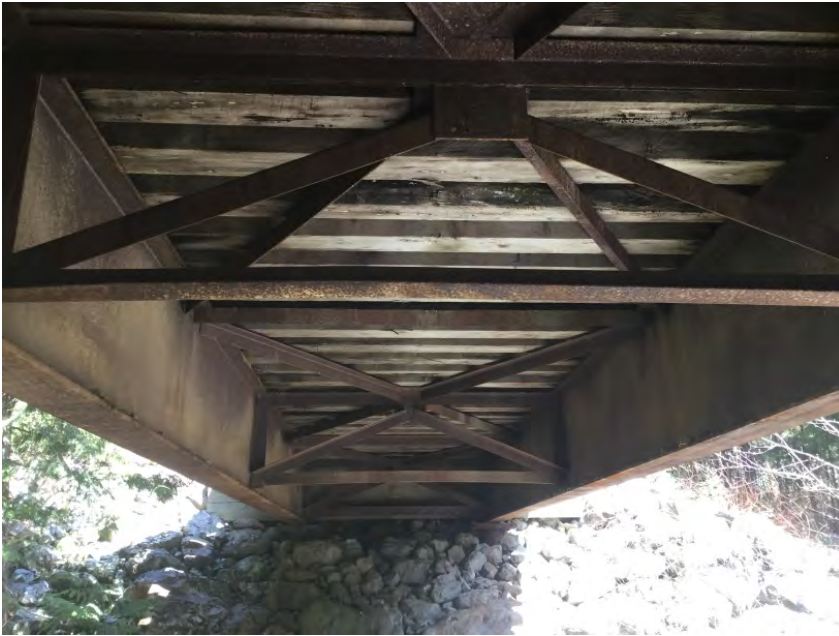
Superstructure

Girders Fair

Surface corrosion

Diaphragms Fair

4 welded bays
