CK-2172

LOST CREEK 18.8km

2018 Inspection

| Structure Class | Temporary Bridge | | |

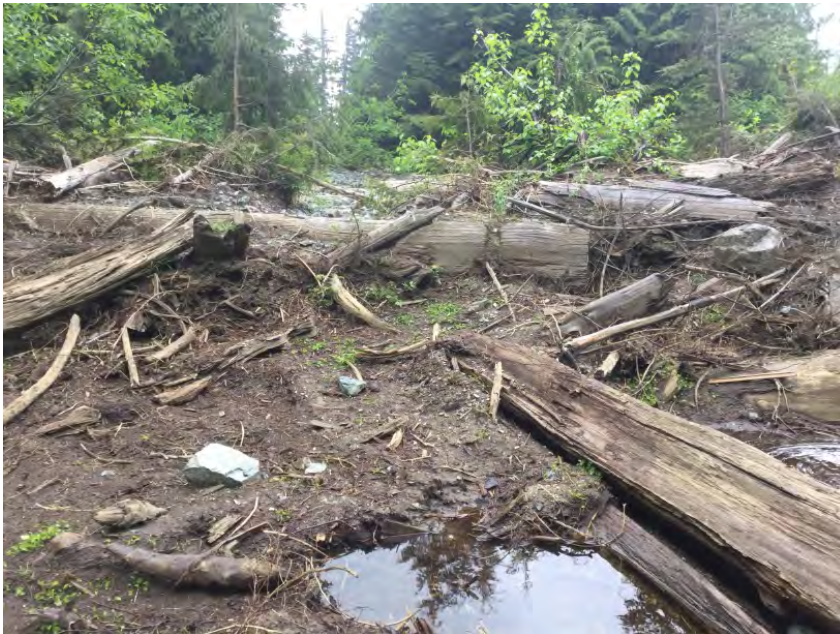
Inlet is completely blocked and stream has flowed over structure eroding surfacing and approach materials. Recommend complete replacement. Access to the site is limited to rugged 4x4 and off road vehicles.

Comments The inlet is completely plugged putting the stability of the entire structure at risk.

The bridge and road approaches are in poor condition, limiting access to the structure. The inlet remains blocked putting the structure at risk. Limit loading to 2 tonnes and plan to remove and/or replace the entire structure soon. Post load rating sign.

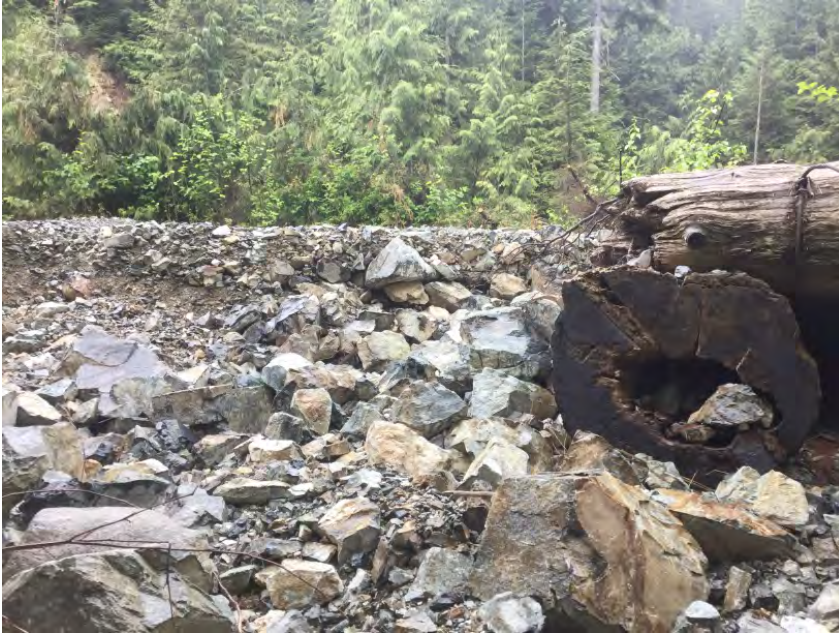
Eroded downstream right approach

Downstream right bank fill has eroded away completely
