CK-2173

LOST CREEK 18.9km

2018 Inspection

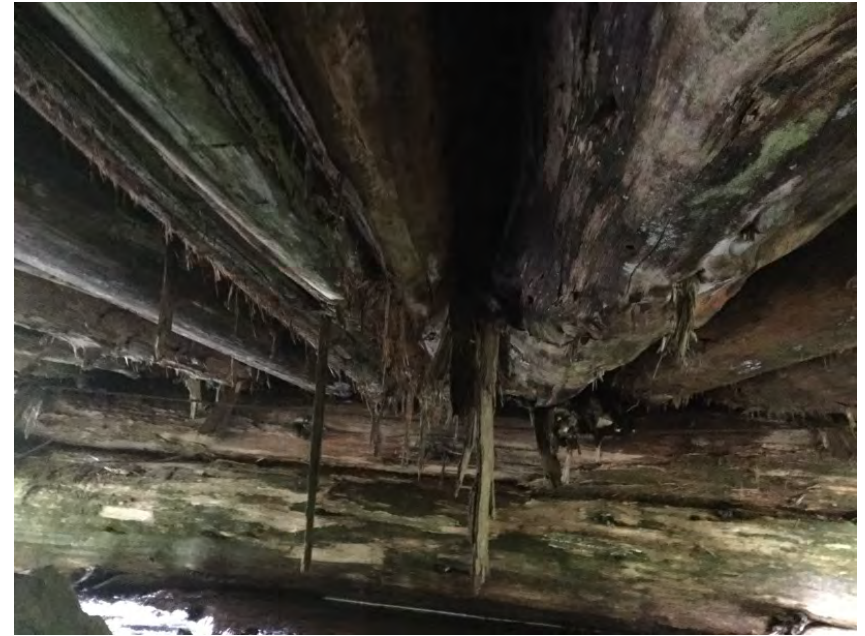
Stringers

Structure is in poor condition  
See last inspection for stringer details
