CK-2174

MURDO 0.7km

2018 Inspection

| Crossing Name | Side Creek |

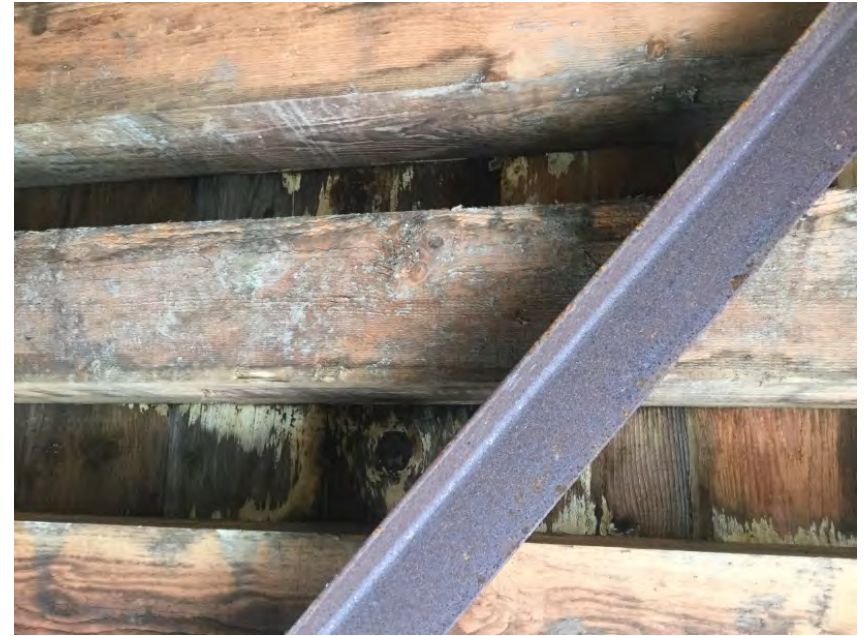
Sub Deck Fair

Indications of subdeck rot - cored and still in fair condition

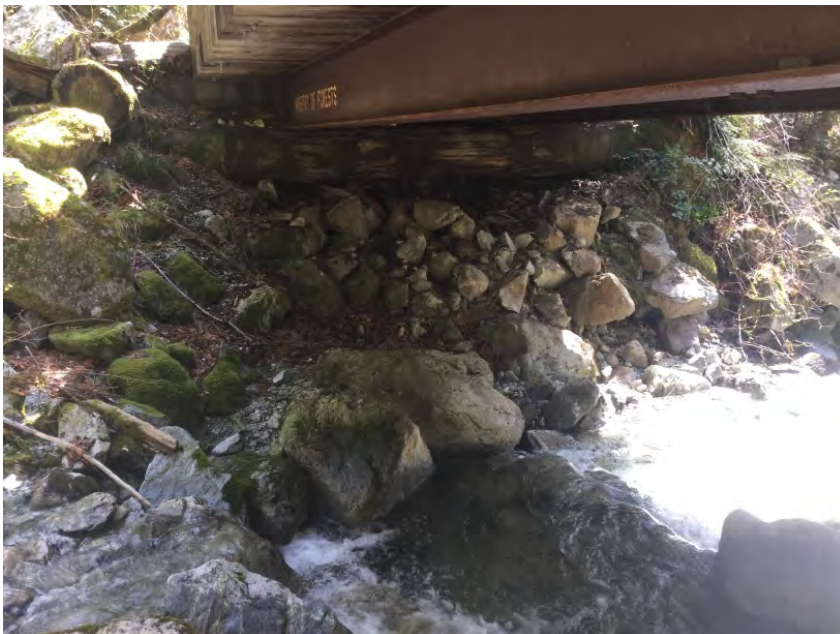
Left Bank Abutment when facing downstream

Log/Timber Cribs Fair 2x and up to 50mm sap rot

Tie Backs Fair 3x - up to 50mm sap rot

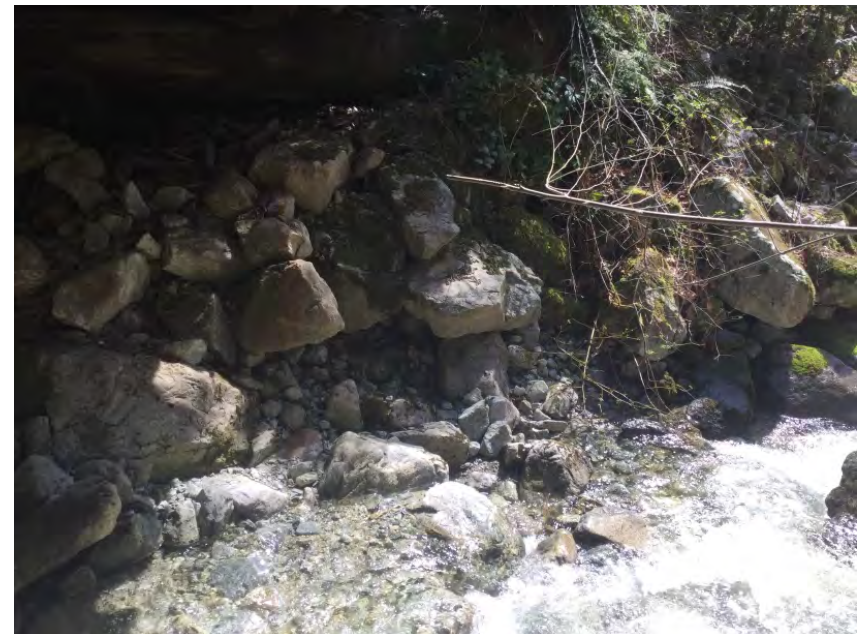
Riprap Fair Scour noted at downstream left abutment

Downstream left bank erosion

Brush approaches and monitor riprap scour noted at downstream left bank. Present load rating of L60 or 54 tonnes to continue.

| Item | Monitor Description | Frequency |
|---|---|---|
| 1 | Downstream left bank riprap scour | Routine Inspection |

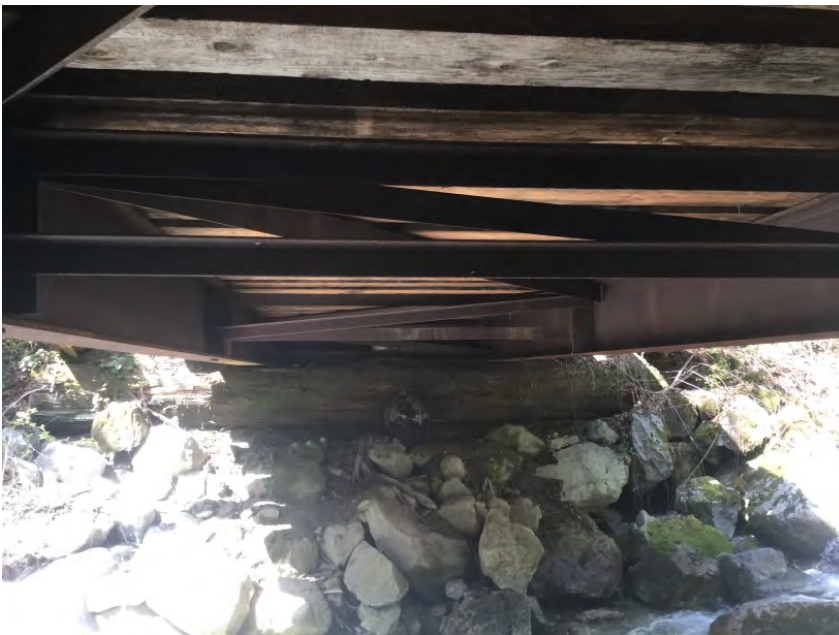
Superstructure

Girders Fair Surface corrosion
