CK-2175

MURDO 1.2km

2018 Inspection

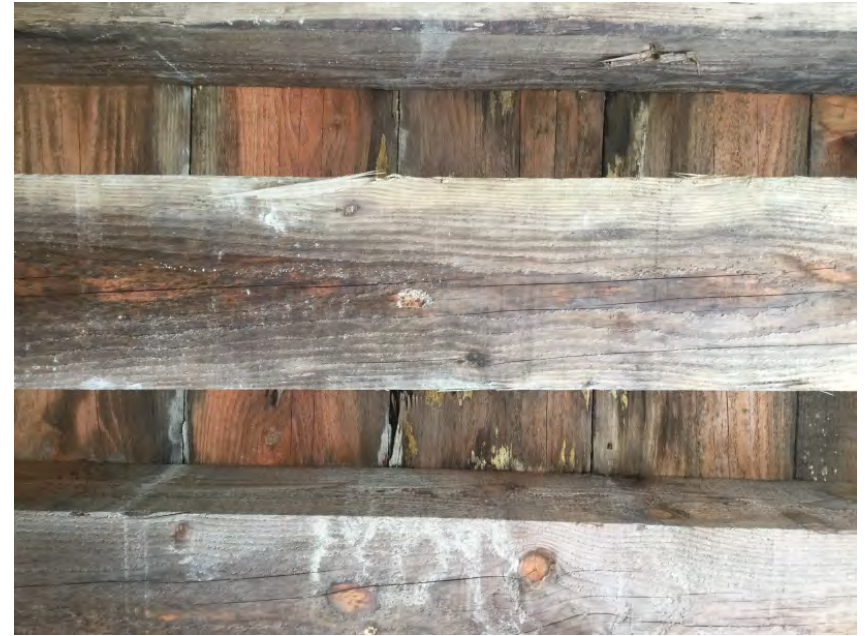
Indication of rot on subdeck - cored and fair condition

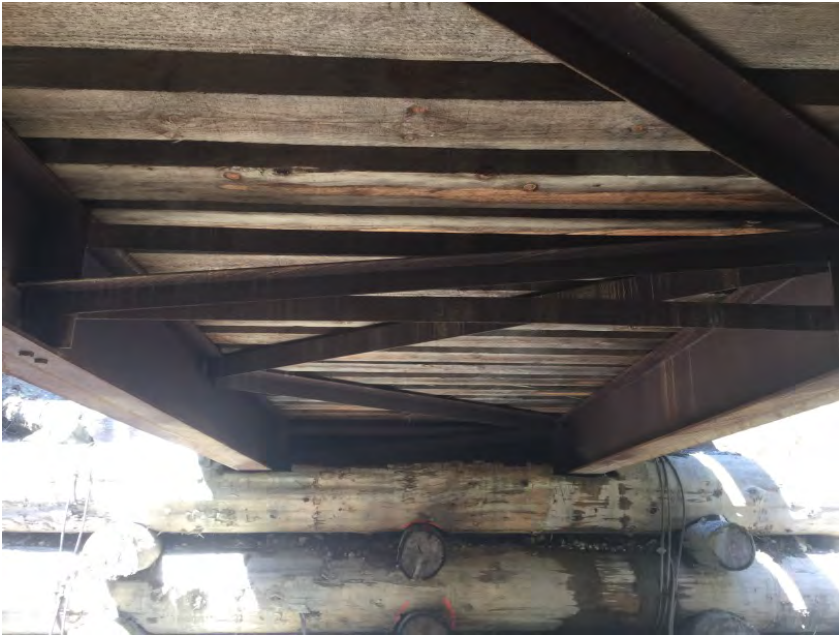
Superstructure

Surface corrosion

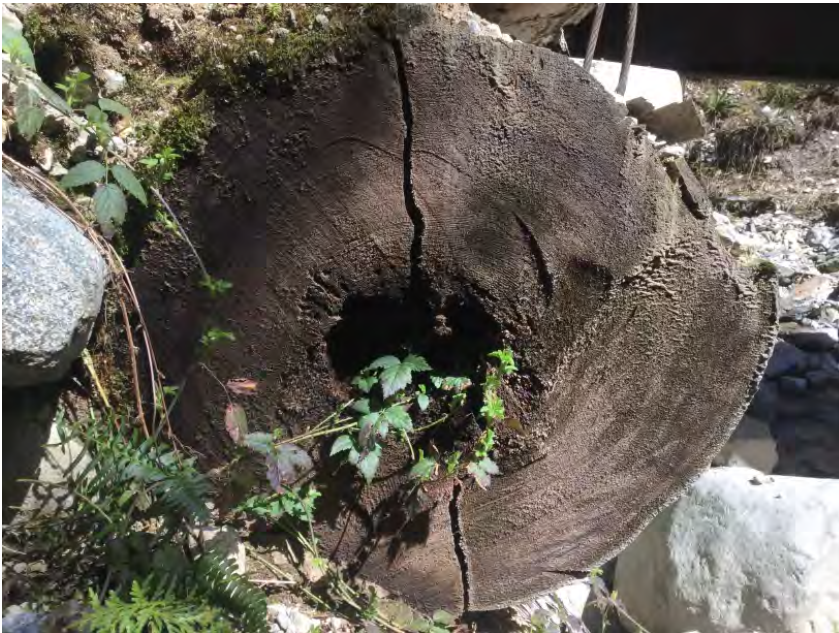
| Item | Monitor Description | Frequency |
|---|---|---|
| 1 | vertical crack on downstream end of top face log on right bank | Routine Inspection |

Vertical crack in crib log on right bank

Replace both left approach delineators with proper ones. Monitor the vertical crack noted on the downstream end of the top face log on the right bank - no apparent change from last inspection. Present load rating of L60 or 54 tonnes to continue.
