CK-2194

MASELPANIK 0.1km

2018 Inspection

Crossing Name Klesilkwa Creek

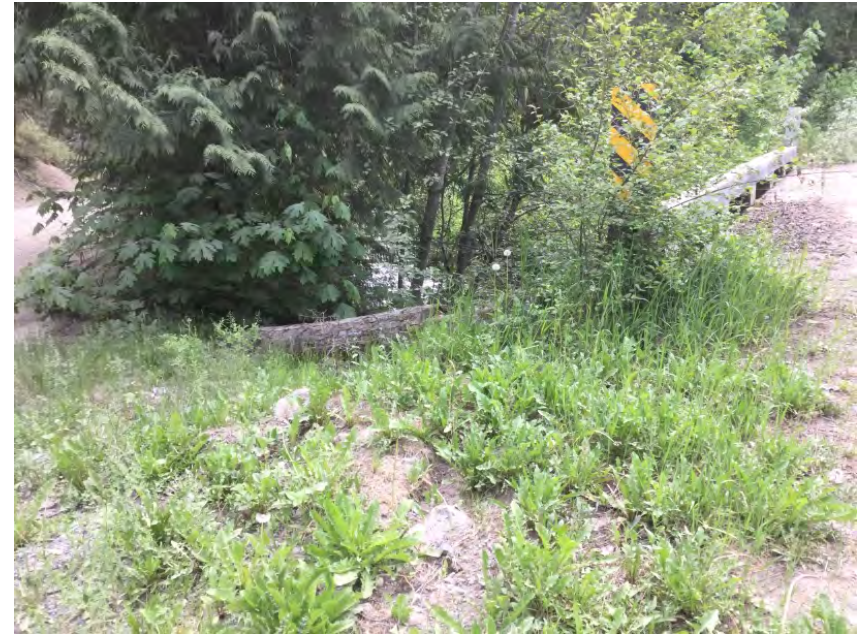
Downstream left bank off road, missing upstream right approach, rotten downstream right approach

Left approach fender log off road

Replace the rotten log fenders with new ones or with concrete no post barriers. Remove the log within the stream channel at the inlet. Brush approaches and post bridge ahead signs. Present load rating of L75 or 68 tonnes to continue.

| 1 | Medium | Replace log fenders |

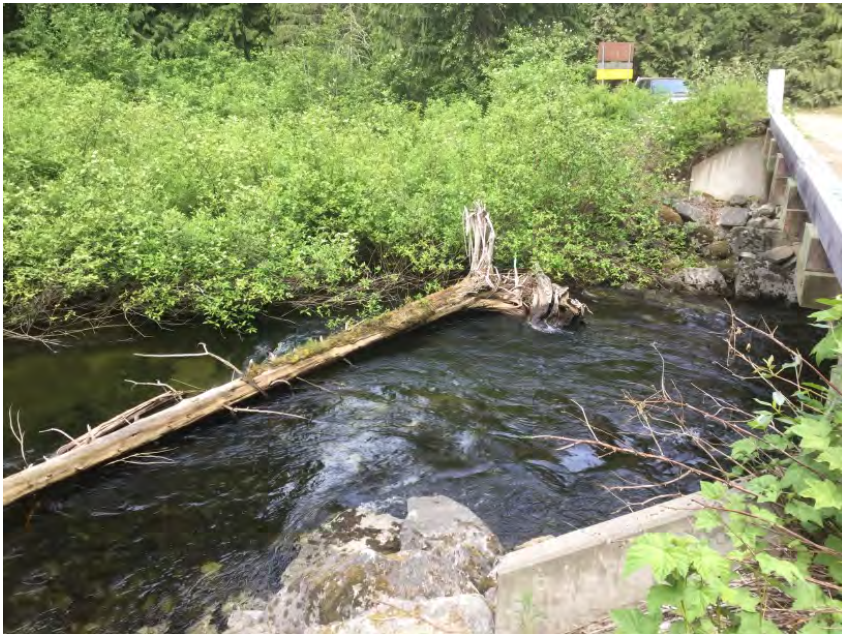
Upstream hazard

| 2 | High | Remove upstream hazard |

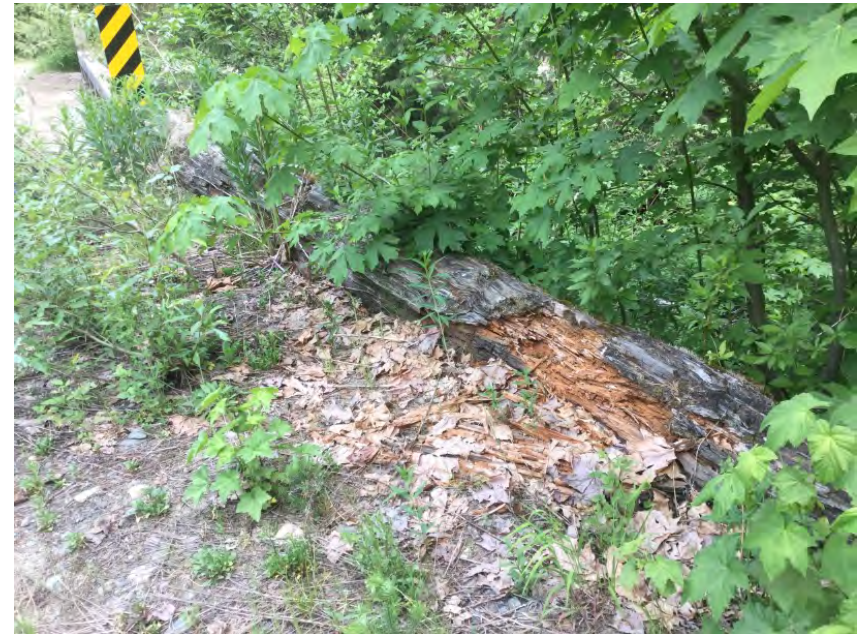
Downstream right approach fender rotten
