## Permanent Bridge Inspection Report

| Structure #: | CK-2196 | Site #: | CK-2196 | Road Name: | NAHATLATCH | Inspection Date: | 2018/06/12 |
| KM: | 0.80 | User km: | 4.80 | Crossing Name: | Nahatlatch River | Next Inspection Date: | 2021/08/31 |

CK-2196

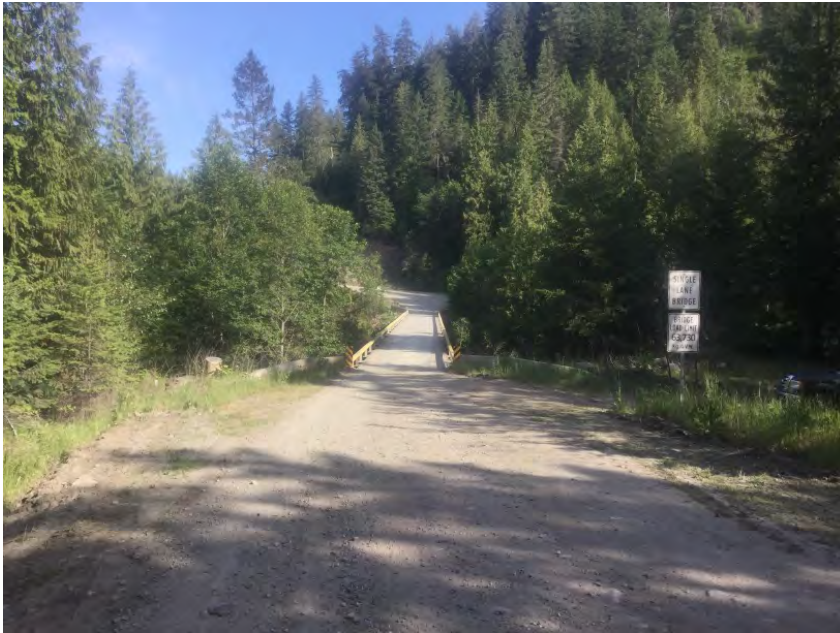
| Road Surface | Fair | Potholes at both approaches |

Approach from Right Bank when facing downstream

| | 1 | Suggested | Medium | \$ | Grade approaches |

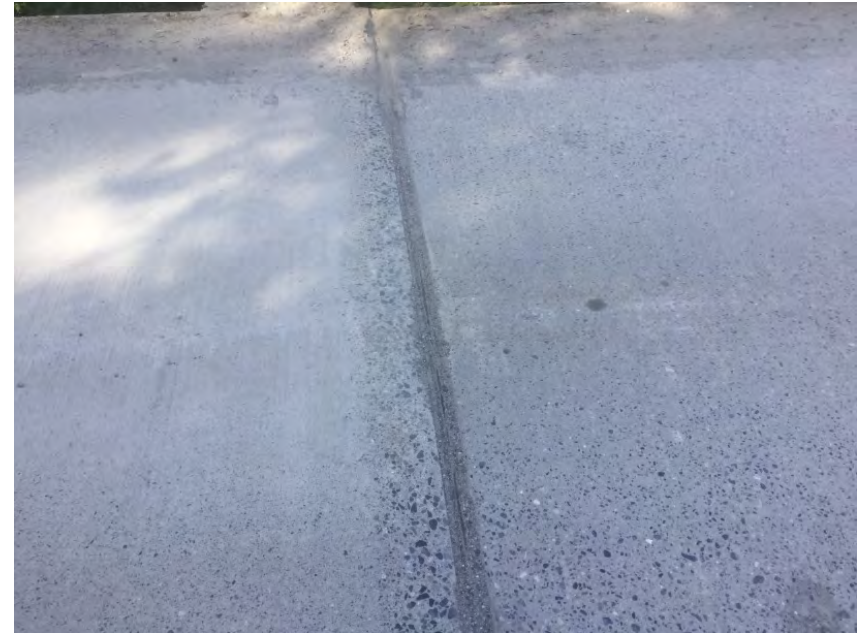
Right span to main span deck seal in place and functional

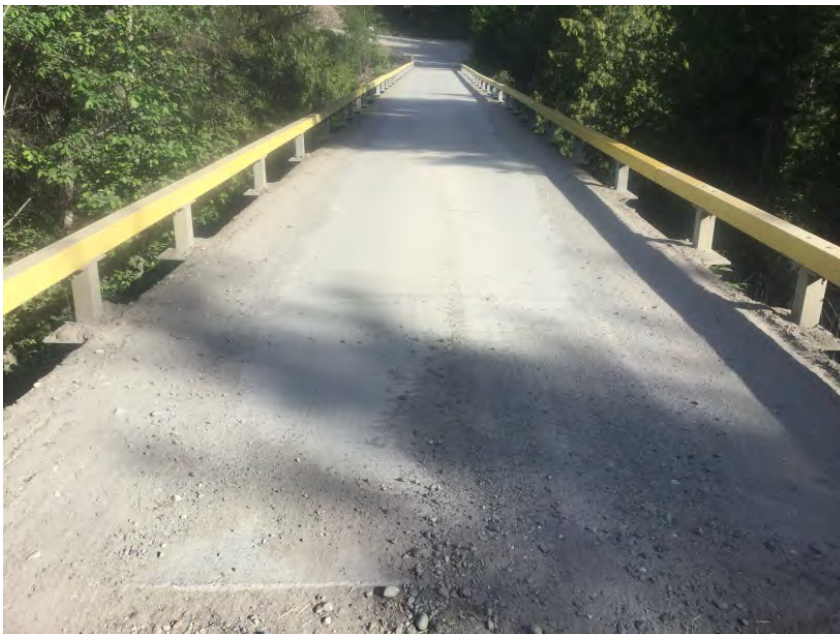
Right span deck

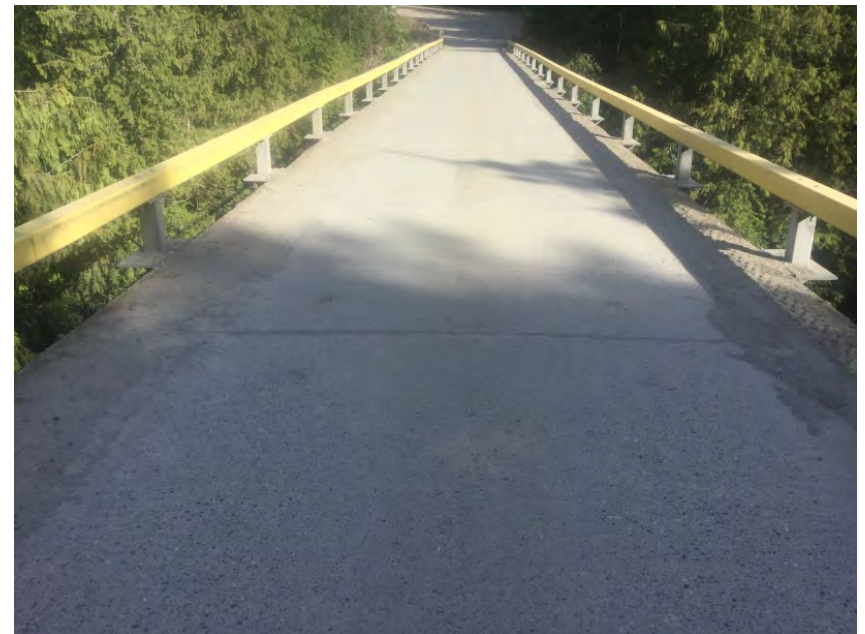
| Concrete Deck | Fair | top portion of lifting hook pockets has deteriorated |

Main span deck

| | 2 | Suggested | Medium | \$ | regROUT lifting hook pockets of deck panels on spans 1 and 2 |

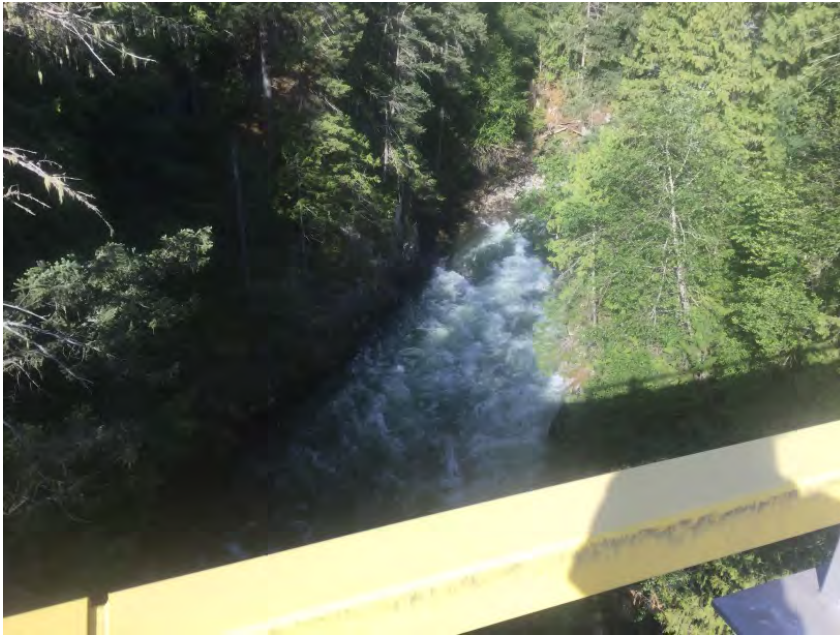
Upstream from Crossing

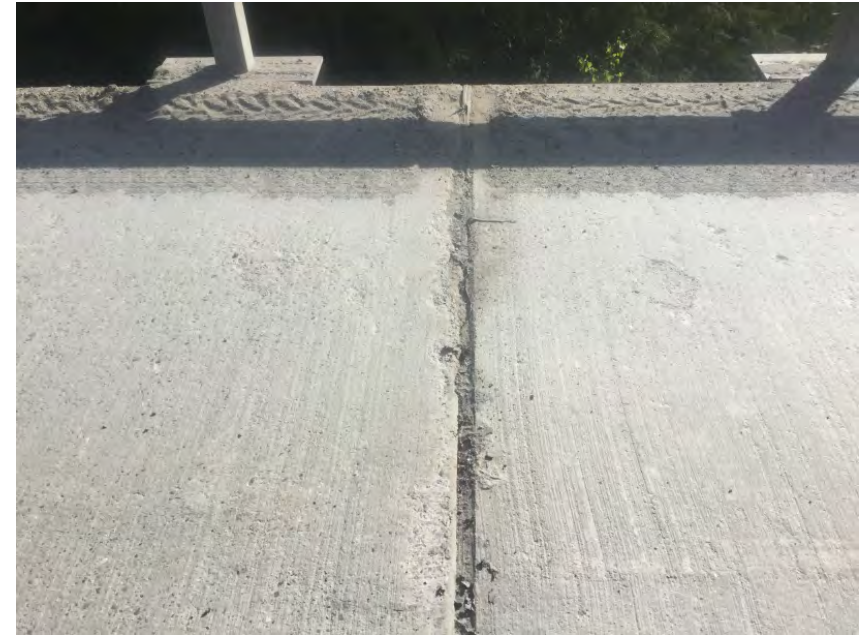
Main span to left seal in place and functional but separating

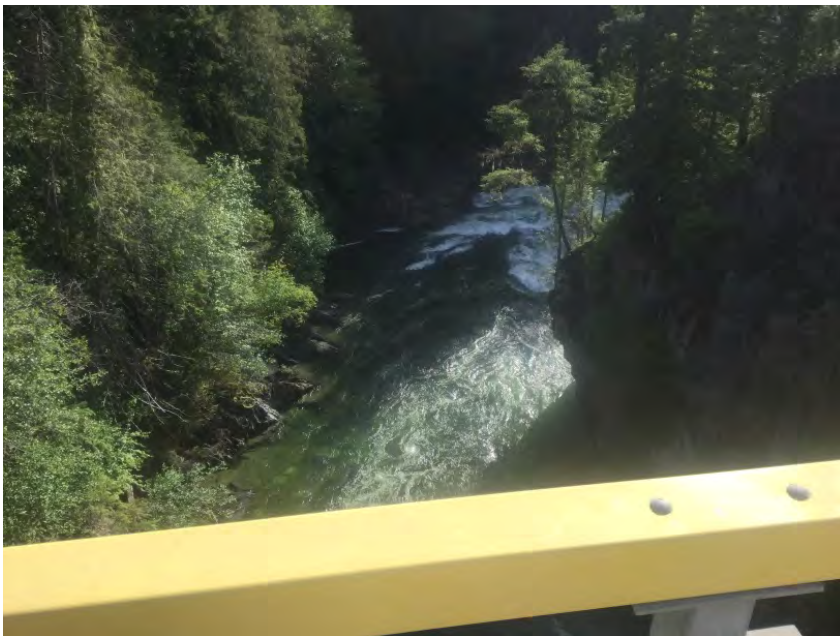
Downstream from Crossing

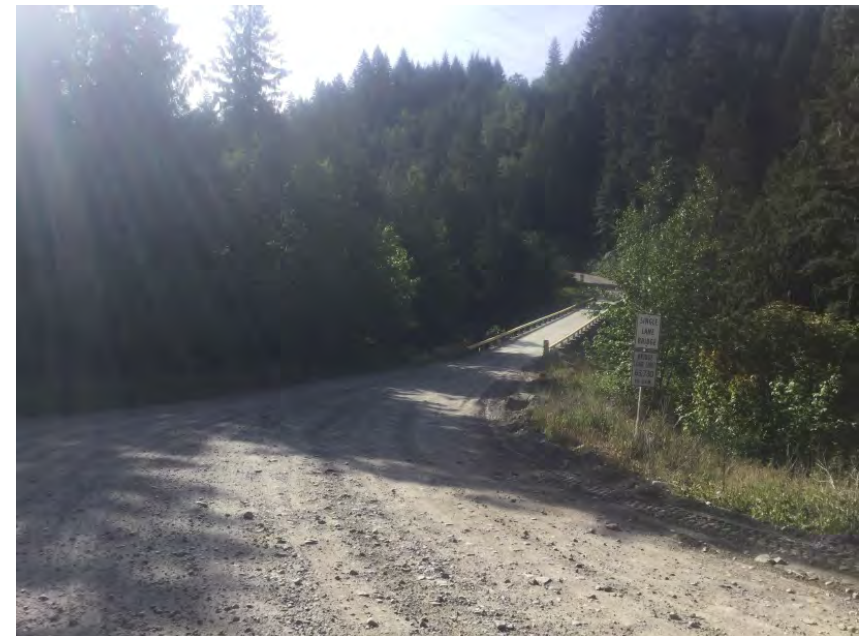
Approach from Left Bank when facing downstream

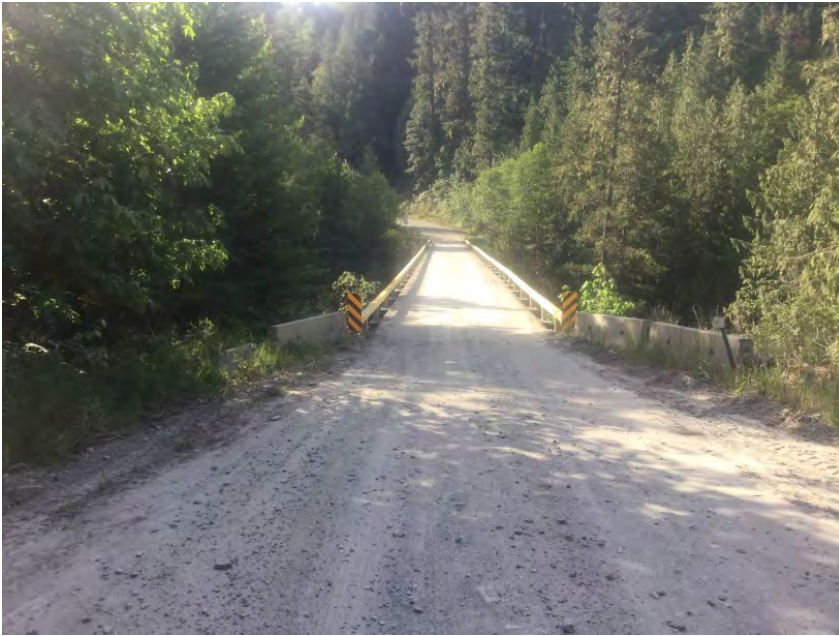
Approach from Left Bank when facing downstream

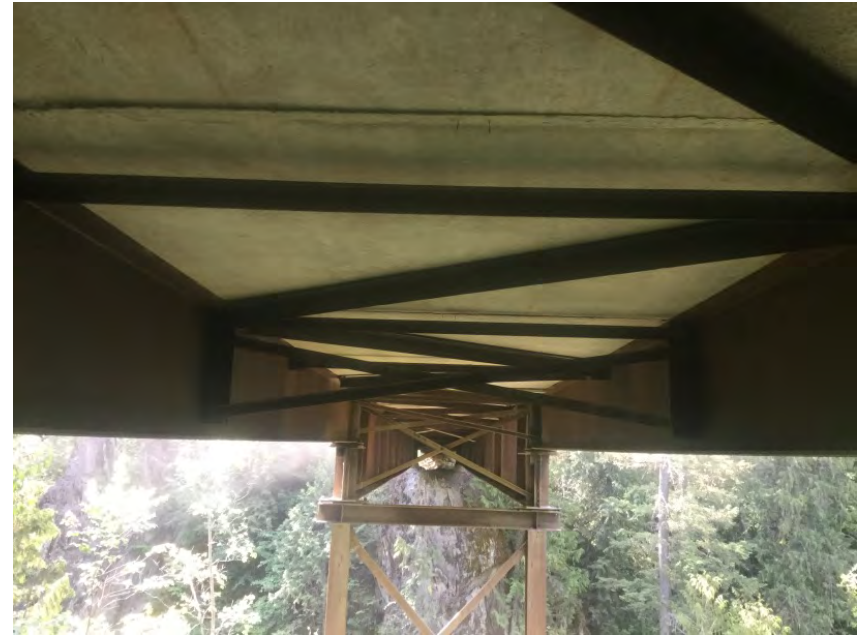
| Girders | Fair | light surface corrosion |

Left span superstructure

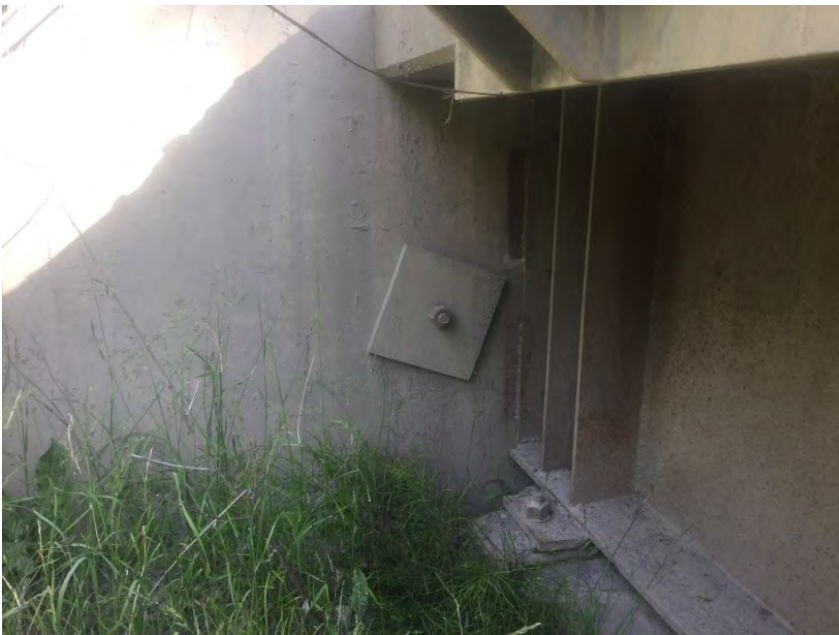
| Ballast Wall | Good | Tieback system on both walls, 2 anchors each wall |

Ballast walls tieback system, typical both walls

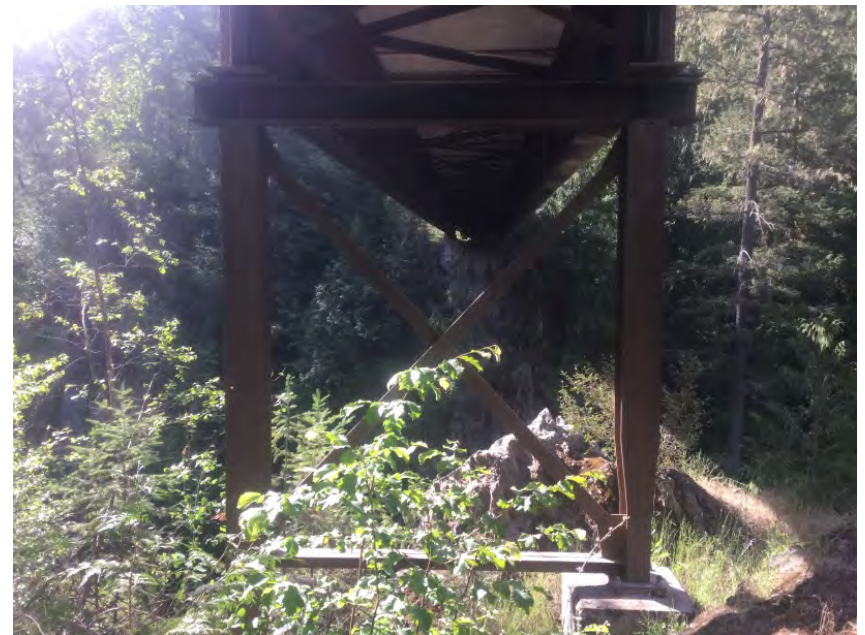
| Bearings | Fair | top plate slightly deformed, bolts sheared of both bearing location but steel restrainers welded in place |

Left pier

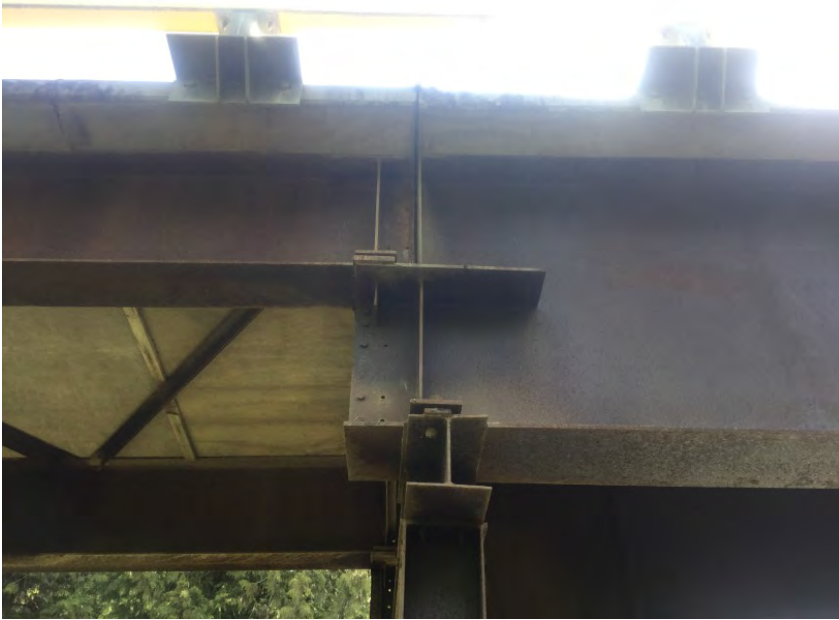
Left span to main span connection

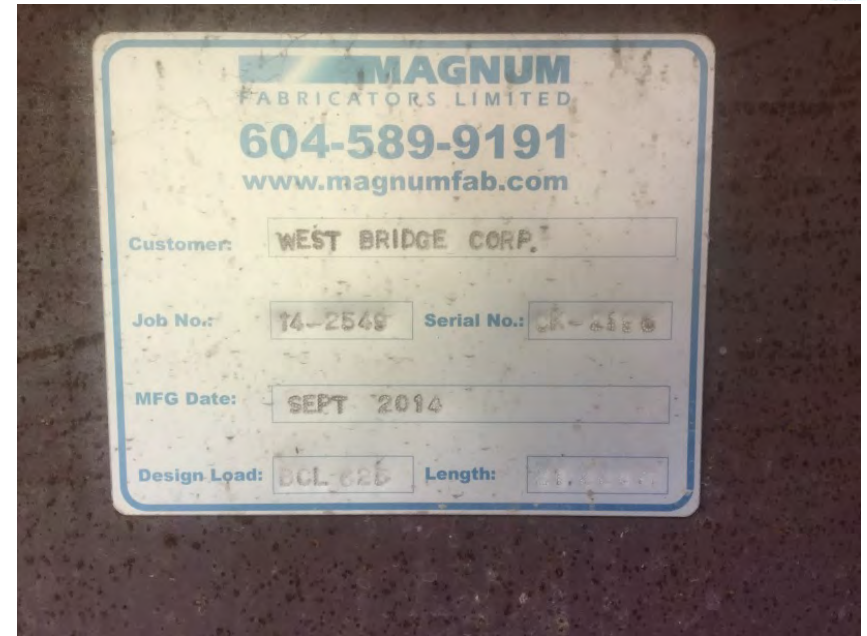
Right span structure ID

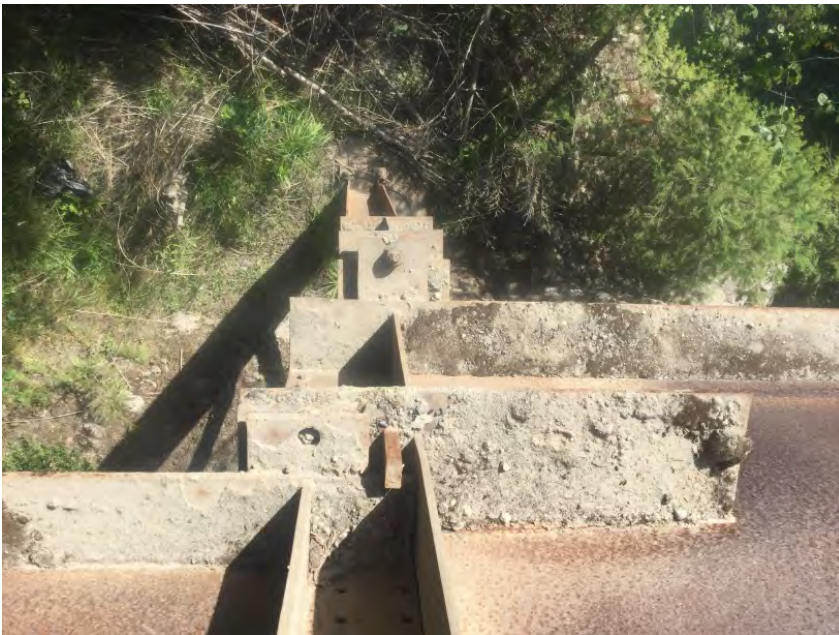
Left span to main span restrainers in place and functional

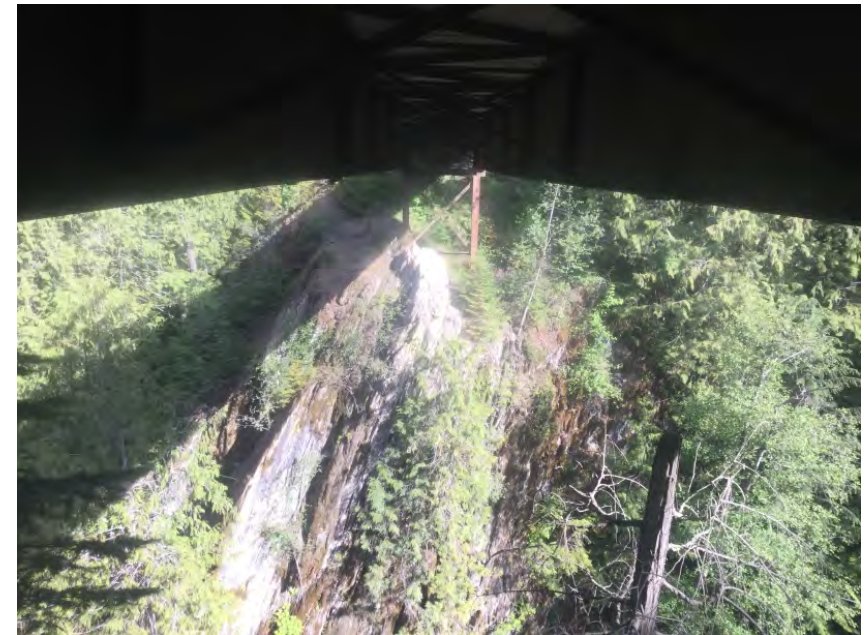
Left Bank Abutment when facing downstream

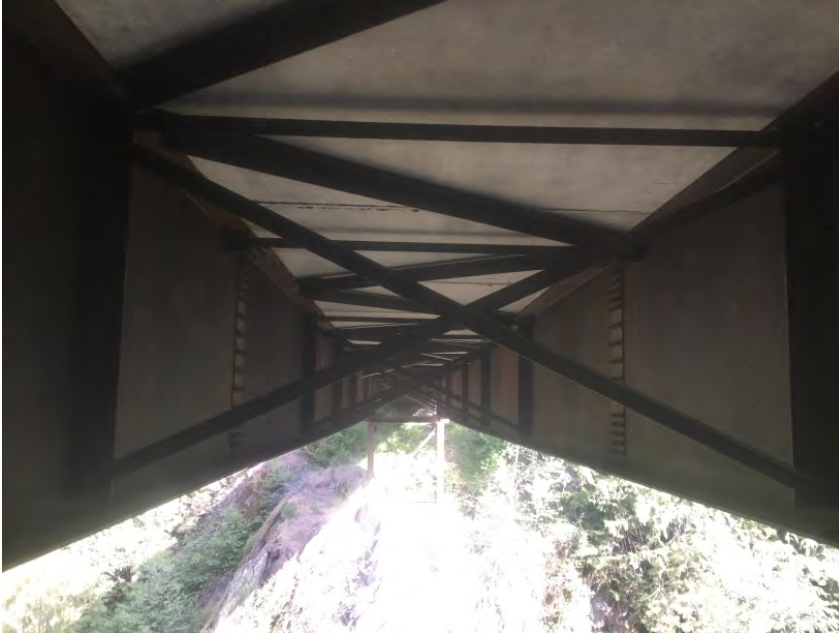
| Girders | Fair | light surface corrosion |

Main span superstructure

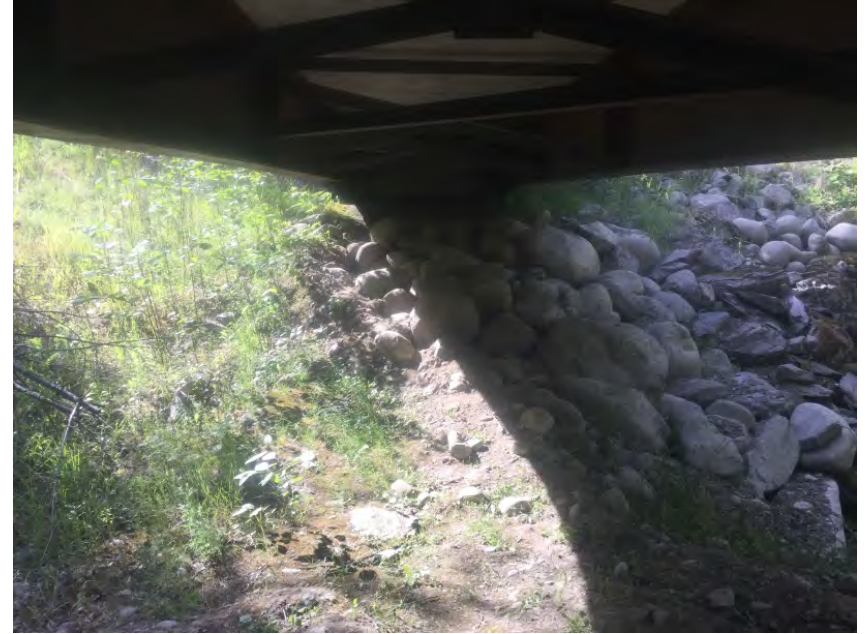
Right Bank Abutment when facing downstream

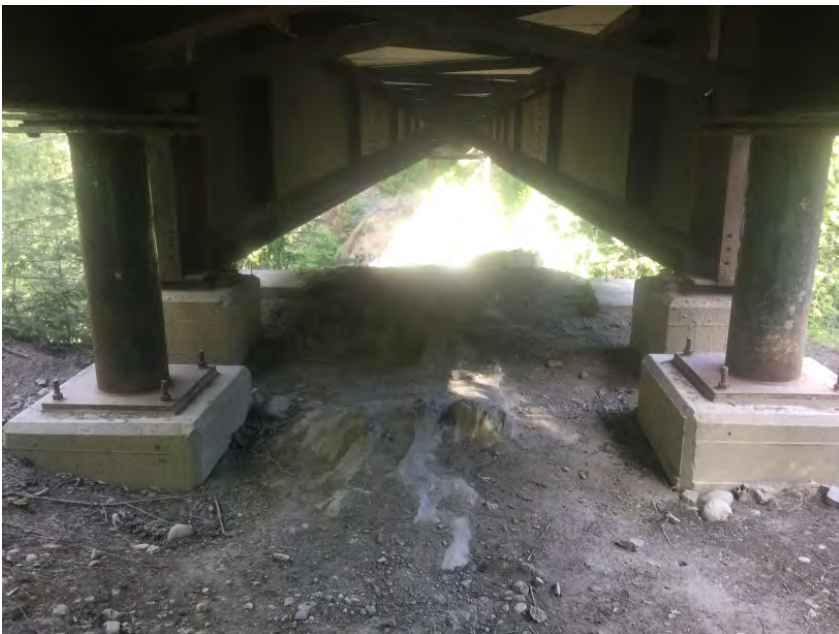
| Overall | Fair | 2 sets of pedestals, see pictures for reference |

Main span left abutment and right span left abutment

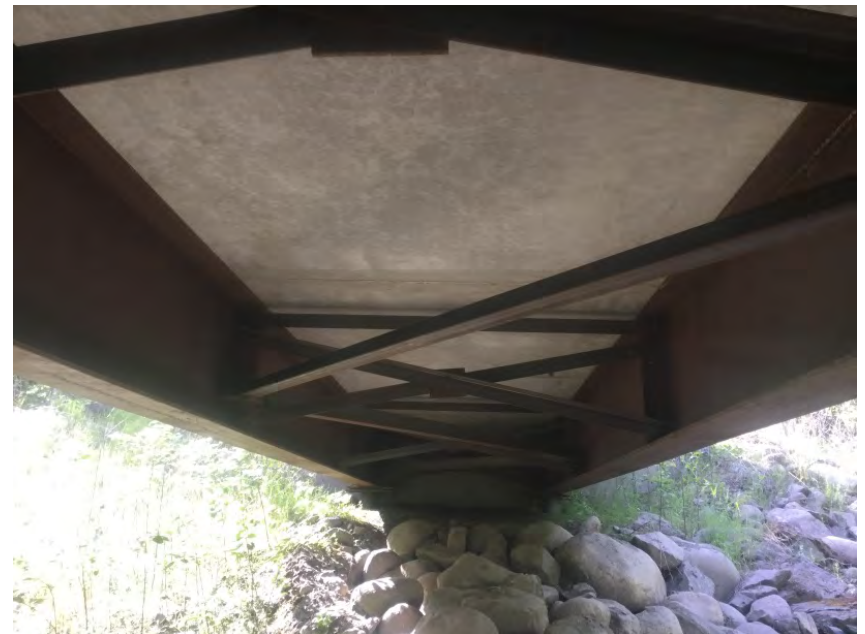
Right span superstructure
