CK-2197

NAHATLATCH 14.6km

2018 Inspection

| Crossing Name | Log Creek |

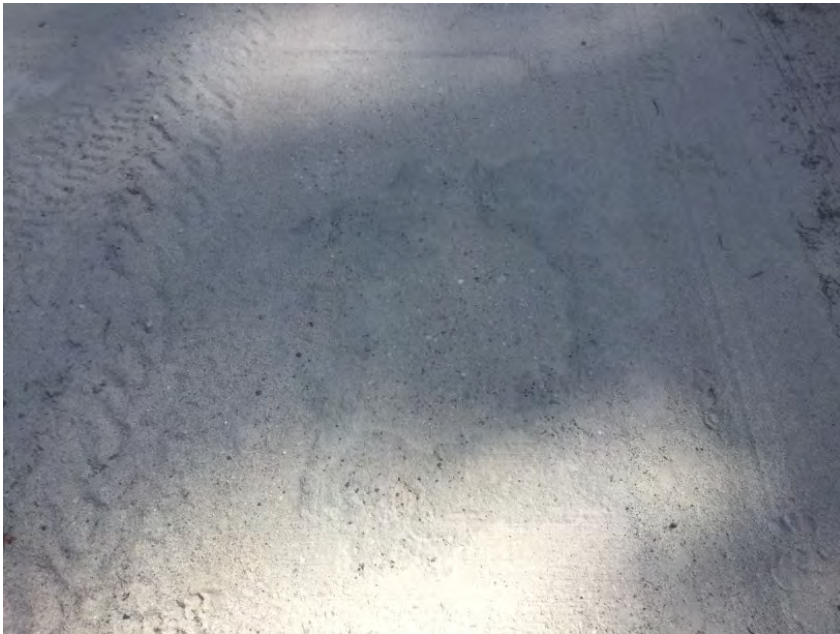
Appears as though grout was spilled on deck at some point

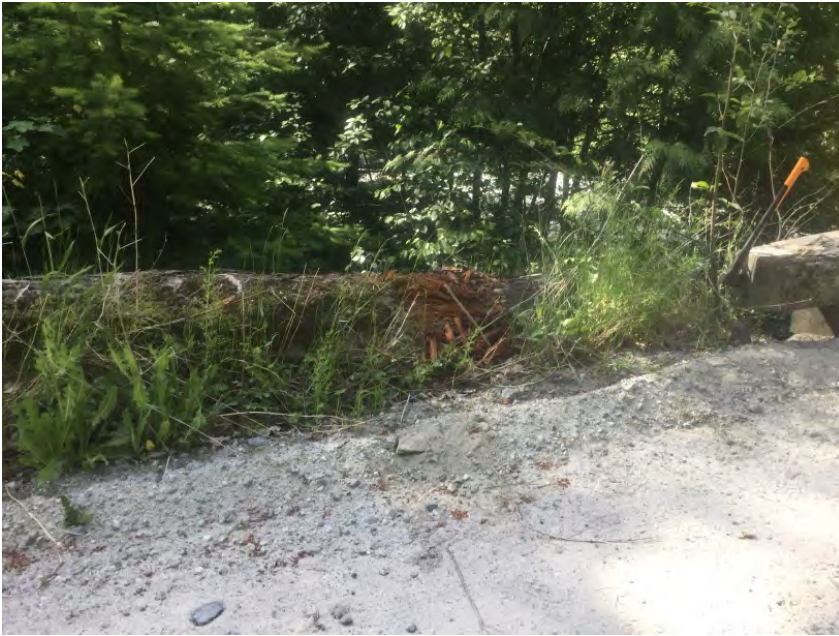
Fender Condition Fair

Old logs

Rotten fender log downstream left approach

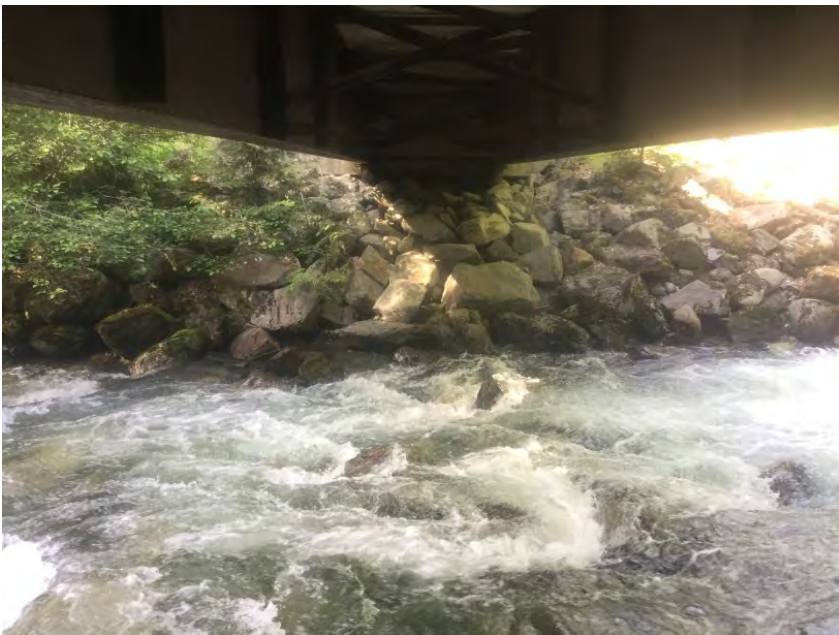
Right Bank Abutment when facing downstream

Minor deformation of bearing plates
