CK-2198

NAHATLATCH 24.9km

2018 Inspection

| Crossing Name | Squakum Creek | | |

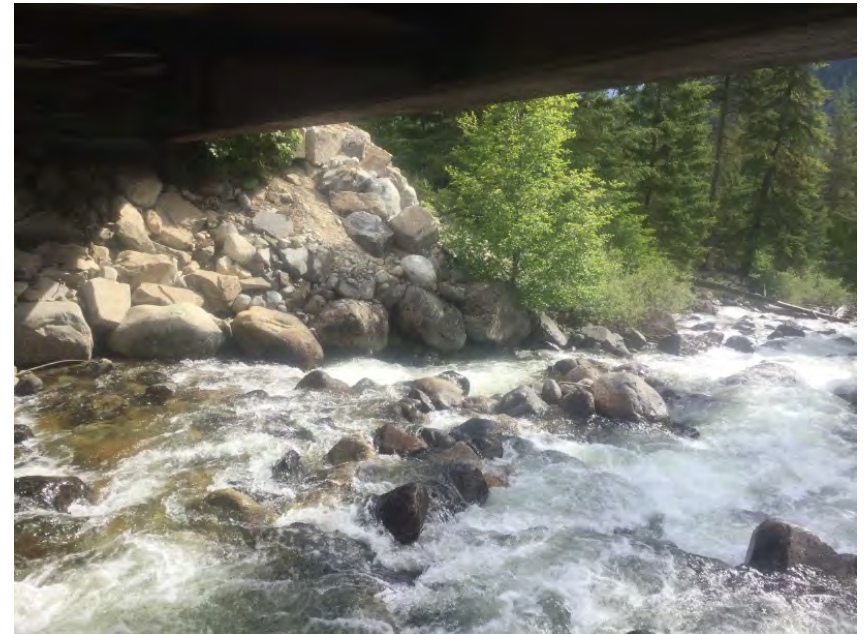
Riprap Fair Downstream left bank is steep and rounded rock

Downstream left bank riprap steep and rounded

Monitor downstream left bank riprap condition. Present load rating of L75 or 68 tonnes to continue.

Comments    Monitor downstream left bank riprap

| Item | Monitor Description | Frequency |
|---|---|---|
| 1 | Downstream left bank riprap condition | Routine Inspection |
