CK-2201

KOOKIPI 3.2km

2018 Inspection

| Crossing Name | Kookipi Creek | | |

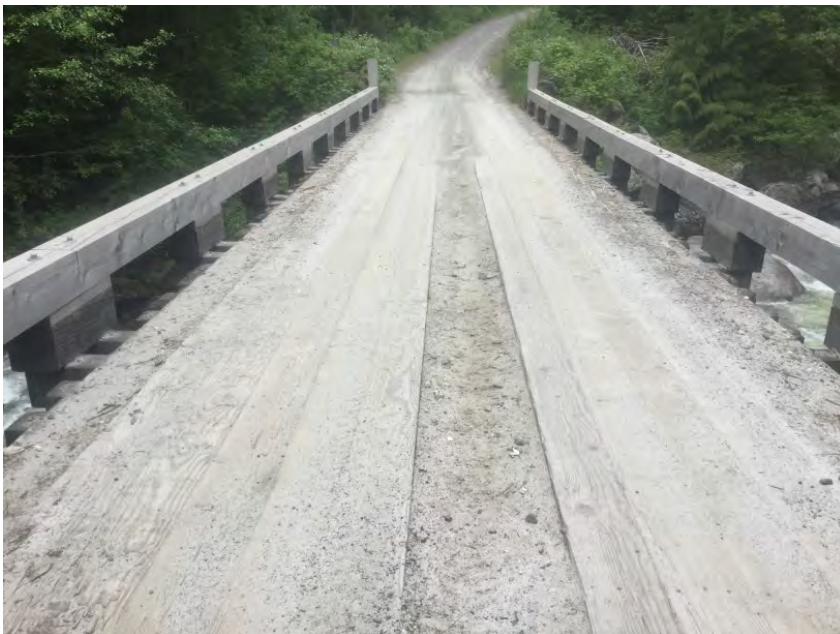
Deck

Fair

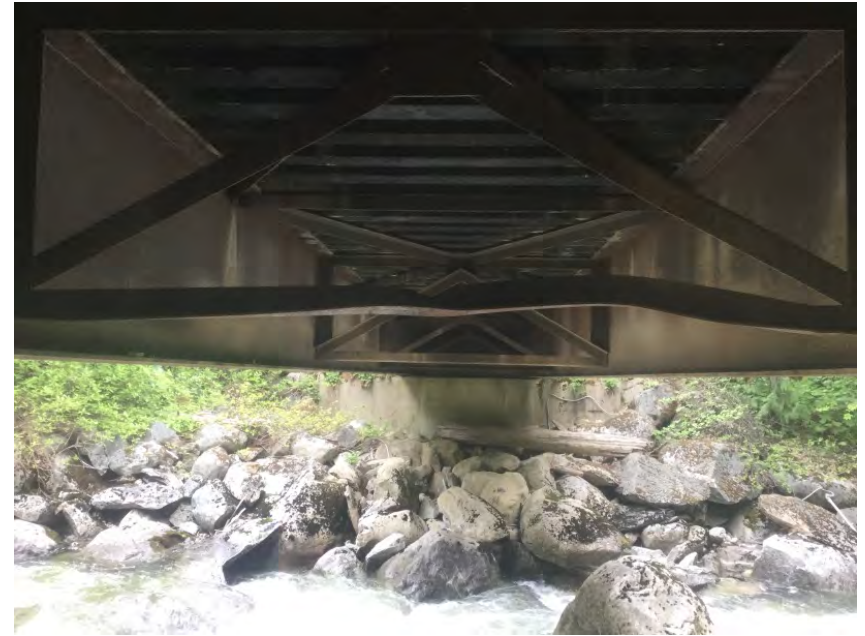
Damage to bottom chord

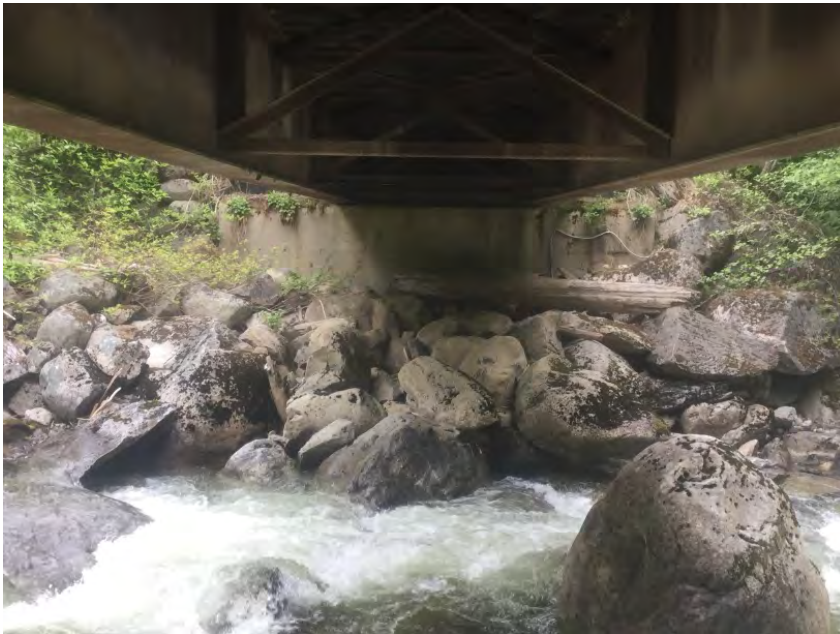
Left Bank Abutment when facing downstream

CIP both abutments

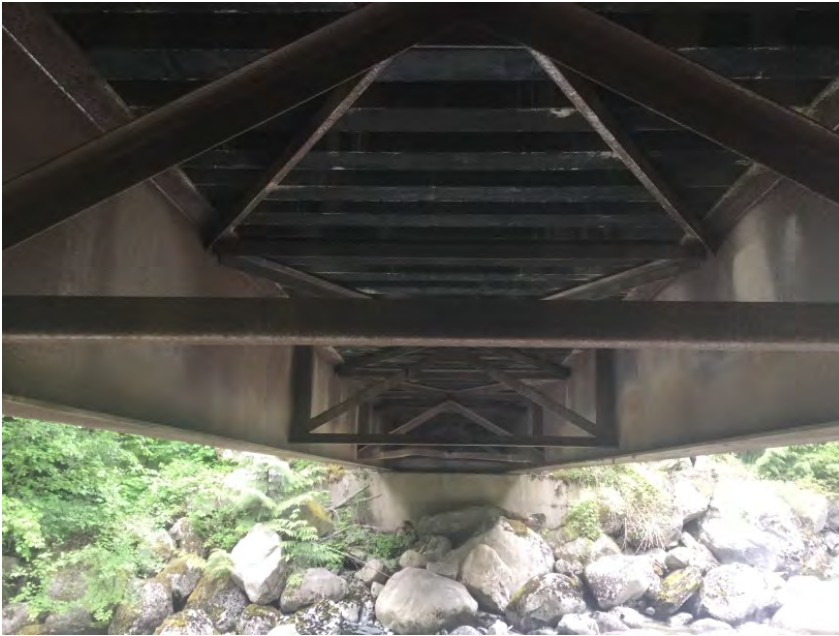
Superstructure

Girders Fair
