CK-2202

KOOKIPI 15.8km

2018 Inspection

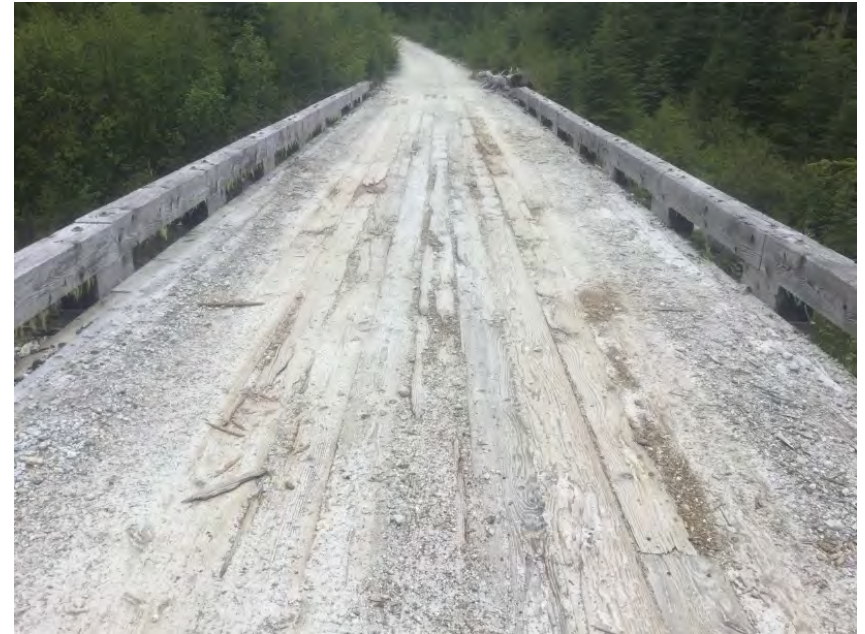
Poor

Rotten

Overall Deck Condition

Due to planks and rail condition

| Item | Priority | Repair Description |
|---|---|---|
| 1 | Medium | Replace running planks |

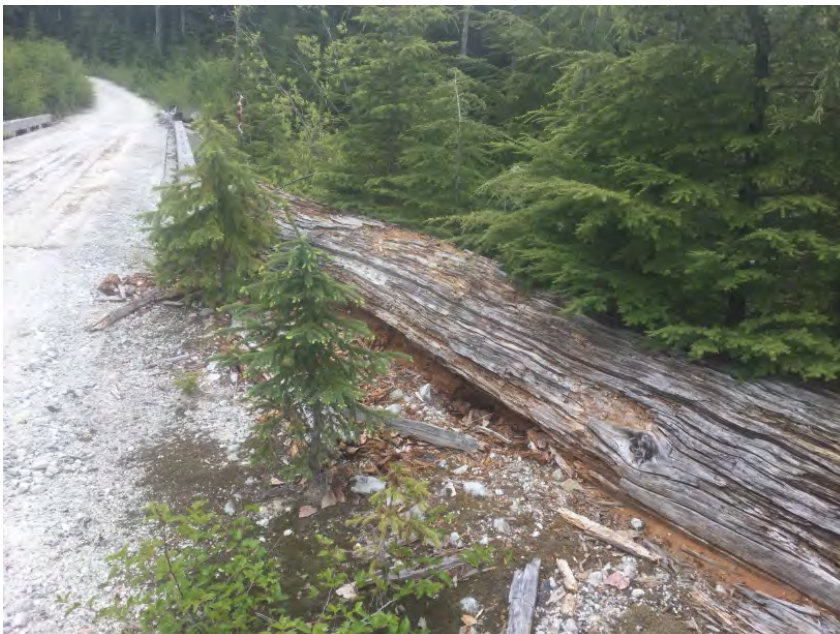
Fender Condition Fair

Rotten logs

Typical fender log condition

| Item | Priority | Repair Description |
|---|---|---|
| 2 | Medium | Replace guardrail, risers, and log fenders |

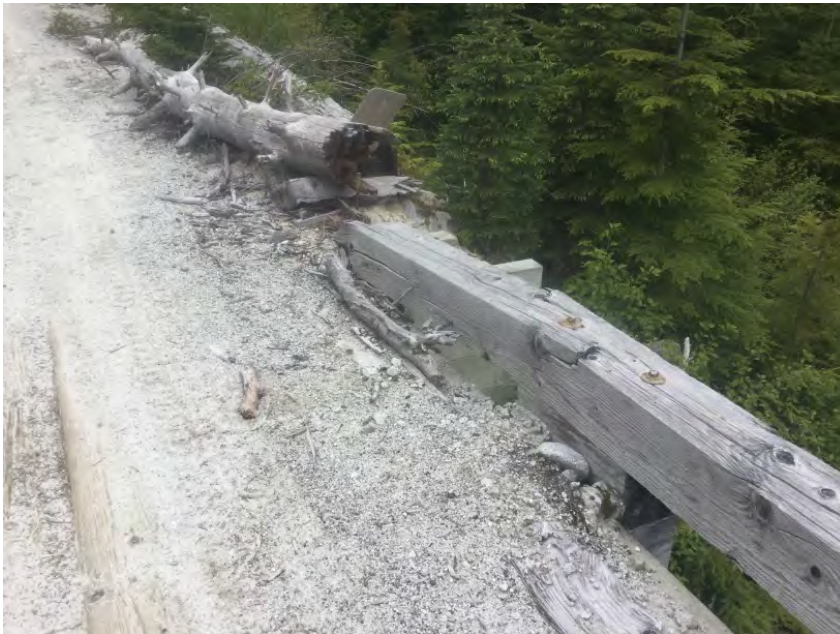
Guard Rail

Poor

Rotten

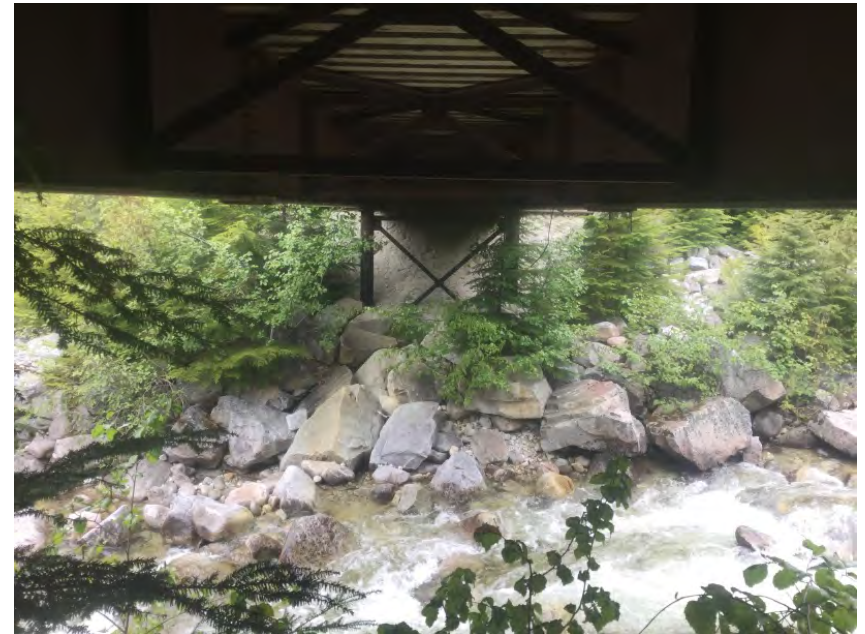
Right Bank Abutment when facing downstream

Treated timbers but fill ravelling from underneath

Ravelling underneath both ballast walls
