CK-2208

MOWHOKAM 16.3km

2018 Inspection

| Crossing Name | Side Creek |

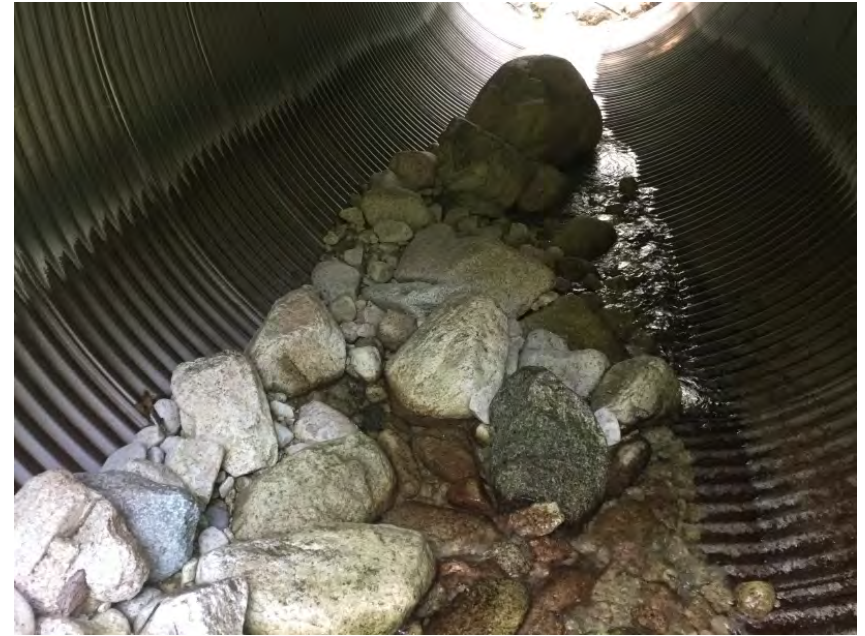
Bedload inside culvert

Material being transported into culvert

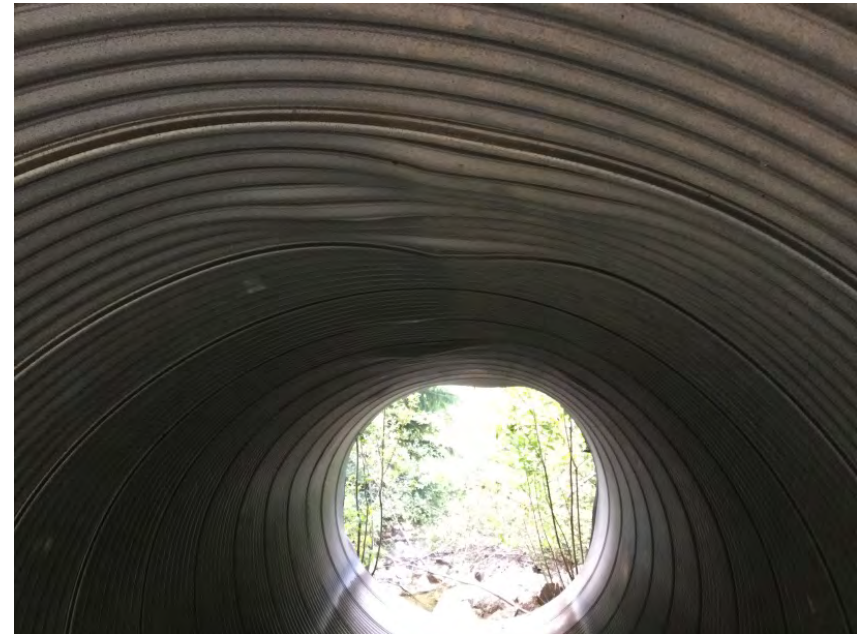
Minor damage and deformation noted

Minor roof damage

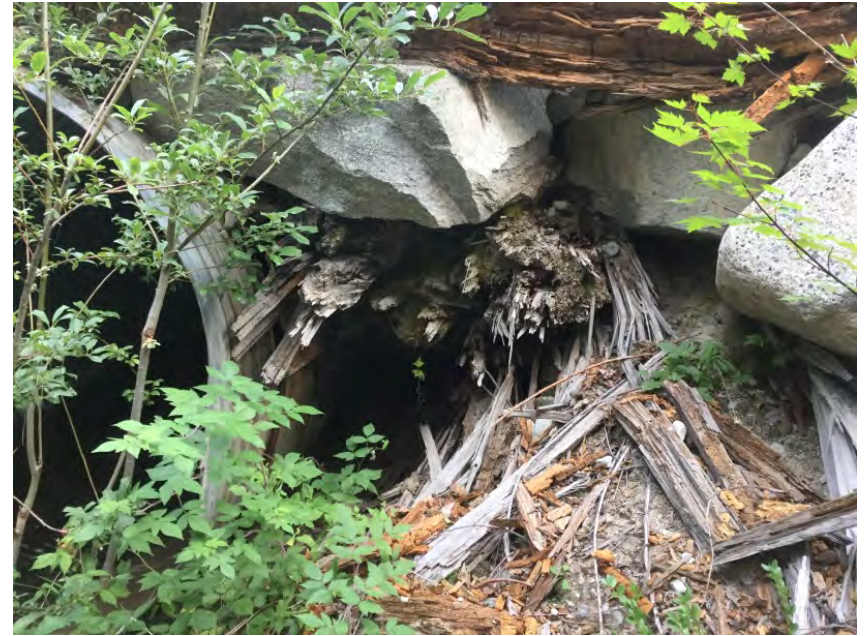
The culvert is too short for the existing road width and proper fill retainment should be added. The culvert is not properly seated as logs have been used to backfill around it, and they are rotting. The logs that were used as backfill are only visible at the outlet. Monitor the condition of the culvert and in the meantime add riprap to both the inlet and outlet to properly retain fill; replace the rotten fender logs and brush the approaches. Limit loading to BCL-625 or 64 tonnes. Post load rating signs.

Logs were used as fill around culvert

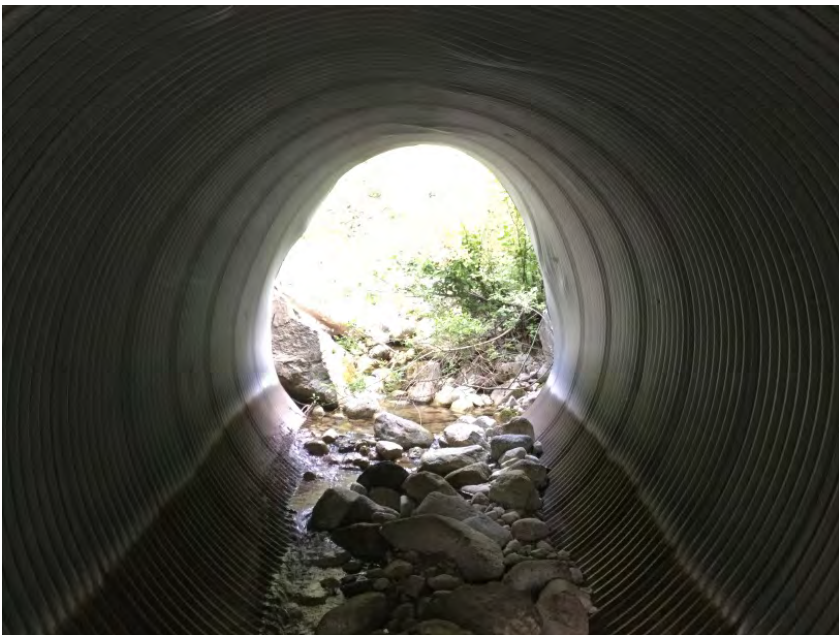
Deformation at inlet

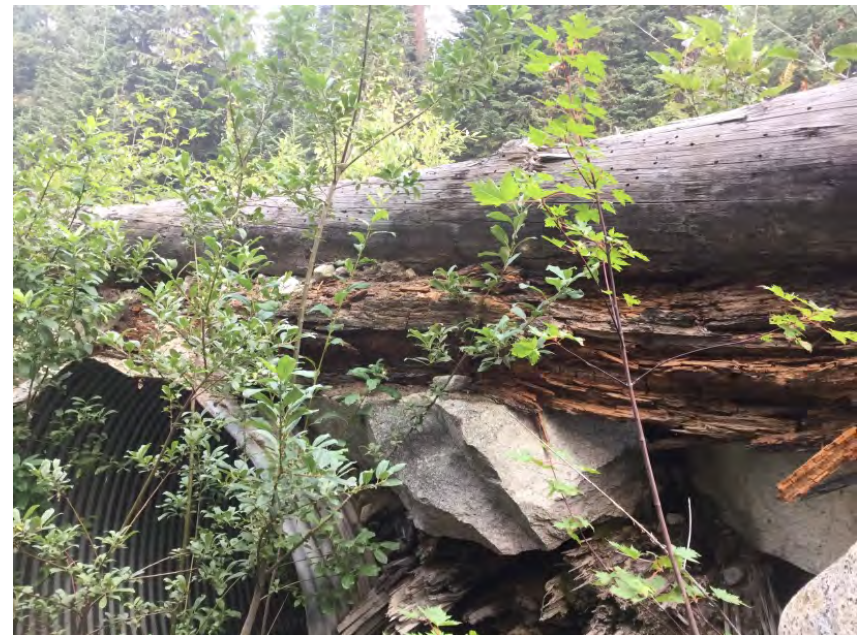
Fender Condition Poor

Rotten logs

Rotten fender logs

| 3 | Low | Replace log fenders |
