CK-2209

MOWHOKAM EAST 0.1km

2018 Inspection

Crossing Name Mohawkum Creek

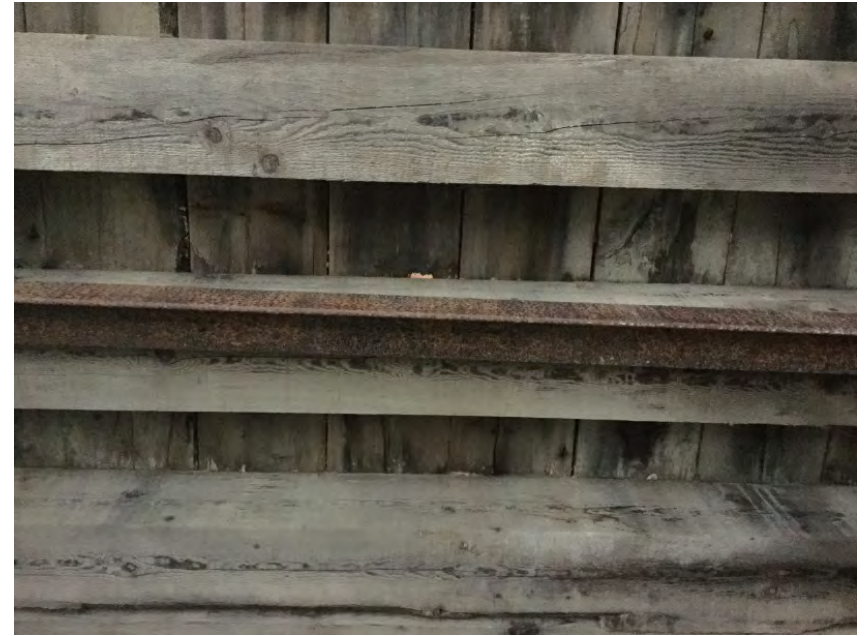
Rot indicators on underside of deck starting to show

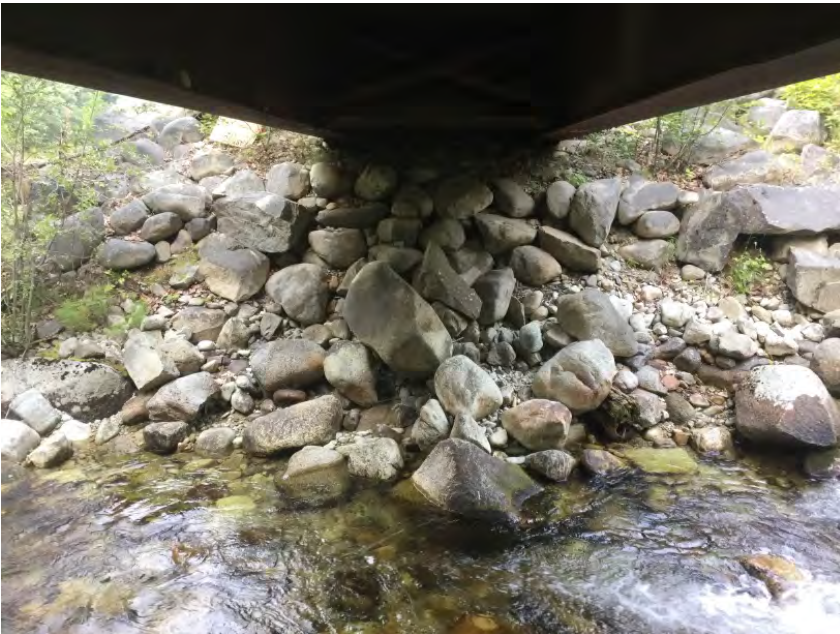
Right Bank Abutment when facing downstream

Round riprap, not well graded or tied into the streambed and is scouring

| Item | Monitor Description | Frequency |
|---|---|---|
| 1 | Riprap condition | Routine Inspection |
