CK-2210

MOWHOKAM EAST 6.3km

2018 Inspection

| Crossing Name | Mowhokam Creek |

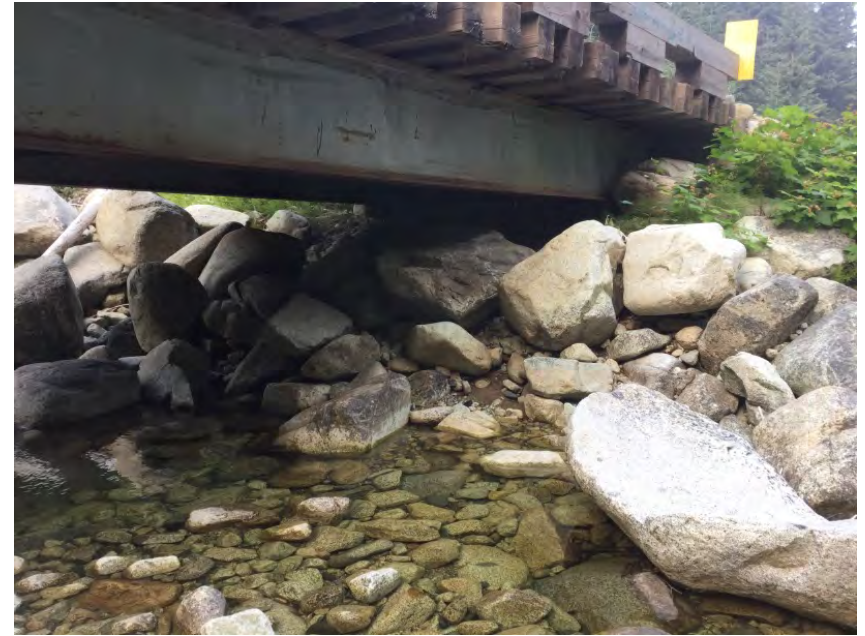
Left Bank Abutment when facing downstream

Round rock, not well graded or tied into streambed

riprap is round, not well graded or tied into the streambed

| Item | Monitor Description | Frequency |
|---|---|---|
| 1 | Riprap condition | Routine Inspection |

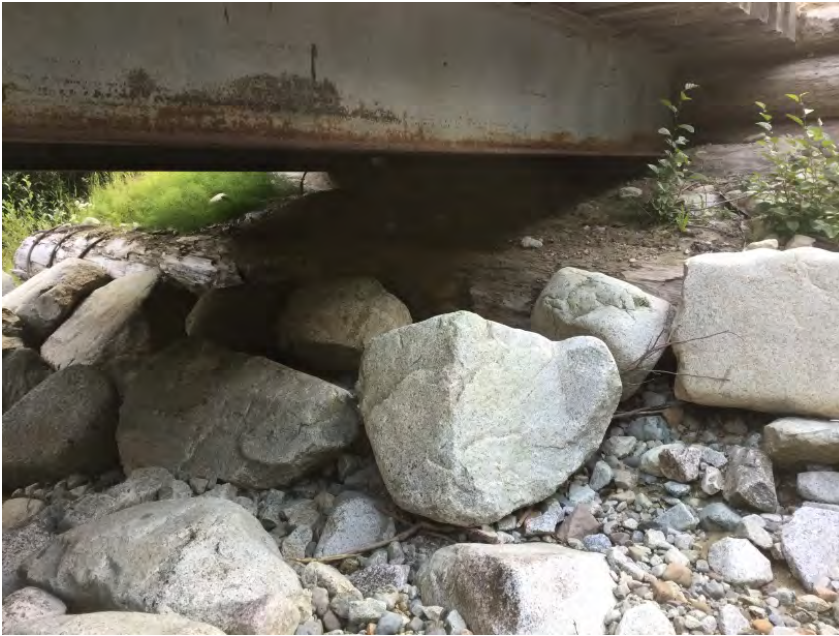
Right Bank Abutment when facing downstream

Logs right bank, timbers left

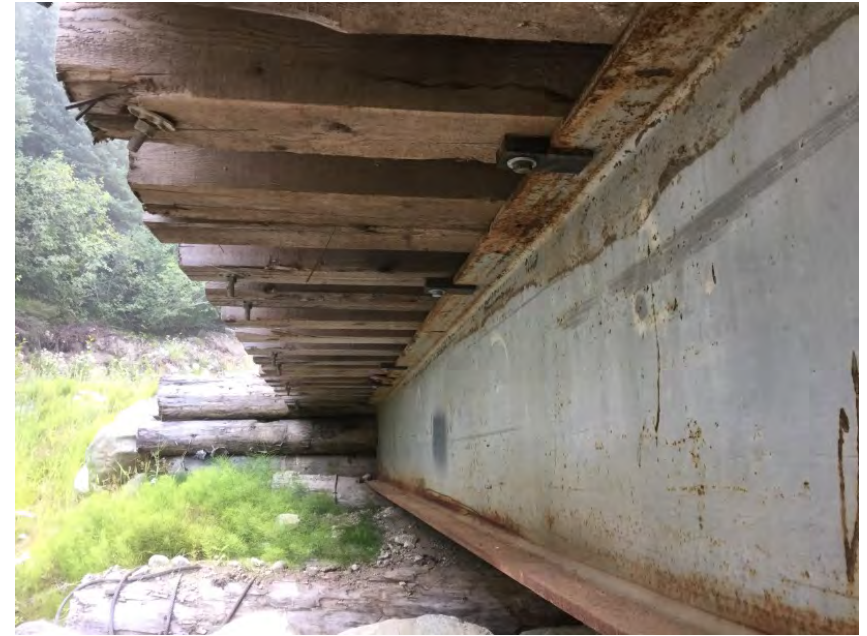
Deck to Girder Bolts Good Deck clips

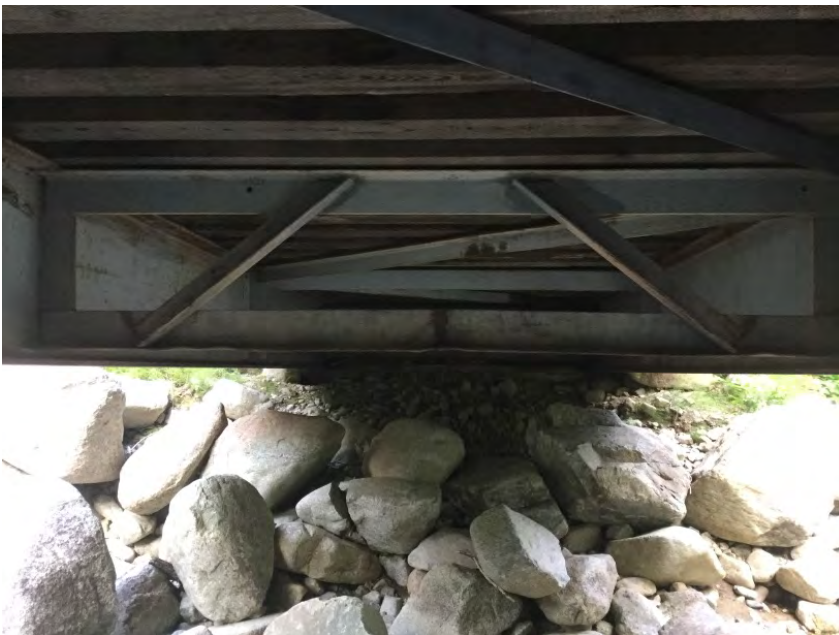
Superstructure

Girders Fair Painted

Diaphragms Fair Welded
