CK-2214

PEERS 0.3km

2018 Inspection

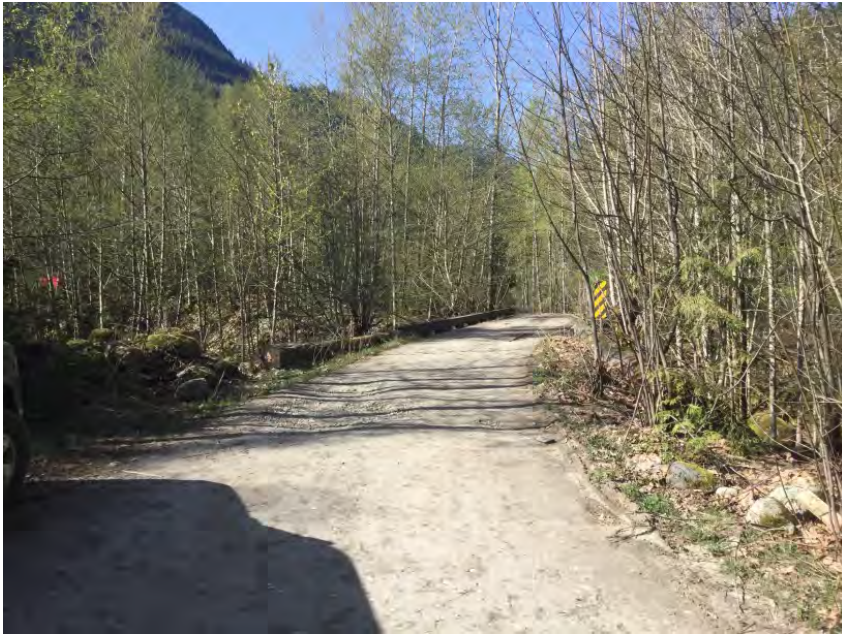
Approach from Right Bank when facing downstream

Road Surface Poor

Potholes

| Item | Priority | Repair Description |
|---|---|---|
| 2 | Medium | Brush and grade approaches |

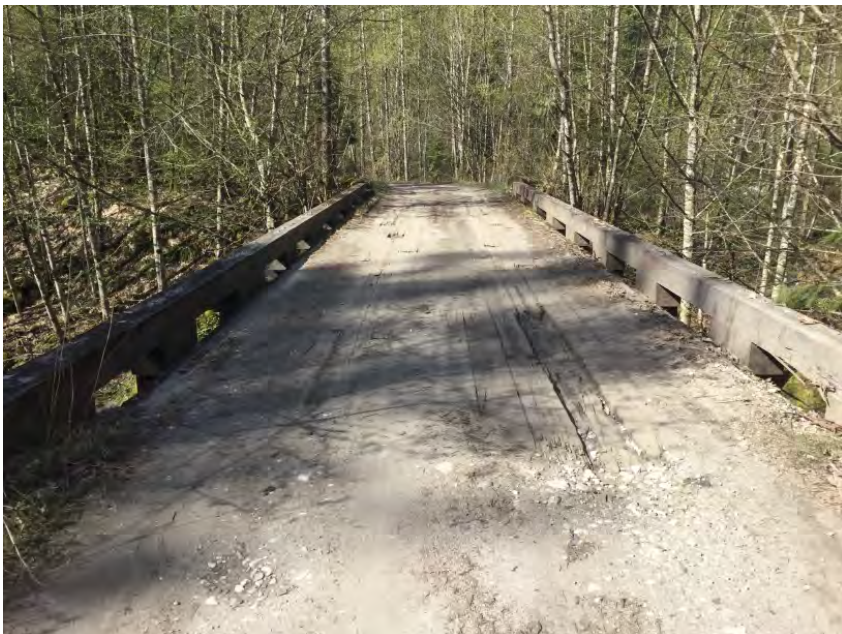
Deck

Poor

Rotten and heavy wear

Protruding through planks

Due to plank condition

| Item | Priority | Repair Description |
|---|---|---|
| 1 | High | Replace wear planks |

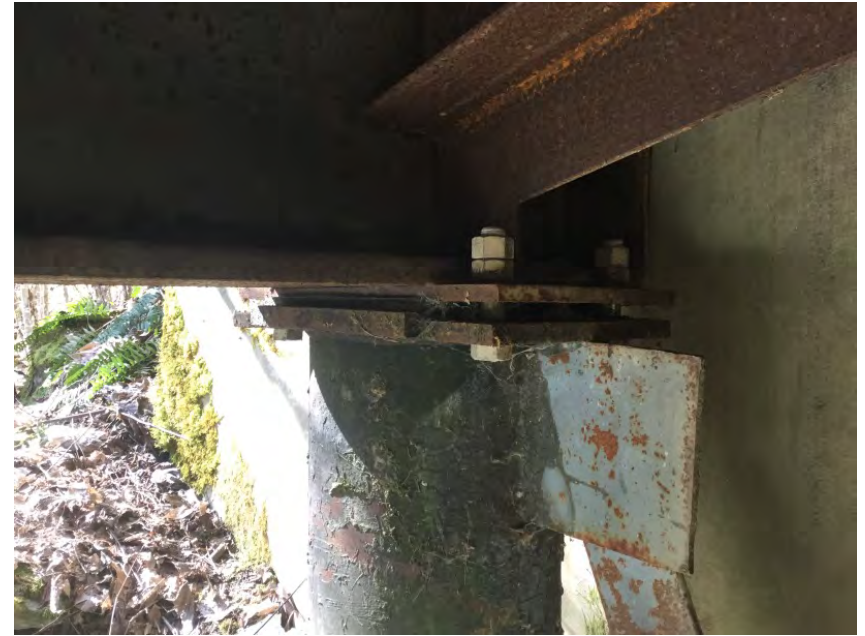
Bearings - typical for all

Bearings Good

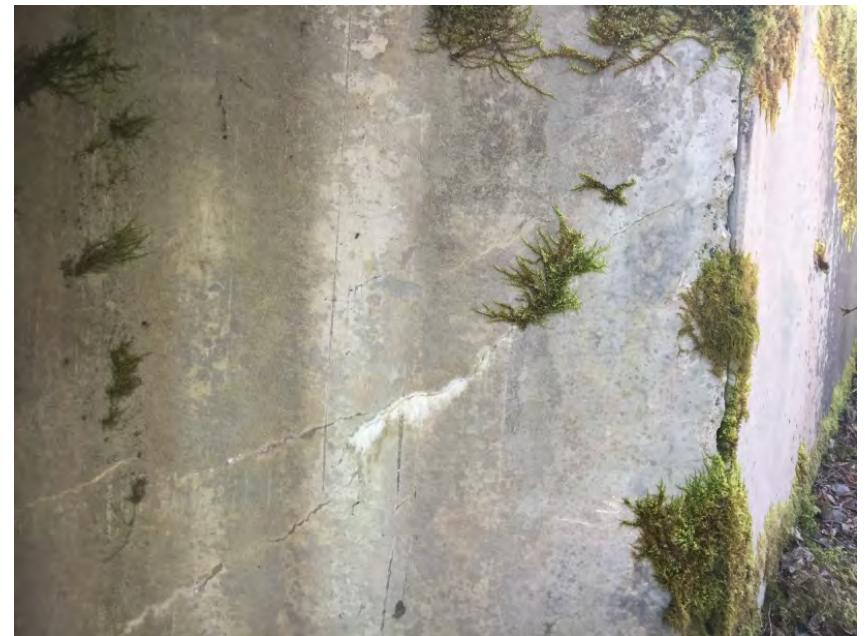
Ballast Wall Fair

Minor damage noted

Hairline cracks noted on downstream left ballast wall

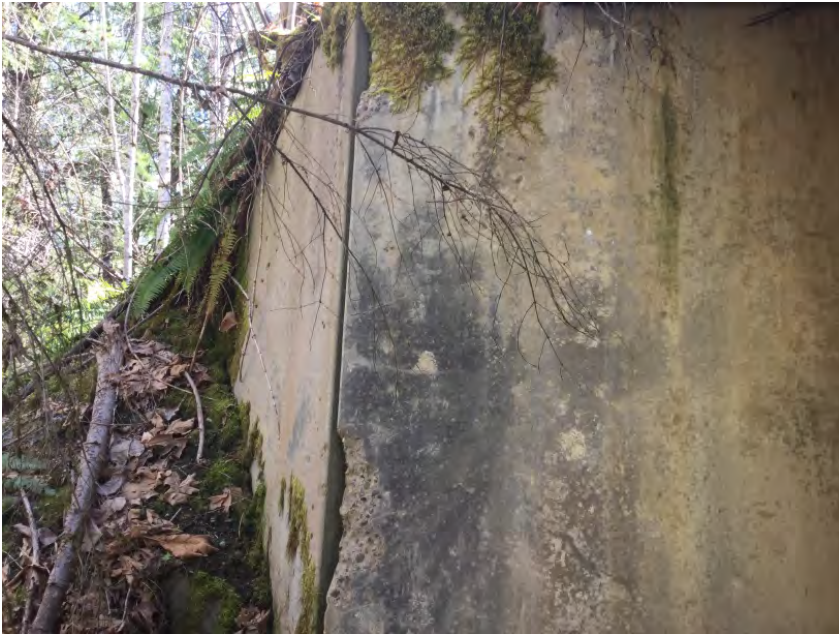
Damage noted to downstream right ballast wall

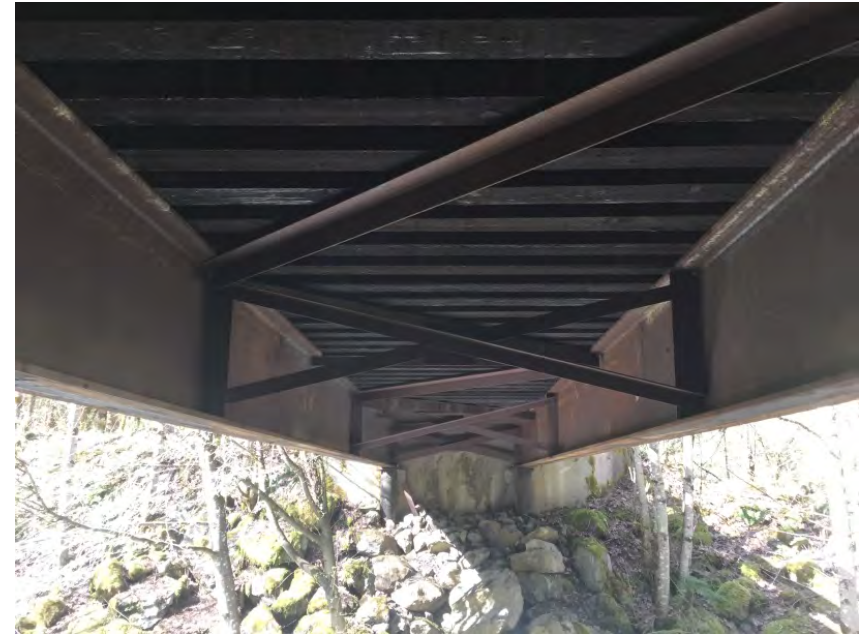
Superstructure

Girders Good Surface corrosion

Diaphragms Good 4 welded bays

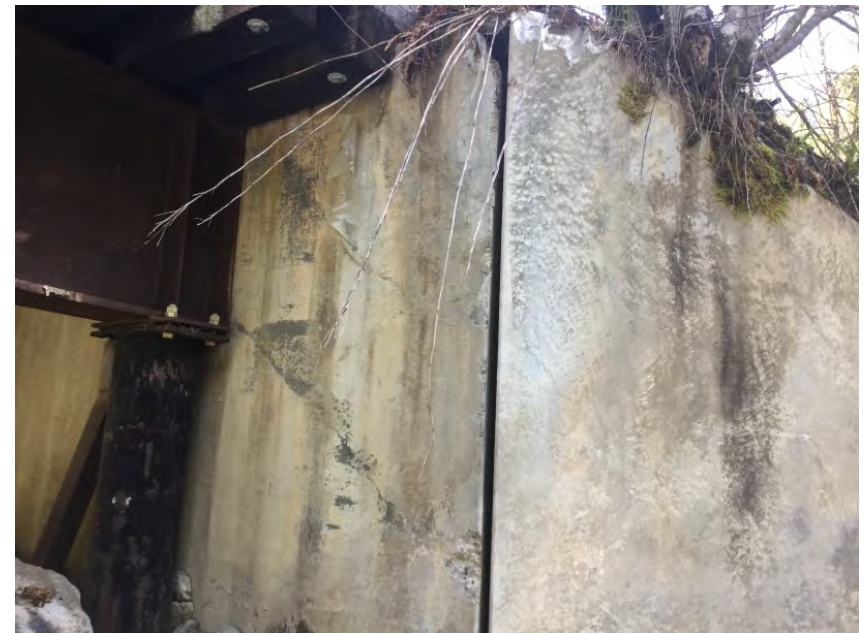
Damage noted to upstream right ballast wall
