CK-2217

PITT RIVER 2.2km

2018 Inspection

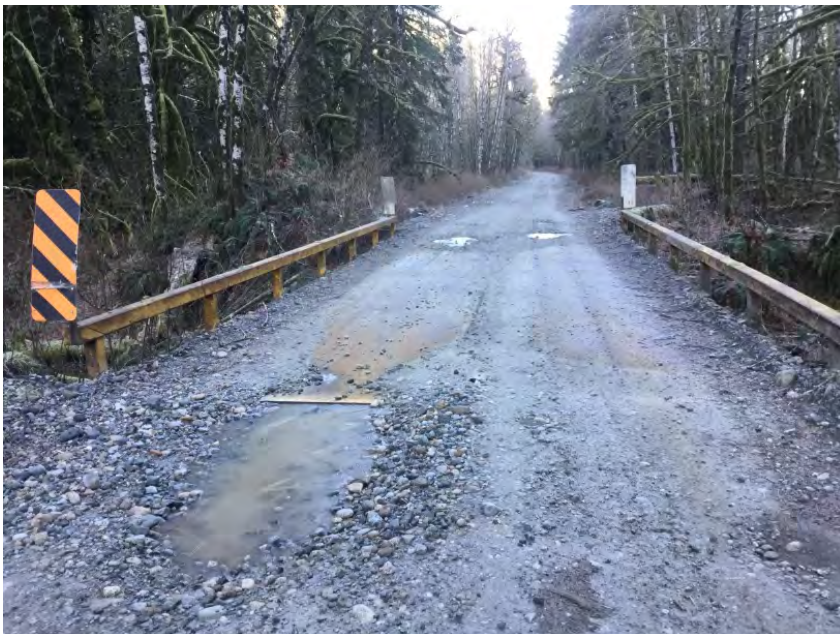
Steel Deck Plate Fair Anti skid surface completely worn off and minor deformation

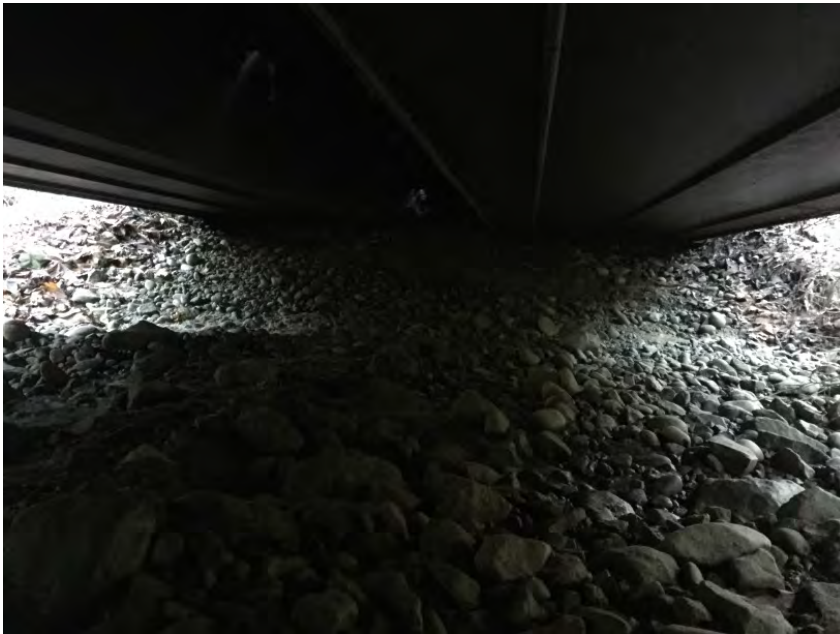
Left Bank Abutment when facing downstream

Caps or Sills Poor Only left abutment visible (timber sill) and can't access for complete assessment; rot visible and no crushing noted

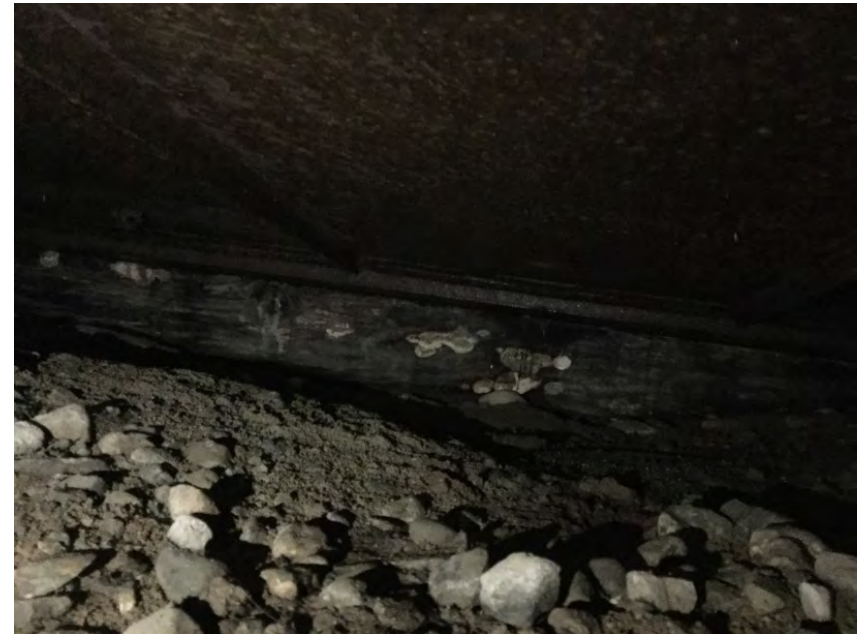
Timber sills

All Steel Portable bridge over spanning old log stringer structure. ASP abutments set back from original log cribs. Low clearance between structures and debris accumulation around ends of bridge prevented complete inspection of the abutments. Timber sill appears to be in poor condition and at the end of their industrial life.

The visible portion of the timber sills are showing signs of rot and at the end of their industrial life. The low clearance between the top of the old log stringer structure and the underside of the All Steel Portable (ASP) structure limits accessibility to other bridge components for complete inspection. The condition of the log stringer structure is unknown due to its difficult accessibility. The file indicates that the All Steel Portable structure was originally planned to be replaced 1 year after its temporary install, originally planned for 2010. Given this information I recommend a complete replacement of the entire structure. Limit loading to L45 or 41 tonnes. Post load rating signs.
