CK-2222

PITT RIVER 18.2km

2019 Inspection

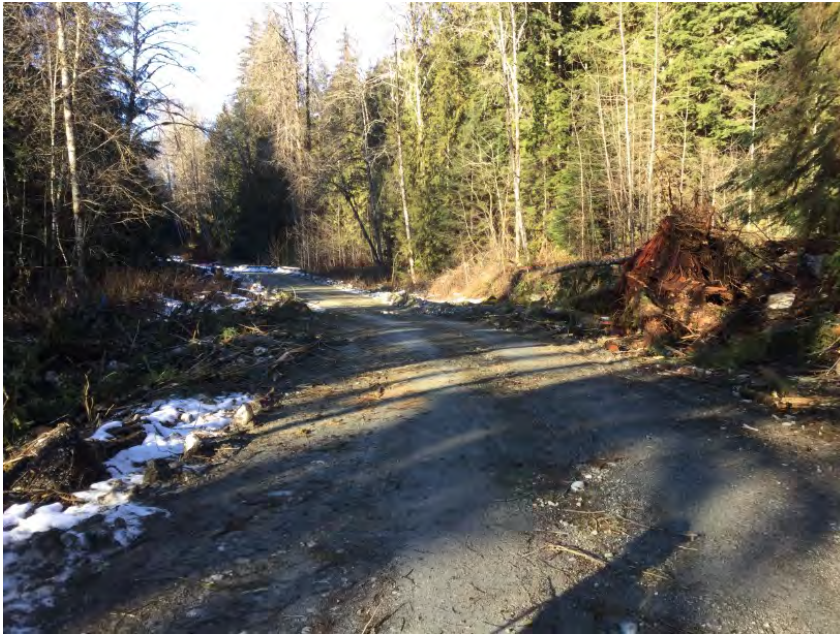
Approach from Left Bank when facing downstream

Bridge Ahead Signs  
Missing ☐ 0 ☐ 1 ☒ 2

Delineator Missing  
Left ☐ 0 ☐ 1 ☒ 2Delineator Missing  
Right ☐ 0 ☐ 1 ☒ 2

| Item | Priority | Repair Description |
|---|---|---|
| 2 | Medium | Replace the missing delineators and post bridge ahead signs |

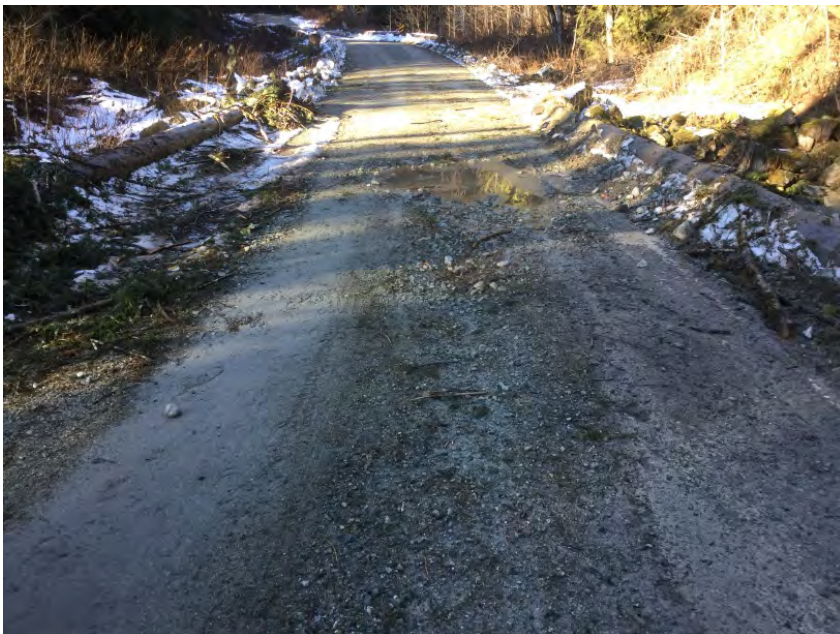
Overall Deck Condition      **Good**

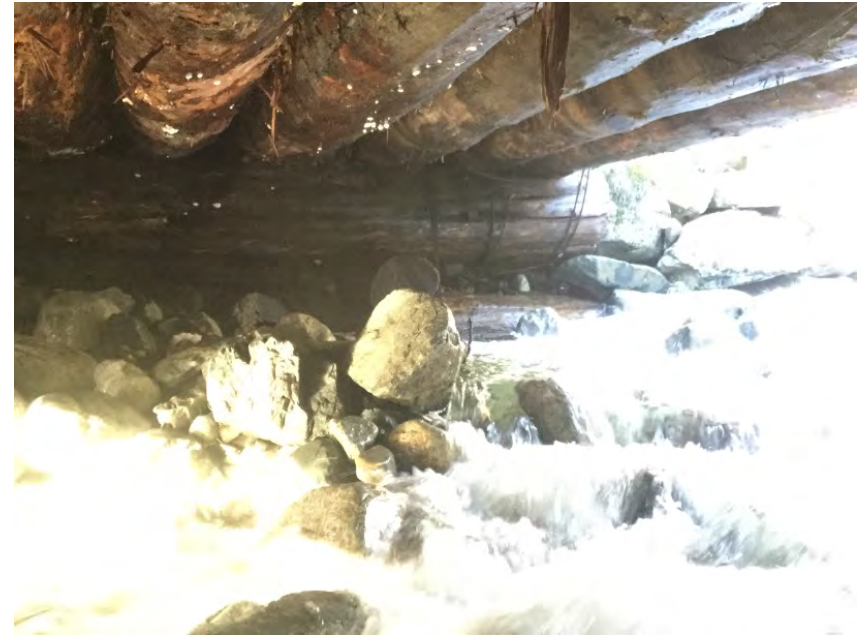
The stream appears to have sustained a large flush as the gravel bars within the channel are no longer present and the stream channel has soured. Minor bank erosion is present.

Scour noted upstream right bank

| Item | Monitor Description | Frequency |
|---|---|---|
| 1 | Monitor stream scour | Routine Inspection |

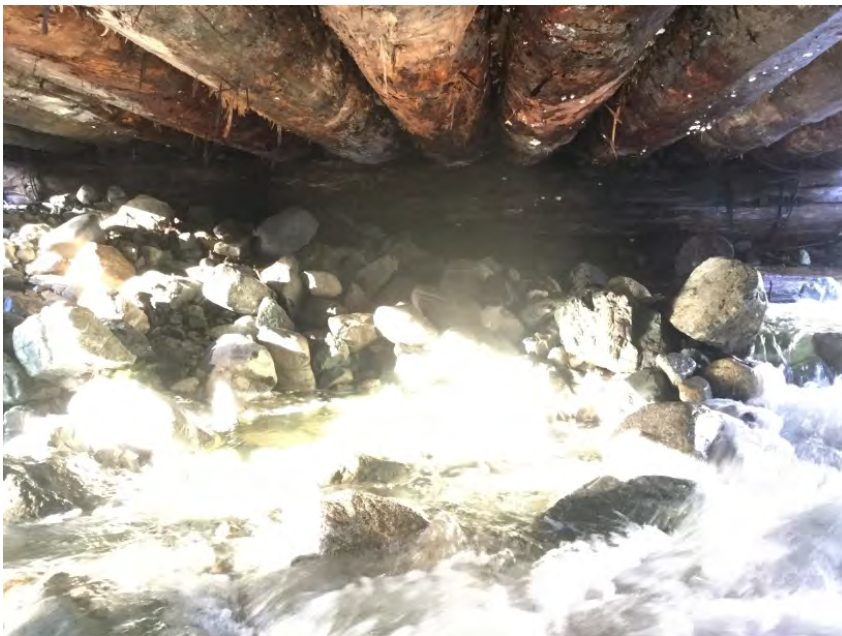
Right Bank Abutment when facing downstream

Log/Timber Cribs Fair 2 face logs, up to 40mm sap rot and no signs of crushing

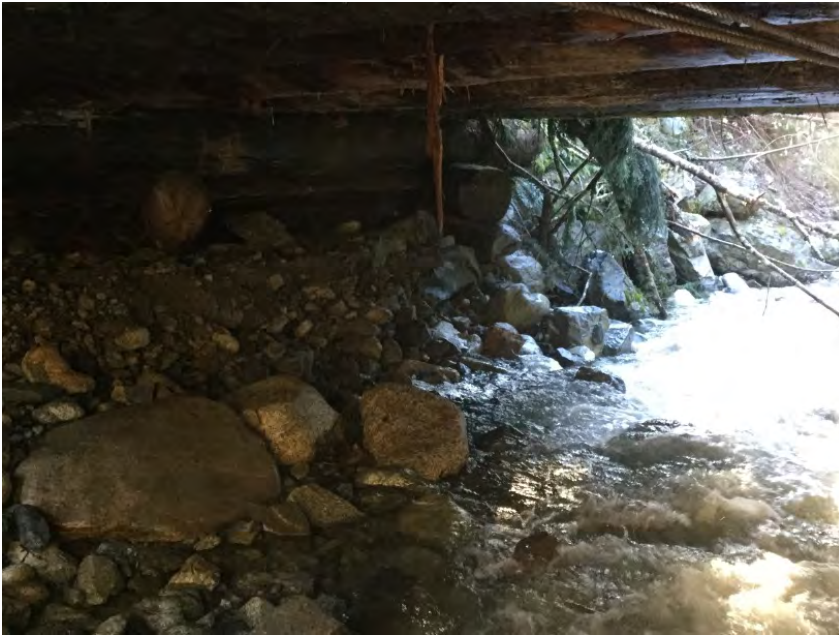
Scour noted downstream left bank
