CK-2224

PITT RIVER 23km

2018 Inspection

| Crossing Name | Shale Creek | | |

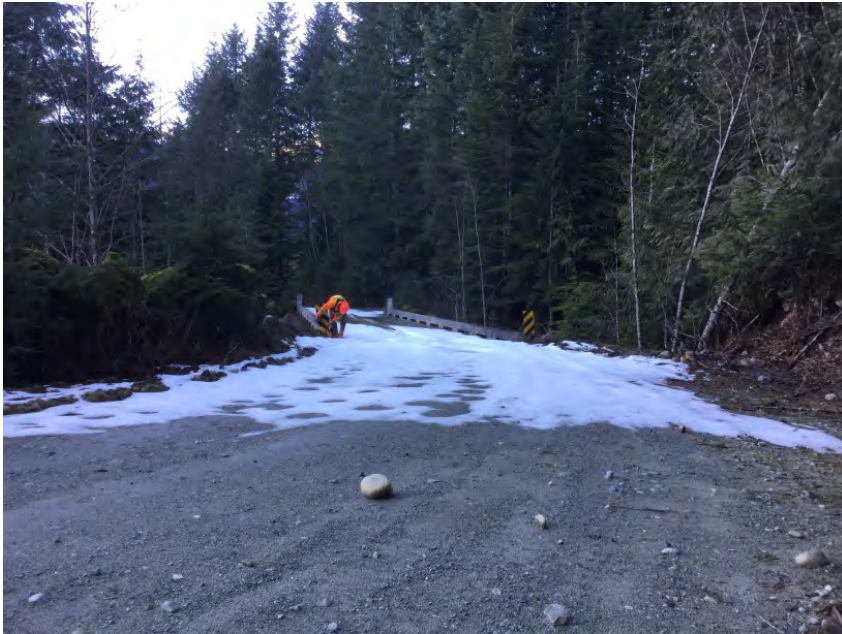
Approach from Left Bank when facing downstream

Undersized and rotting. Boulders downstream left approach

| Repair Item | Priority | Repair Description |
|---|---|---|
| 1 | Medium | Replace fenders with minimum 600 mm diameter |

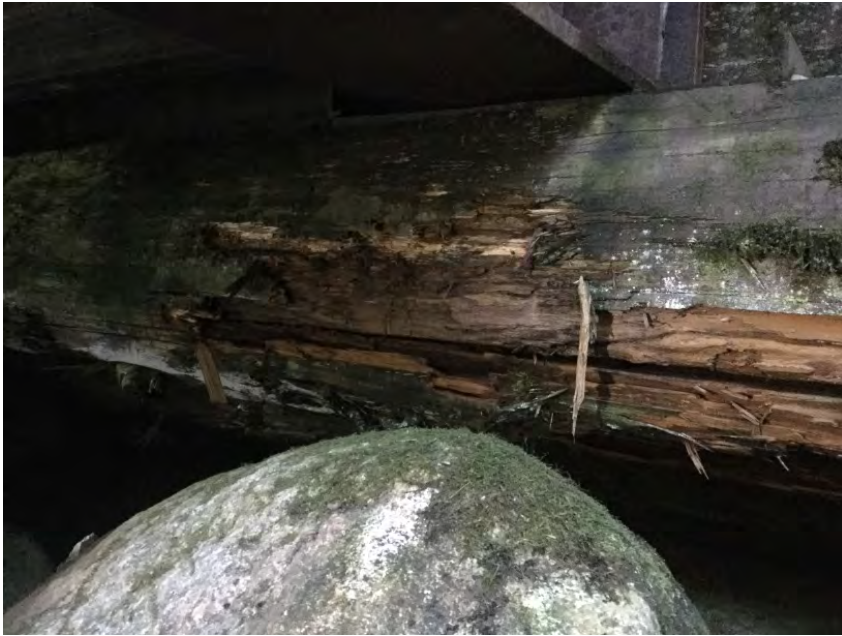
4 face logs. 4 m horizontal crack on top face log right bank, however no signs of crushing to distress - monitor

Horizontal crack (4m) on top faced log right bank abutment

| Item | Monitor Description | Frequency |
|---|---|---|
| 1 | Top face log on right bank | Routine Inspection |
