CK-2227

BOISE 2km

2019 Inspection

Crossing Name Side Creek

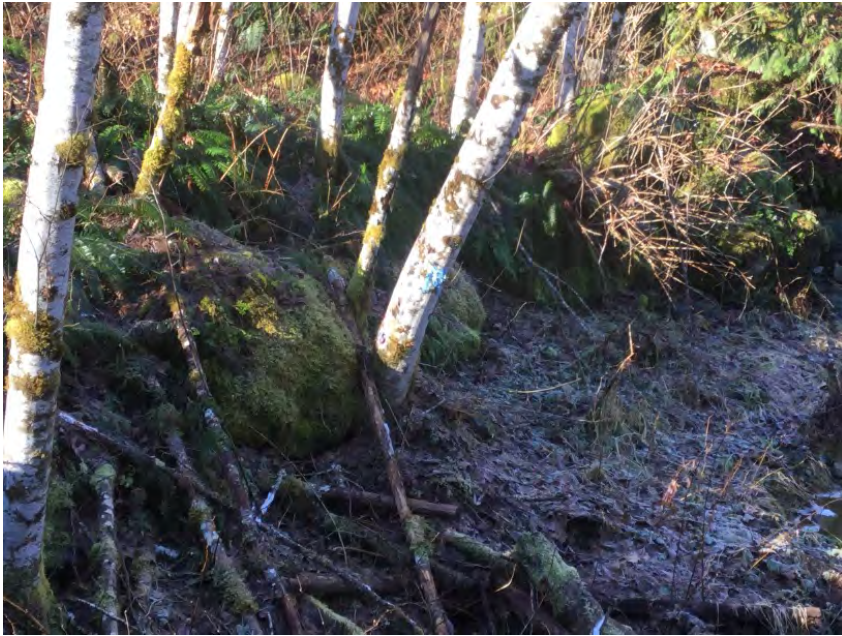
BM noted

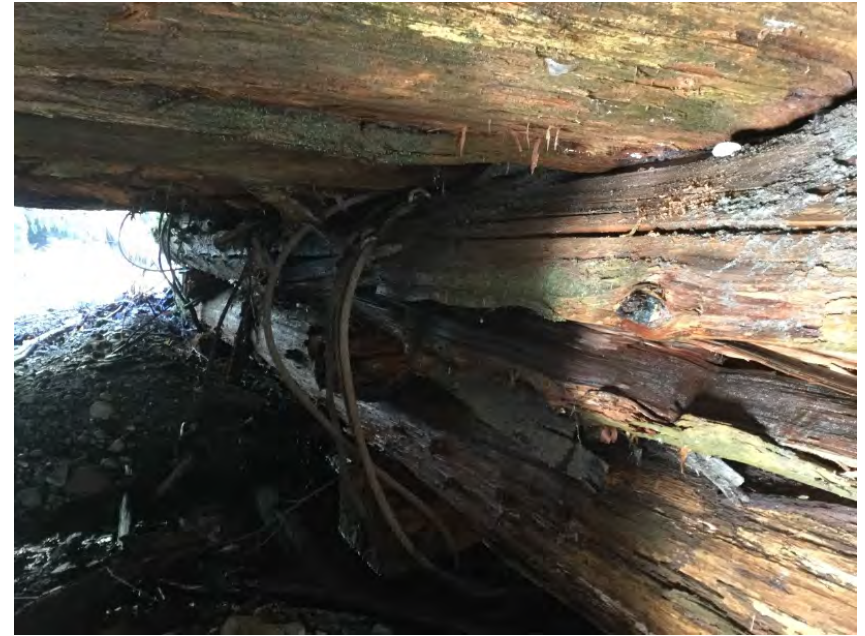
Log/Timber Cribs Poor Top face log on left abutment crushing

Top face log on left abutment crushing
