CK-2228

BOISE 3.2km

2018 Inspection

| Structure Class | Temporary Bridge | | |

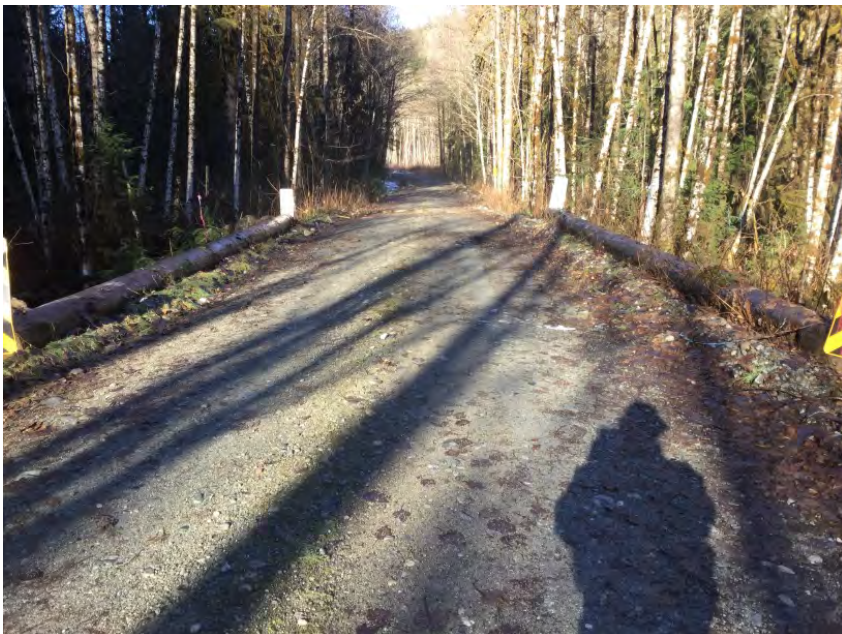
Deck

Gravel Surface Fair

Curb Rail/Blocks/Posts Fair

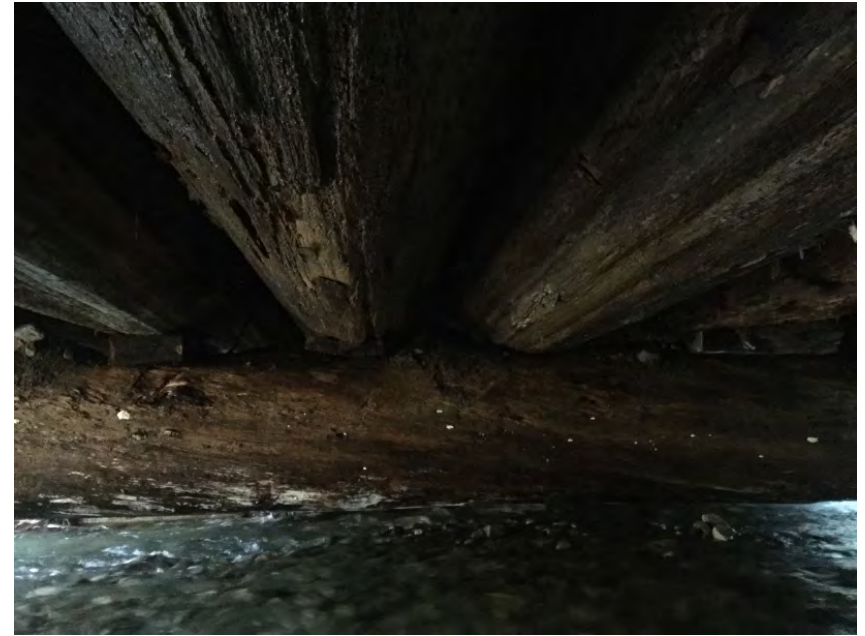
Stringers

Needle Beam Poor Cw, 700mm and not tight to stringers

Needle Lashing/  
Shimming Poor loose

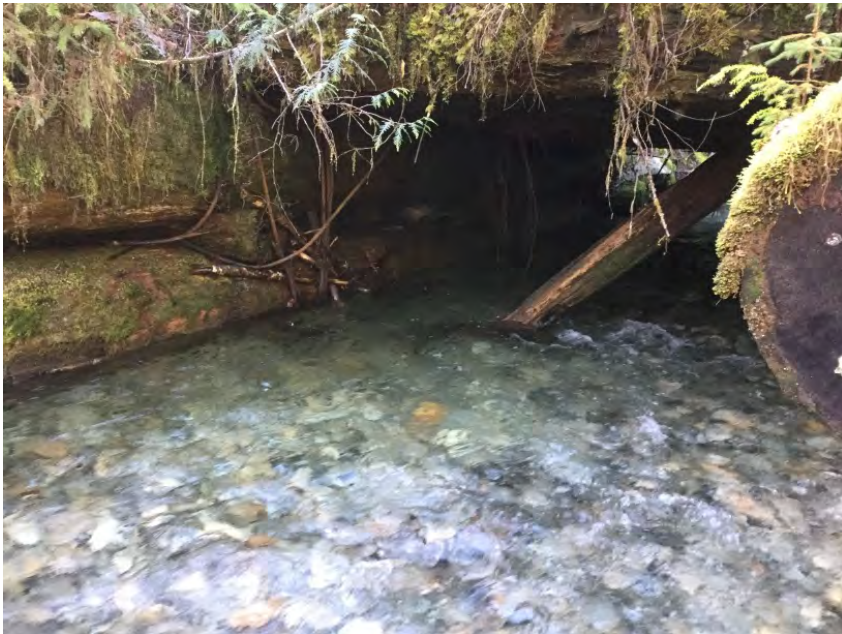
Right Bank Abutment when facing downstream

Log/Timber Cribs Fair 2x

Tie Backs Poor Rotten

Hardware Poor Loose lashing

Riprap Poor None
