CK-2234

RUBY 17km

2018 Inspection

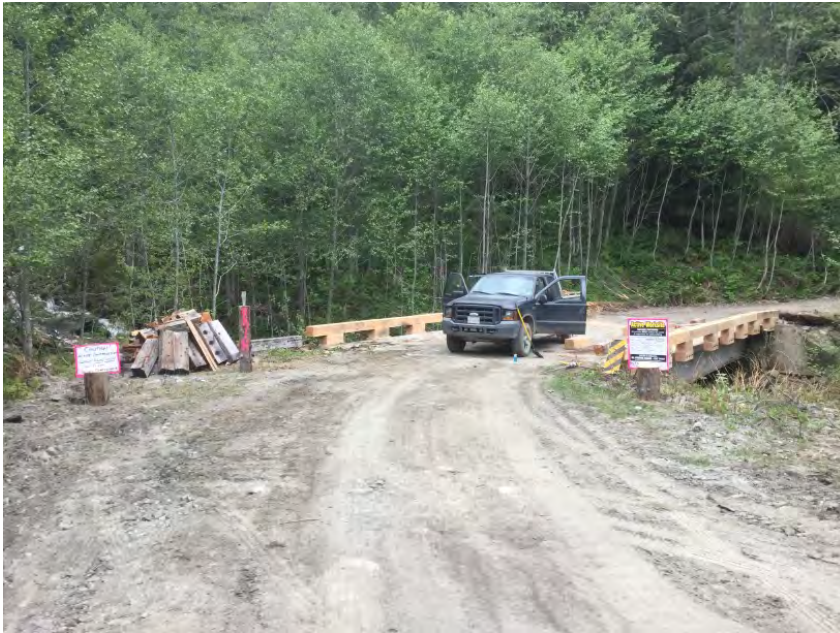
Approach from Right Bank when facing downstream

Fender Condition Poor

Missing right bank fenders

| Item | Priority | Repair Description |
|---|---|---|
| 2 | Medium | Place fenders at right approach and post bridge ahead signs |

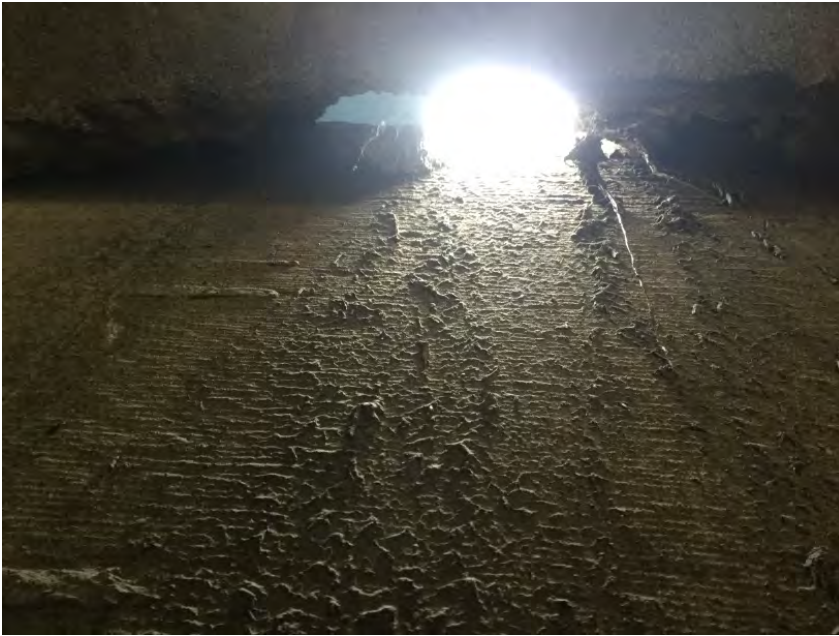
At the time of inspection the guardrails were being replaced and delineators were onsite. The crew was also instructed to repair the damaged concrete panel as identified in the last inspection

Damage to downstream left bank panel 1

Ensure the damage noted to the deck panel has been repaired. Place log fenders or concrete no post barriers at both approaches and post bridge ahead signs. Current load rating of L60 or 54 tonnes to continue. Because the design load rating is lower then the highway legal limit I recommend posting load rating signs.

| Item | Priority | Repair Description |
|---|---|---|
| 1 | Medium | Repair damage to panel |
